FLYER TO THE SHIPPING INDUSTRY

Fatality on the diving support vessel *Wellservicer*

January 2010

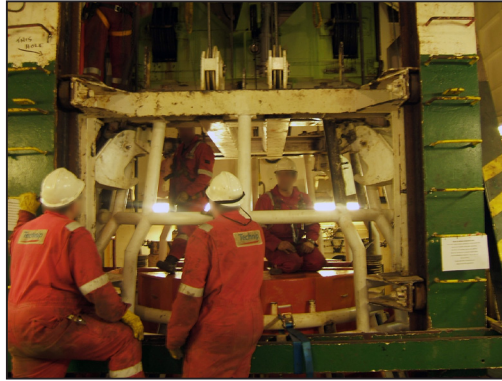
A crew member suffered fatal injuries while carrying out modification work on the diving bell recovery system of the diving support vessel *Wellservicer*.

Part of the modification required the removal of buoyancy blocks from the top of the diving bell. A rigger climbed on top of the bell to do this, but the blocks were very cumbersome and it became apparent that the cursor would have to be raised further to enable the blocks to be removed. Power was applied to the new winch and an operator went to a control position sited above the cursor and diving bell from where he began to raise the cursor. From the control position, the operator was unable to see the top of the diving bell and he was directed by a rigger using hand signals from a visible part of the deck below. Once the cursor was at a suitable height, lifting was stopped, power to the winch was switched off and work on top of the bell set to continue. A few seconds later the winch rendered and the cursor fell, trapping the rigger between the diving bell and the cursor.

The cause of the winch failure was attributed to a faulty pilot valve in the cursor's winch control system, which prevented the winch brakes from applying once hydraulic power was removed.

- The design of the hydraulic circuit for the new cursor winch meant that the two brakes fitted to the winch did not operate independently, as they were required to do, since a single, defective, pilot valve was common to both brake circuits.

- The installation team failed to apply the most basic of safety principles while working under the suspended load. Regardless of whether the winch had been commissioned and declared fully functional, the cursor should have been supported by additional means, before anyone went underneath it.

- It is extremely inadvisable to place any confidence in the safe operation of machinery that has not been fully commissioned and which therefore has not been properly tested.
