IMCA Safety Flashes summarise key safety matters and incidents, allowing lessons to be more easily learnt for the benefit of all. The effectiveness of the IMCA Safety Flash system depends on members sharing information and so avoiding repeat incidents. Please consider adding safetyreports@imca-int.com to your internal distribution list for safety alerts or manually submitting information on incidents you consider may be relevant. All information is anonymised or sanitised, as appropriate.

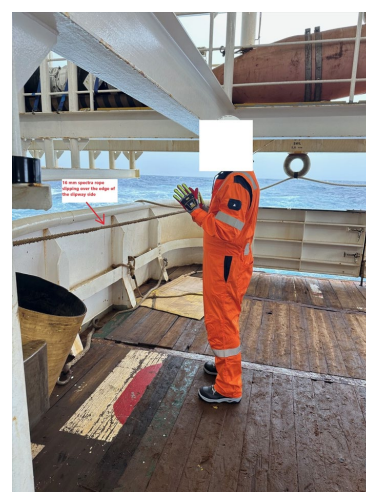
A member of the crew suffered a serious hand injury when struck by a rope under tension. The incident occurred when equipment in the sea was being retrieved to deck. It was necessary to attach a winch rope to stabilize the equipment as it was hauled aboard. While the equipment was being maneuvered, the winch rope jumped the side of the slipway and snapped back hitting the injured person. He raised his hands as a brace and was struck in his right hand by the rope under tension.

- The underlying causes were:
 - The equipment being recovered was moving around owing to sea conditions, causing the winch rope to move also;
 - It had been thought that this would be a safe zone as this has not happened before;
 - The injured person was stood in a hazard area not recognized as such – there was no “No go zone” outlined;
- The root causes were:
 - There was complacency and potential risks were not identified;
 - The vessel was not designed to handle equipment in the way it was being done.

Position of crew at time of injury (re-enactment)

- Situational awareness: take a new look at how work is taking place, and try to recognize previously unnoticed new situations that place crew members in the line of fire;
- Better identify and mitigate dynamic risks during operations – if necessary, adapt plans to the weather and environmental conditions;
- There was a review of the work instructions for this activity;
- A “No-Go Area” during recovery was implemented;
- This task was redesigned to remove the risk as far as was possible.

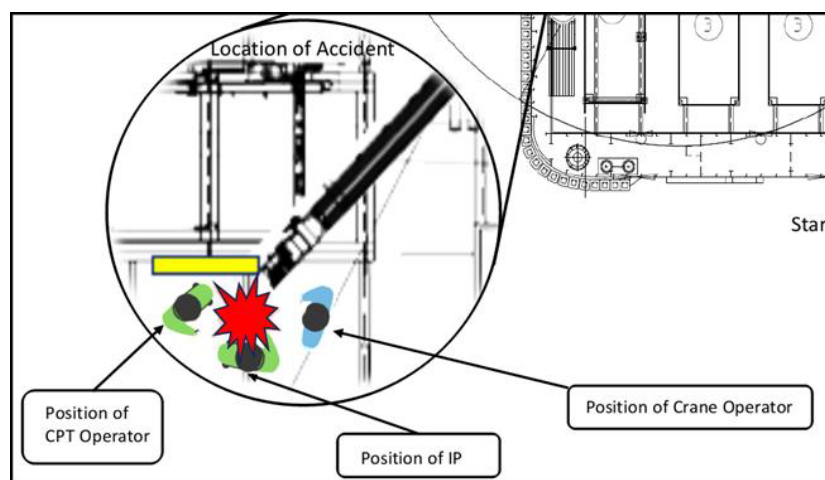
Event 1

While positioning for a lift the boom of a deck-mounted 1.5t folding crane was slewed and extended causing the overhaul ball to contact the sheave (two-block), resulting in the crane wire parting. The overhaul ball, lifting hook, and lifting chains (22.5kg) fell to deck from a height of approximately 6m. A member of the work party was struck and sustained a soft tissue injury.

- Only trained, competent, and experienced personnel should be involved in lifting operations;
- Supervisors need to actively supervise the work – and not be tempted to offer practical help or to join in;
- All personnel must be vigilant and keep themselves and others out of the line of fire;
- There is a shared responsibility for safety which exists between the supervisor – the person controlling the work and the people doing the work.

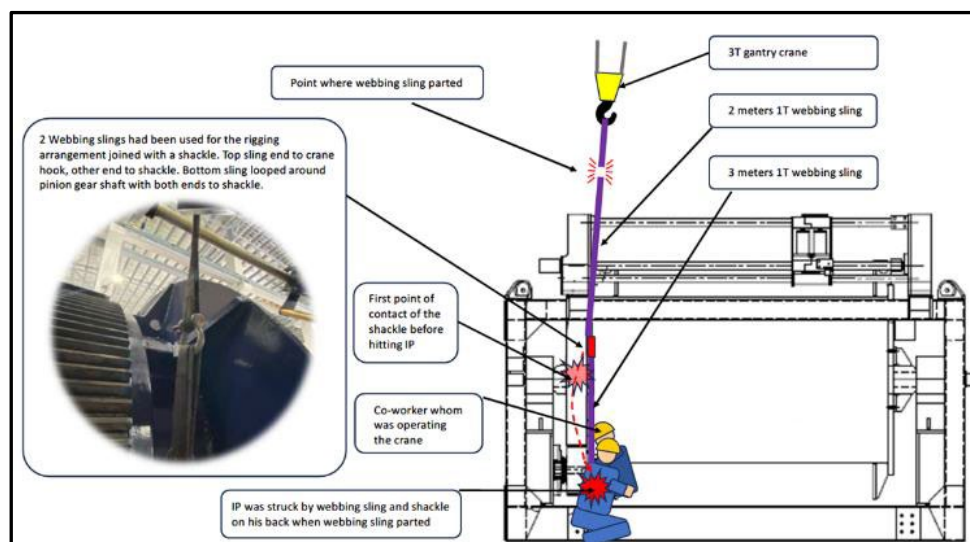
Event 2

During the assembly of a LARS winch, an overhead gantry crane was being used for the final positioning of a component. The intent was only to use the crane for alignment of the component, rather than lifting, however excess load was inadvertently placed on the soft sling being used. This caused failure of the sling and the uncontrolled release of a connected shackle. The shackle struck a member of the work party again causing injury.

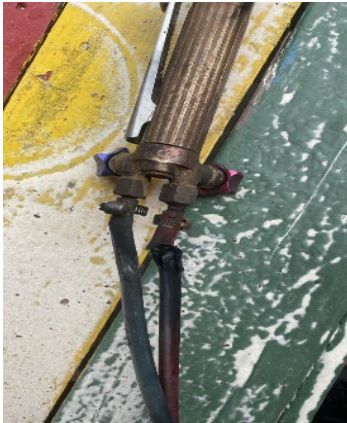
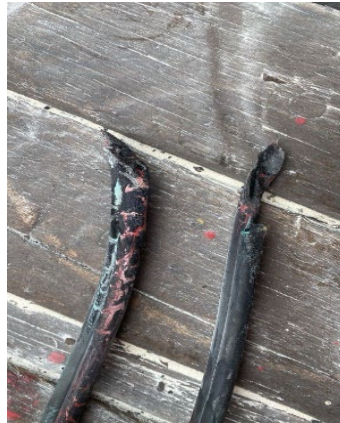
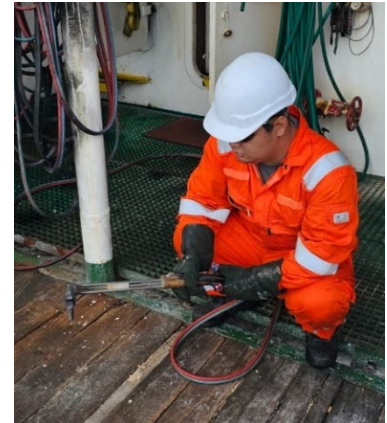
There was a small explosion and fire when crew were working on an oxy-acetylene system. Two engineers were setting up a new oxygen and acetylene cylinder for testing. They installed a flash arrestor and hoses on the cylinder, ensuring they were free from oil and grease. One of the engineers opened the nozzles of the oxy-acetylene bottle, igniting flames at the nozzle tip. A small explosion occurred, followed by flames from the acetylene hose connection on the torch. The hoses burst within seconds, causing that worker to get burnt. The other engineer pulled the injured person to safety. The fire was extinguished using a dry powder fire extinguisher. The injured engineer suffered first-degree burns.

Showing equipment damaged (re-enactment)

- The Oxygen/acetylene torch was not equipped with adequate flame or flashback arrestors;
- There had been excessive bending of the hoses which had led to a compromised flow of gas and increased risk or rupture under pressure;
- There was faulty equipment: The hose crimps on the cutting valve (acetylene) were faulty which led to the flashback occurring.

- Fit flash arrestor to both the oxygen & acetylene gas hoses near to the regulators, for length hose, fit arrestor on both the torch and regulator;
- The fitting of a flashback arrestor is not a substitute for safe working practices. After a flashback, carefully check for damage to the torch, hoses, regulators, flashback arrestor and other components, if found faulty replace the parts.

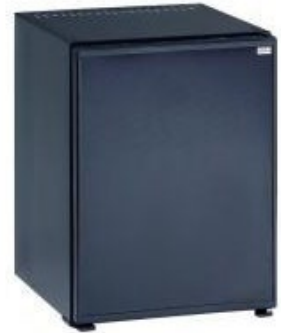
On a vessel alongside, there was a fire in the cab of a crane. At 03:52 the fire alarm panel on the bridge sounded, displaying an indication that fire detection within the crane cab had activated. There were no work tasks being conducted on the crane at the time of the alarm. Two team members were sent to investigate. Upon accessing the crane cab platform, the attending riggers confirmed there was a fire within the crane cab.

The fire was confined to the crane cab, which was destroyed. The incident is suspected to have originated from an electrical fault within the small refrigerator located in the cab.

Members may wish to check small appliances of this nature that may be left powered in an unsupervised place for long periods and identify areas where access with emergency equipment may be restricted.
