Gangway Failure

For further information, email alerts@nopsa.gov.au and quote Alert number 36.

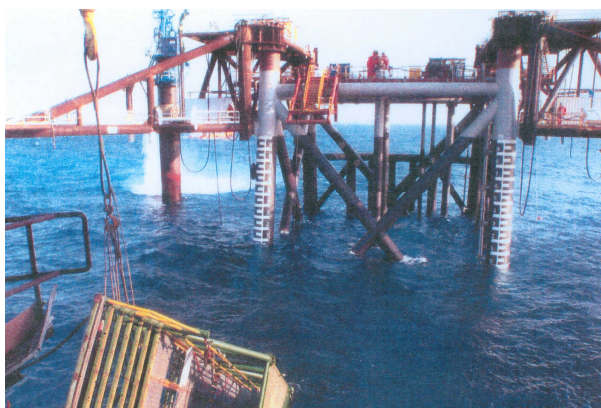
Although slings and chains were placed on the gangway and connected to the landing platform they were too long to prevent the gangway from dislodging from the landing platform, and were of insufficient strength to withstand the impact loads and prevent the gangway from falling into the sea.

The gangway collapsed into the sea

2. Secondary fall protection arrangements must be properly engineered and specified in the installation, operation and maintenance procedures for gangways.
3. These operation and maintenance procedures also need to provide for close visual inspection at least once per shift when the gangway is in use.

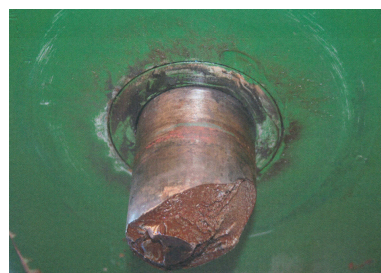
A purpose-built project modular gangway for jacket access from a construction barge parted at the jacket end and fell into the sea. To allow for movement of the construction barge, the gangway had a roller support at the barge end and was supported by a gimbaled joint at the platform jacket end. The failure occurred in the vertical pin of the gimbaled joint.

Investigation determined that a weld around the centre of the pin was omitted during the fabrication process, which would have increased the stress levels in the pin. It was further determined that the incorrect grade of steel for the pin was ordered, although the yield stress of the steel was as specified in the design.

The failed gimbal pin

1. Fabrication yard quality assurance must include a thorough inspection to ensure that the design and specification have been met. These need to include checks that all specified welds have been made, not just Non-Destructive Testing (NDT) of the welds that have been made, and that mill certificates for the steel used matches the grade that was specified, not just in relation to yield stress.
