SB2/2014

Fire and subsequent foundering of workboat

ECC TOPAZ

MAIB SAFETY BULLETIN 2/2014

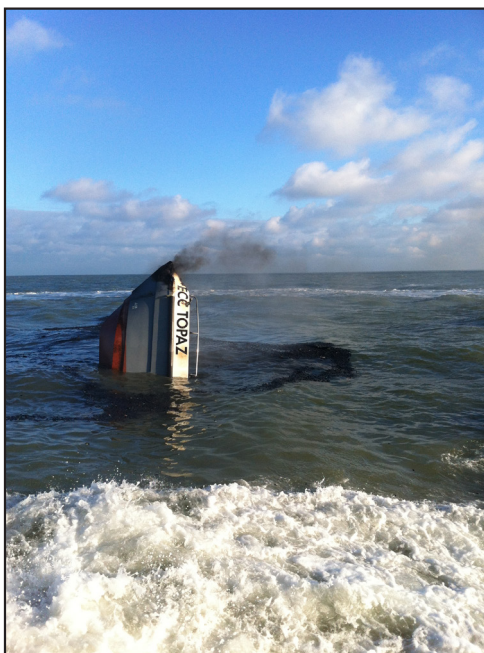
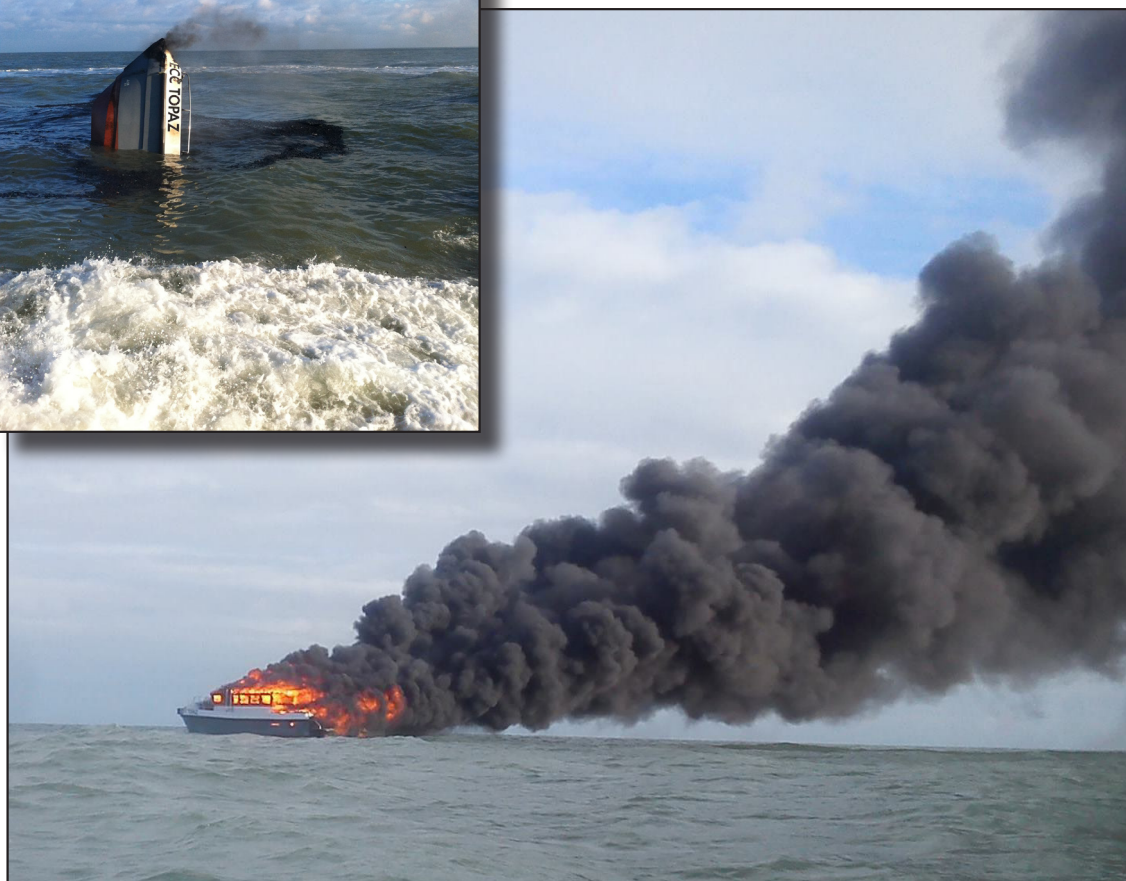
Figure 1: ECC Topaz on fire (inset: subsequent foundering)

At approximately 1230 (BST) on 14 January 2014, the 14m wind farm support catamaran, *ECC Topaz*, caught fire 11nm east of Lowestoft. The three crew members on the vessel were unable to extinguish the fire, which spread rapidly throughout its GRP structure (**Figure 1**), forcing them to abandon to a liferaft. There were no passengers on board at the time of the accident.

Once in the liferaft, the skipper transmitted a “Mayday” call using a hand-held VHF radio and then activated a Search and Rescue Transponder (SART). The crew of another vessel in the vicinity alerted the coastguard when they saw thick black smoke on the horizon. The crew of *ECC Topaz* were winched from the liferaft by helicopter and taken to a nearby hospital for treatment. The fire on *ECC Topaz* continued unabated and, at 1422, the burnt out remains of the vessel foundered in 33m of water (**Figure 1: inset**).

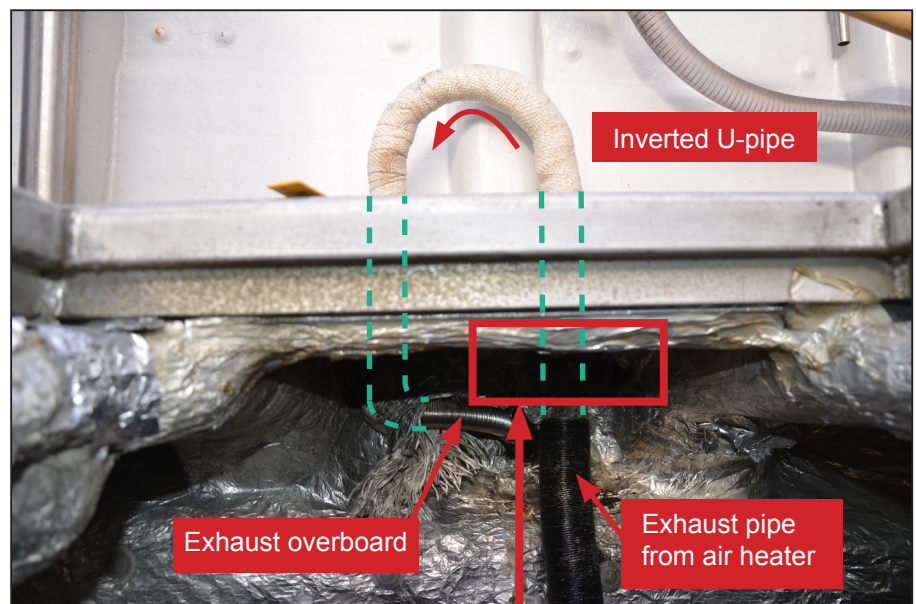
Detailed examination of one of these vessels revealed that the heater exhaust had been modified to route through a single walled, inverted U-pipe on the main deck (**Figure 2a**) to prevent sea water ingress from the exhaust overboard. As originally built, the exhaust pipe was insulated by woven glass lagging protected by an aluminium oversleeve (**Figure 3**) to prevent the hot exhaust gases (around 450°C) from heating the surrounding area. However, where the exhaust piping had been broken to route it through the main deck,

Figure 2a: Air heater exhaust pipe layout on similar vessel

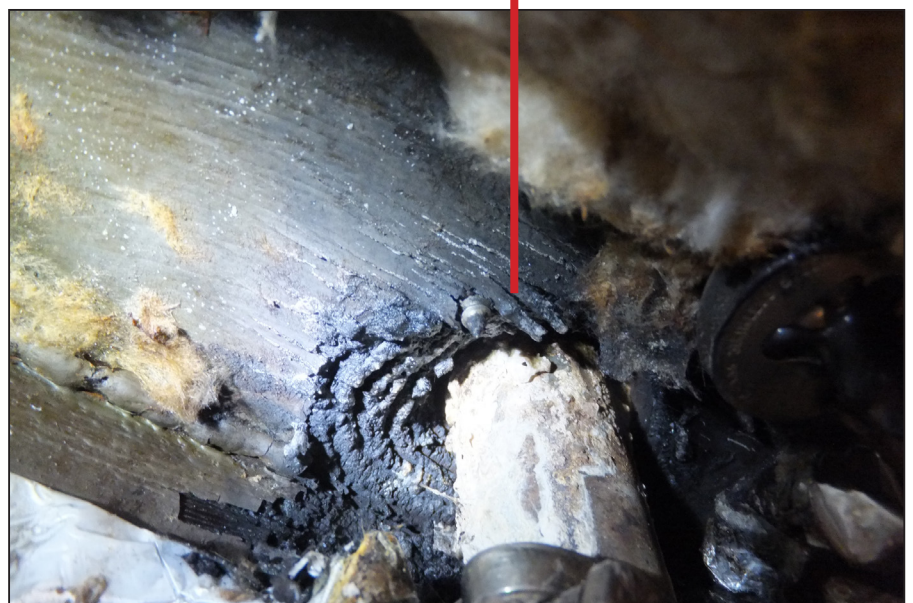
Figure 2b: Scorching under deck on similar vessel

the connection between the heater exhaust pipe and the inverted U-pipe was not insulated. Consequently, the uninsulated section of the hot exhaust pipe in close proximity to the plywood underside of the deck, caused the charring seen in **Figure 2b**.

- Check that all exhaust pipes on their vessels are fully insulated and do not come close to combustible material.
 - Fit fire/smoke detectors in enclosed spaces where diesel-fired air heaters are installed.
 - Avoid placing flammable material in compartments that contain potential heat sources.
- A useful reference is MGN 497 (M+F): 'Dangerous Goods – including Chemicals and other Materials – Storage and Use on Board Ships.'

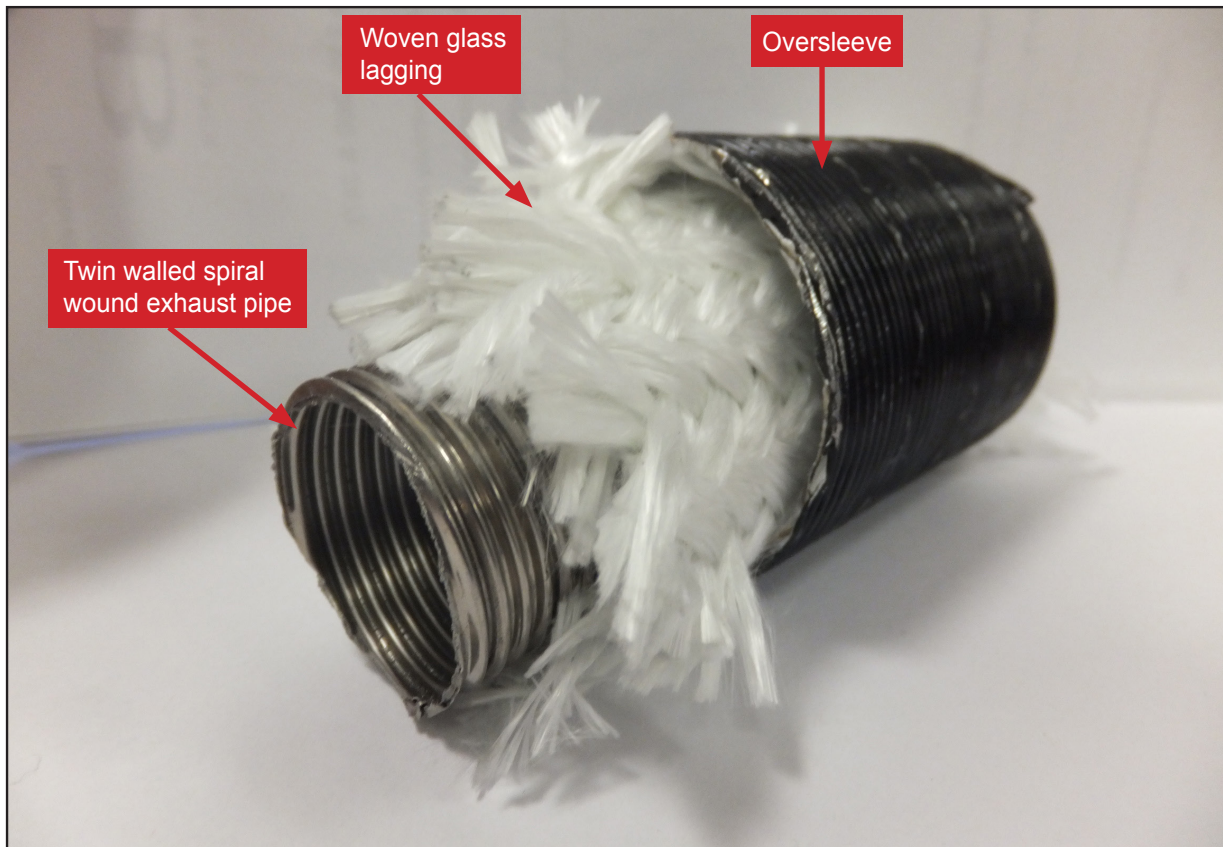
Figure 3: Heater manufacturer's supplied exhaust pipe with insulation
