Isle of Man Ship Registry

Casualty Investigation Report No. CA118

Isle of Man Registered "Sharp Lady"

Enclosed Space Fatality and Near Fatality

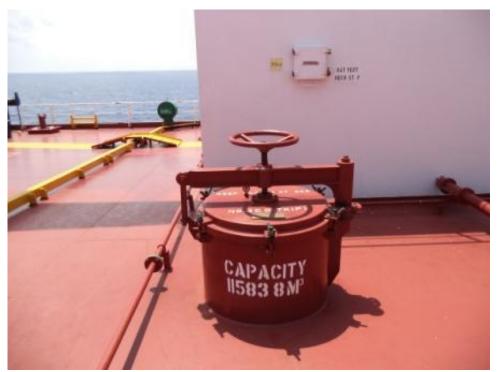
Sharp Lady - 3P Cargo Oil Tank - tank access hatch

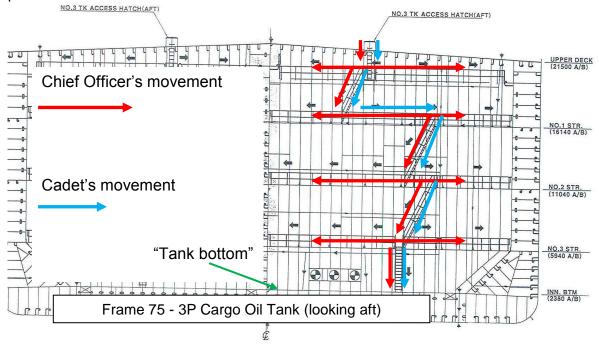
The diagram below depicts the movement of the Chief Officer and Cadet in 3P Cargo Oil Tank. The Chief Officer proceeds first, he climbs down onto the first platform and checks the atmosphere across the platform with the personal gas meter. The Cadet then proceeds down the stairs to meet him. This is repeated for the remaining platforms until No 3 Str platform.

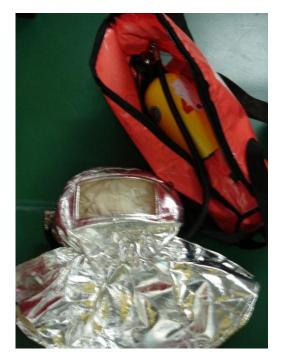
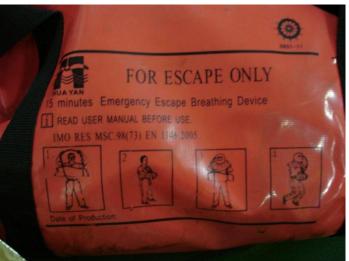
IMO MSC Circular 849 specifically forbids the use of EEBDs for entering oxygen deficient voids or tanks. In this case the EEBDs were not used to enter an oxygen deficient atmosphere but to escape from high hydrocarbon gas concentrations.

The Sharp Lady is provided with 15 Jiangsu Huayan Marine Equipment EEBDs each capable of approximately 15 minutes duration of average usage. The EEBD is approved to IMO Res MSC.98(73). The EEBD is a self-contained, open circuit, compressed air, constant flow EEBD. It comprises a compressed air cylinder with a combined reducer/cylinder valve, attached to a close fitting escape hood by a breathing hose. The whole unit is contained within a stowage bag ready for immediate use. The high-visibility bag is clearly marked FOR *ESCAPE ONLY*. See the following pictures;

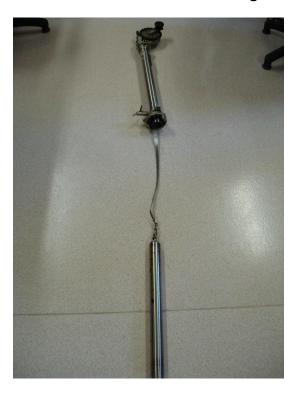
The complete oil sampler device

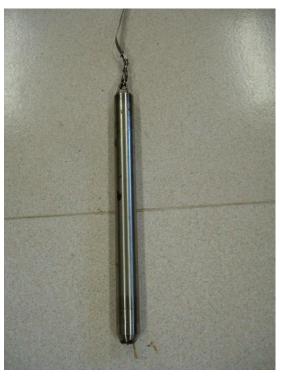
The oil sampler bucket
