Accidental breaker trip

DP Event • Published on 3 September 2019 • Generated on 28 January 2026 • DPE 03/19

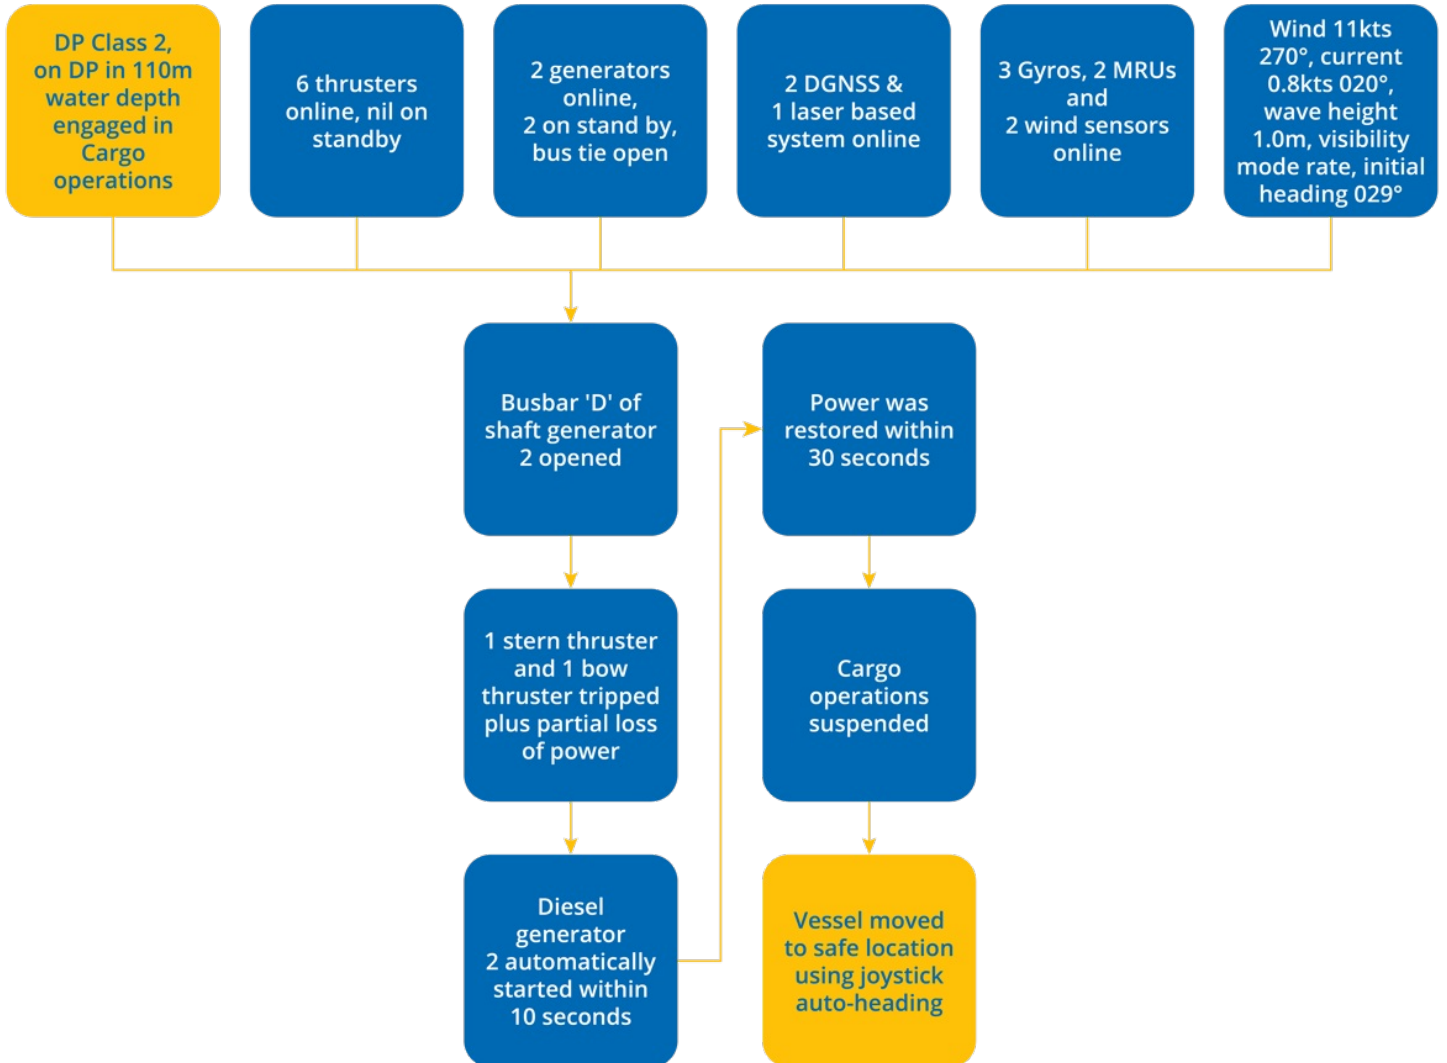
The watch keeping engineer lost his balance and his hand made contact with the shaft generator breaker push button.

The vessel was experiencing heavy rolling and pitching. The watch keeping engineer lost his balance and his hand made contact with the No.2 shaft generator breaker push button, thus opening the breaker and causing the loss of power.

The vessel has installed transparent covers over vulnerable breaker push buttons to avoid re-occurrence.
