Bow thruster tripped due to lack of power

DP Event • Published on 13 September 2016 • Generated on 21 January 2025 • DPE 03/16

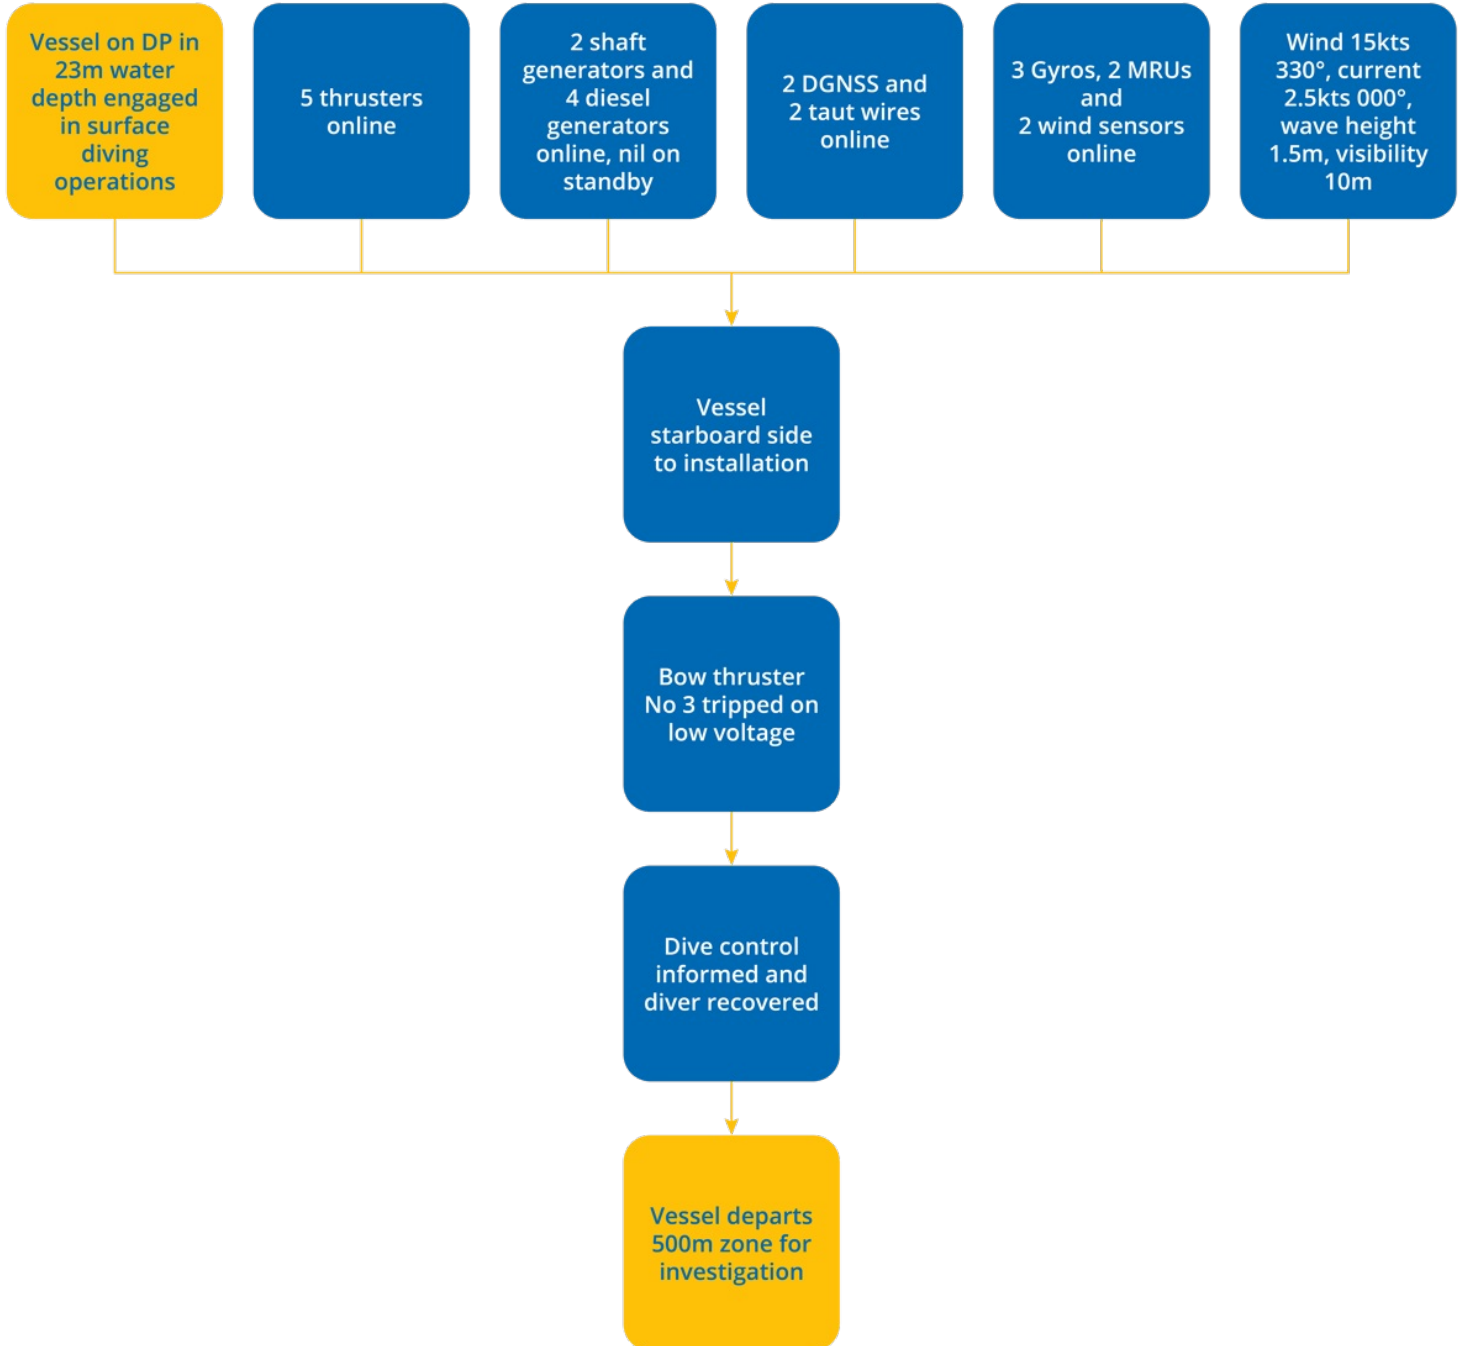
The seat for the stop solenoid on the engine was damaged causing a slight air leak causing a reduction in main engine rpm.

The seat for the stop solenoid on the port main engine was damaged causing a slight air leak past it, this acting on the stop cylinder piston caused a reduction in main engine rpm. The reduction in rpm caused a low voltage alarm followed by breaker trip and low frequency alarm. Power was lost to bow thruster No.3 due to a breaker trip on the switchboard, the port azimuth thruster was not affected as the clutch out rpm was not reached.

The vessel has reduced the inspection interval of the stop solenoid valves from annual to six months.
