Configuration – PRS' hidden common failure

Incident ●

DP Event • Published on 13 December 2021 • Generated on 23 January 2025 • DPE 04/21

A yellow DP alert was activated on a vessel conducting ROV operations in open waters in the North Sea.

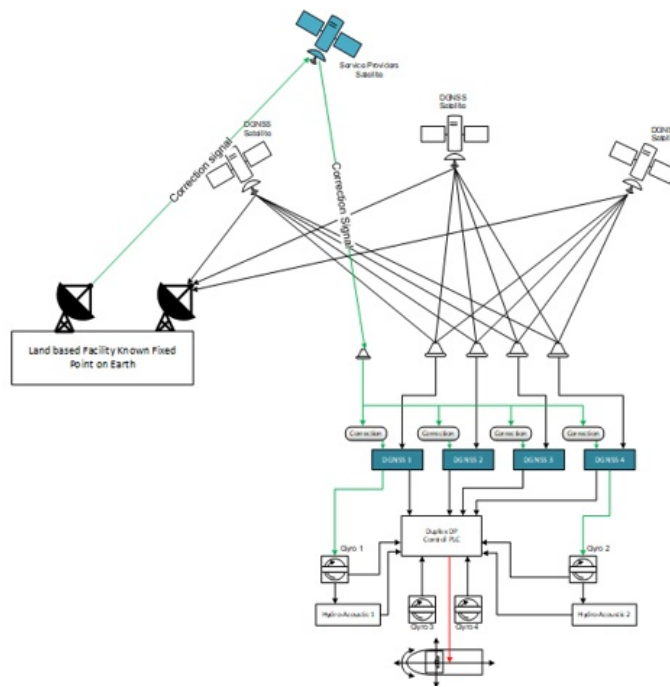
Figure: DGNSS correction configuration prior to failure

Below is a list of step causes that together led to the incident highlighted above, the figure below shows how the DGNSS was configured prior to failure:

- The correction signal suppliers satellite signal was reported as failed for 1hr 3mins.
- All four of the DGNSS modulators (signal correction modules) were locked onto a single source.

- Failure of the single correction source led to the loss of DGNSS and prompted the DP Control to reject all four DGNSS PRSs.
- Both Gyros 1 and 2 took automatic updates from the DGNSS for latitude and speed correction.

- A common mode failure had been introduced.

- For the Hydro-acoustic calibration, the configuration was altered and did not appear to be documented and, as such, was not returned to the fault tolerant configuration.

- Not all stakeholders were party to the fact that the calibration required a configuration change – in this case the DPOs were not informed.
- Check lists did not capture the fact that only one common correction was being used and that the settings for DP Control would reject DGNSS on loss of correction signal (Raw data usage is an option for some DP Control systems). The DGNSS topology needs to be clearly displayed and understood and this can be an area where people instinctively shy away from, due to its perceived complexity.
