DP2 Service Operations Vessel (SOV)

Incident ●

DP Event • Published on 18 June 2021 • Generated on 28 January 2026 • DPE 02/21

The importance of careful selection and planning in the use of position reference sensors and the potential consequences therein.

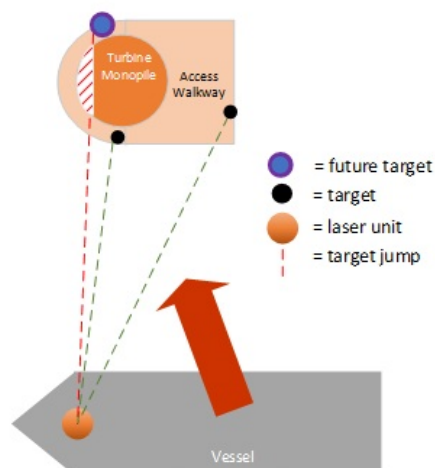
VESSEL APPROACH

During the handover of the watch, the SDPO took control and commenced with the DP handover checklist. The vessel was stopped in all movements, outside the 50m radius – abeam from the wind turbine. The laser position reference sensor was operating and set on a target, but not yet enabled in DP. The SDPO initiated a 20m move in order to move slowly inside the 50m radius of the turbine. On finalising of the six hourly DP handover checklist, the laser position reference was selected to DP. All reference systems were online and were enabled in DP. The laser position reference was set on “auto tilt” and brightness filter at 60%, blanking zones were set.

The distance to the tower was 40m when the SDPO commenced a move of the vessel towards the tower in order to get the vessel alongside for walk to work operations. After the move was completed, the SDPO deselected the laser position reference

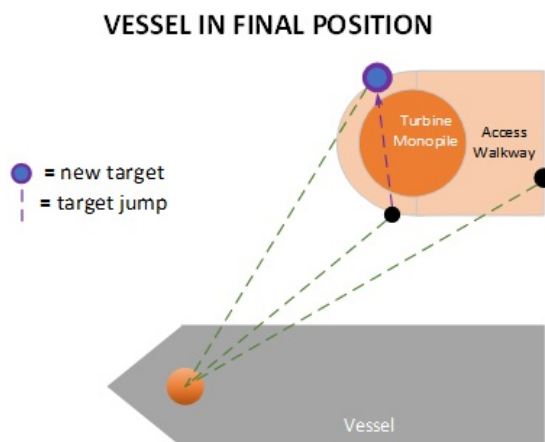
The SDPO changed the selection of the target because it would get obstructed by the railings of the walkway around the turbine when the vessel would move closer. The 'new' selected laser target had a clear sight with the laser position reference transponder/receiver unit. Once the laser signal was stable the SDPO enabled it back in DP. Shortly after, the vessel arrived in final position and the SDPO informed the walk to work management team.

When the SDPO was looking to the reference system main view, he saw that the DGNSS were at the bottom on the edge of the median test line and that the laser reference had disappeared from the view (view range set to 5m). At this time, the DP system alarmed, "Reference prediction error Laser", and, "Reference median deviation laser". The SDPO informed the walk to work management team to standby. As the SDPO could clearly see that both DGNSS were operating well, he disabled the laser reference from DP. As expected the vessel started to accelerate towards the tower and the SDPO deselected the sway axis to stop the movement towards the wind turbine.

During the station keeping event, the maximum position excursion towards the wind turbine was around two metres and heading deviation around two degrees.

The DPO controlled the vessel's speed for sway axis with the joystick and moved 10 metres away from the wind turbine. Sway axis was selected on DP again and an assessment was made in order to use the laser reference again. The blanking zones of the laser reference were slightly adjusted, in order to prevent accidentally "jumping" onto false targets. After the laser reference looked stable again, it was enabled on DP and the vessel was moved back in position for walk to work operations. Walk to work operations were completed with no further station keeping issues.

- The fast acting response of the crew undoubtedly prevented this event from becoming more significant.
- The planning of the use of position references is of key importance in such an operation where there is a relatively small target area such as a monopile of a wind turbine. The smaller the area, the more challenging the risk of target jumping becomes. The number and placement of targets is of paramount consideration.
- The use of difference sensor technology may have avoided this event. For example, microwave position references.
- The event report did not highlight the use of activity specific operating guidelines nor any change to DP status during the DP event.
