DP2 supply vessel

DP Event • Published on 25 August 2021 • Generated on 28 January 2026 • DPE 03/21

After 'daily checks' on the running engine, engineers accidentally activated the emergency stop which resulted in an immediate blackout.

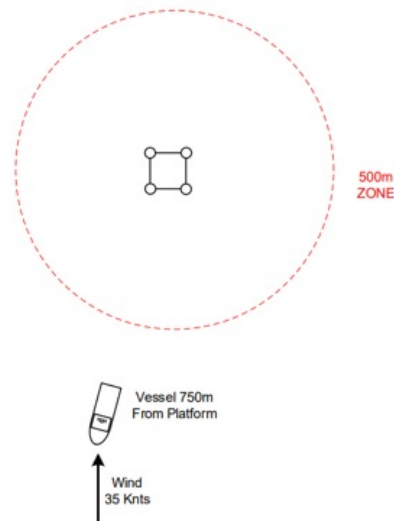
A DP2 supply vessel was sitting on stand-by outside a 500m zone of a gas platform awaiting orders for cargo operations. Whilst outside the 500m zone and on standby, the vessel closed the bustie and reduced to a single generator and three out of the five available thrusters.

Note that the vessel was upwind of the platform and in a 'Drift on' position. The area was difficult to find a safe drift off position due to location of several other platforms and sandbanks with shallow water.

Figure one – Vessel on stand-by outside 500m zone

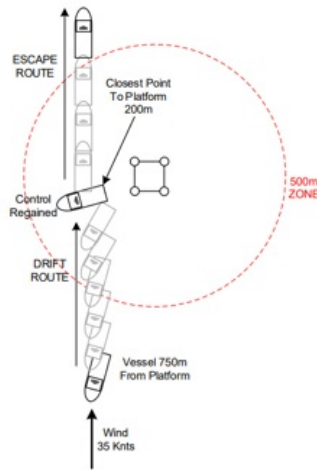
Whilst carrying out 'daily checks' on the running engine the engineers accidentally activated the emergency stop, this resulted in an immediate blackout. The vessel started to drift towards the 500m Zone and it was observed that the wind speed was increasing. As shown below.

Figure two – Direction of drift

As the vessel started to drift, the standby generators started and connected, however blackout recovery was a manual process that required re-setting of breakers and starting of critical machinery. As a precautionary measure an anchor was deployed that held the vessel until full manoeuvring control of the vessel could be gained. The anchor held the vessel 200m from the platform and once thrusters were back in control, the vessel exited the 500m zone.
