## Following a track on DP causes power issues

DP Event • Published on 10 August 2017 • Generated on 28 January 2026 • DPE 03/17

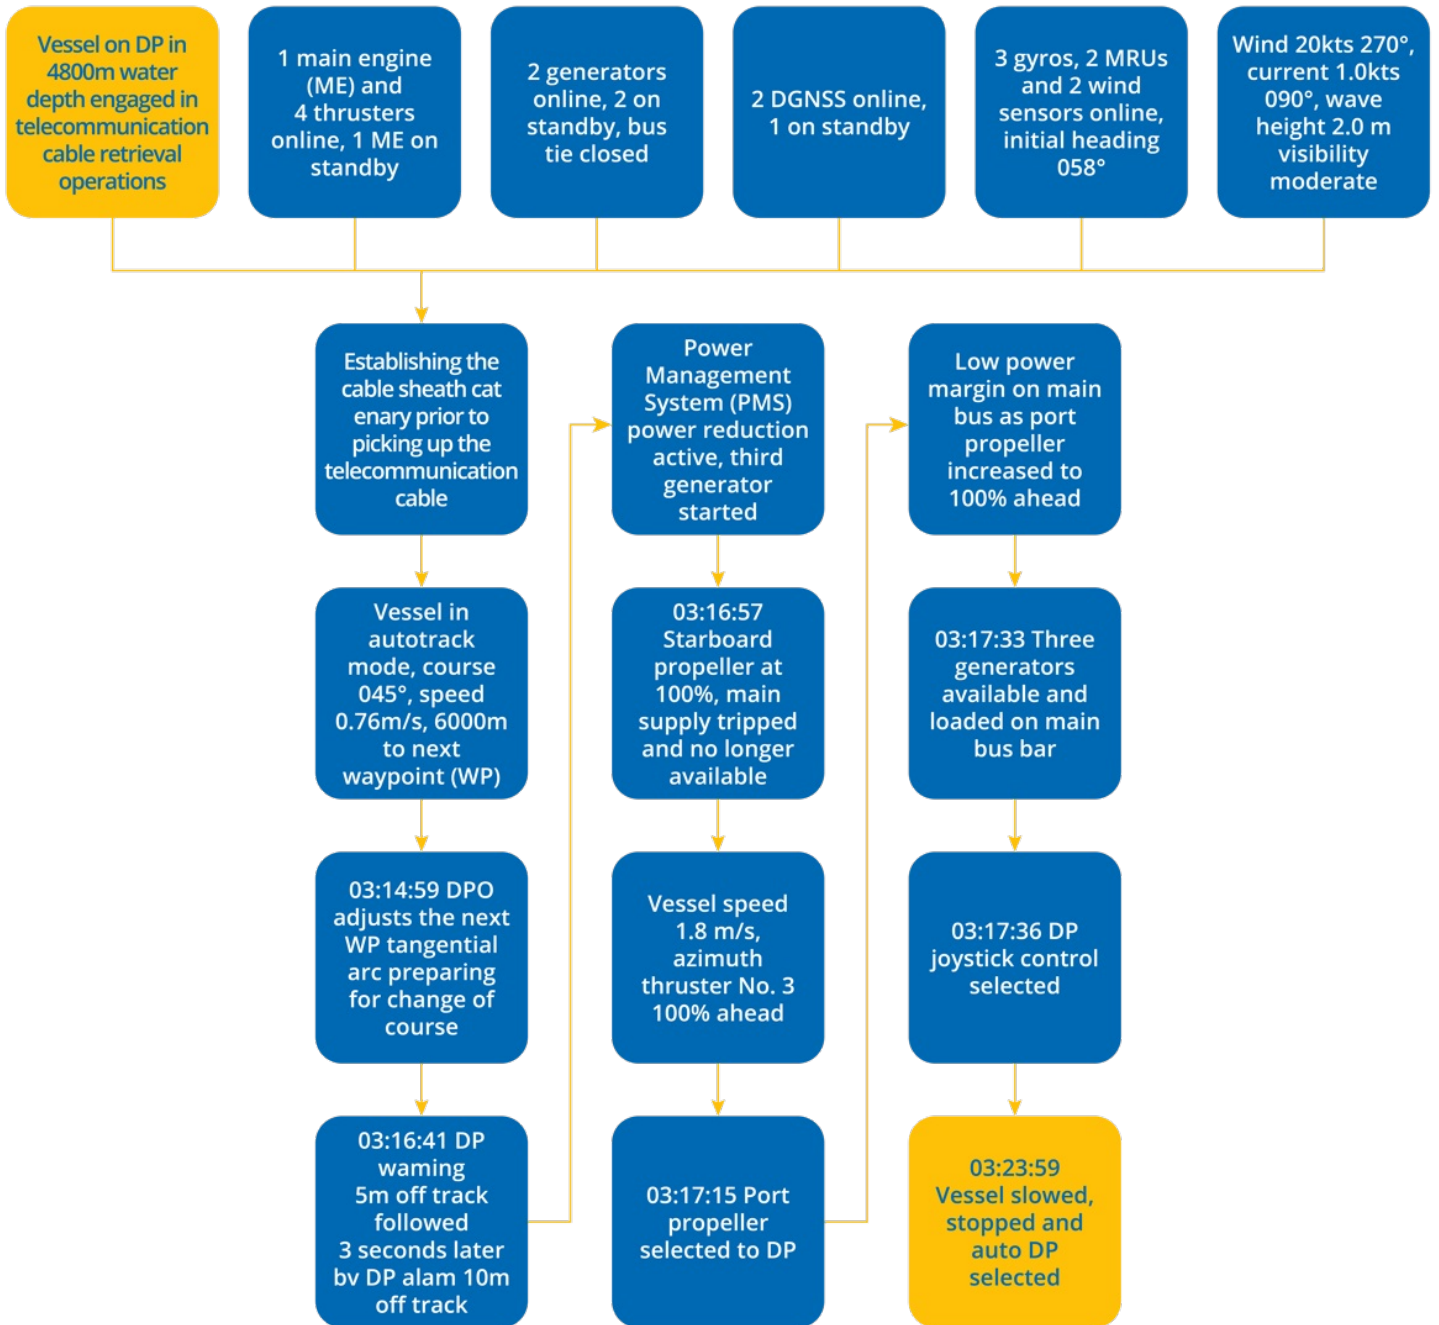
Chosen settings of gain, corridor limits, rate of turn and speed of the vessel could all have contributed.

- The initiating event was a sudden increase of propulsion to full ahead.
- The main cause was attributed to the computer with unexpected thrust allocation.
- The secondary cause was human factor due to a slow reaction to switch to manual mode.

- This is an extremely deepwater operation, although margins are large, DP control is still desirable.
- The limitation of using DGNSS as the only position reference system should be known and acknowledged by those involved in the operation.
- From the information available it would seem this could be an operator initiated problem. Chosen settings of gain, corridor limits, rate of turn and speed of the vessel could all have contributed.
- The operator could have selected the 'Stop' function on the DP console to stabilise the situation, instead of selecting joystick.
- It is important that instructions for switchboard configurations are supplied and followed.
- The starboard propeller tripped at 100% load; this should not happen.
