Fuel oil filter change leads to generator failure

DP Event • Published on 13 September 2016 • Generated on 28 January 2026 • DPE 03/16

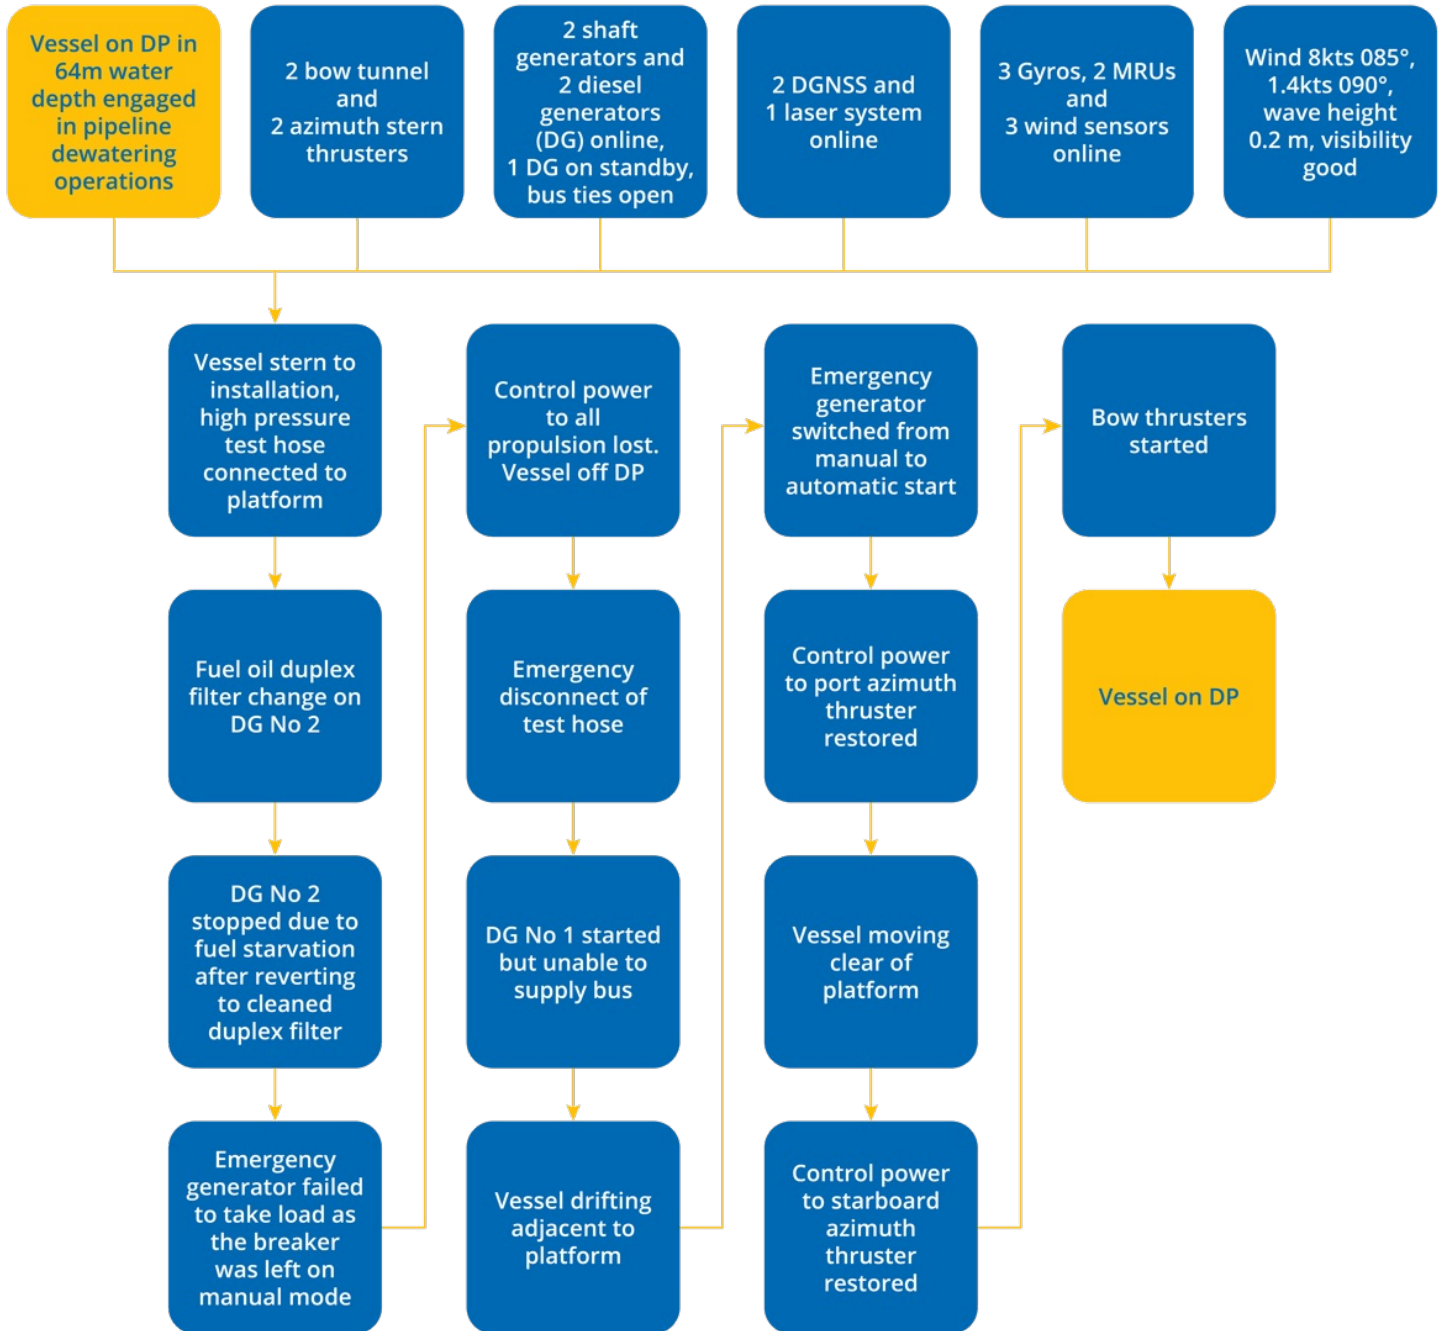
The vessel was five years old, and a design fault was not captured in the FMEA or annual DP trials.

During 'routine' rounds the engine room watchkeeper decided to replace the left filter of the duplex fuel oil filter of DG No.2. This

generator was part of the port redundant system and supplied power to the 415v and 220v bus A and emergency switchboards.

DG No.2 suffered a blackout due to FO starvation after the filter was changed and as a consequence of incorrect operation of the duplex fuel filter. DG No.1, which is also part of the port redundant group, was started, however it was unable to supply power to the bus.

The emergency generator did not connect to the bus bar as the breaker was left in manual mode therefore losing power to bus A and the emergency bus bar.

At this juncture batteries should take the load for control power of DP essential equipment, however the batteries were drained.

The failure of the port redundant group should not have resulted in the loss of all propulsion control power as there was no failure on the starboard redundant group. However, this was not the case because there was a design fault such that the 220v AC and 24v DC systems providing control power for all propulsion was from the port redundant group only.

The vessel is five years old and this design fault was not captured in the FMEA or annual DP trials. The last annual DP trials was conducted less than three weeks prior to the incident.

The principle corrective actions initiated were:

- No maintenance to be undertaken on any active or passive DP component whilst working within the 500m zone of an installation.
- Switchboard setup was permanently modified so that propulsion control power was supplied from different redundant groups.
- Switchboard setup to be verified by two separate watchkeepers.
- Regular DP blackout drills to be instigated.
- Regular switchboard setup training to be conducted.
- Battery checks and testing routines improved.
- Company test and trials programmes reviewed and updated.
