Human Factors caused a DP incident

DP Event • Published on 21 April 2021 • Generated on 28 January 2026 • DPE 01/21

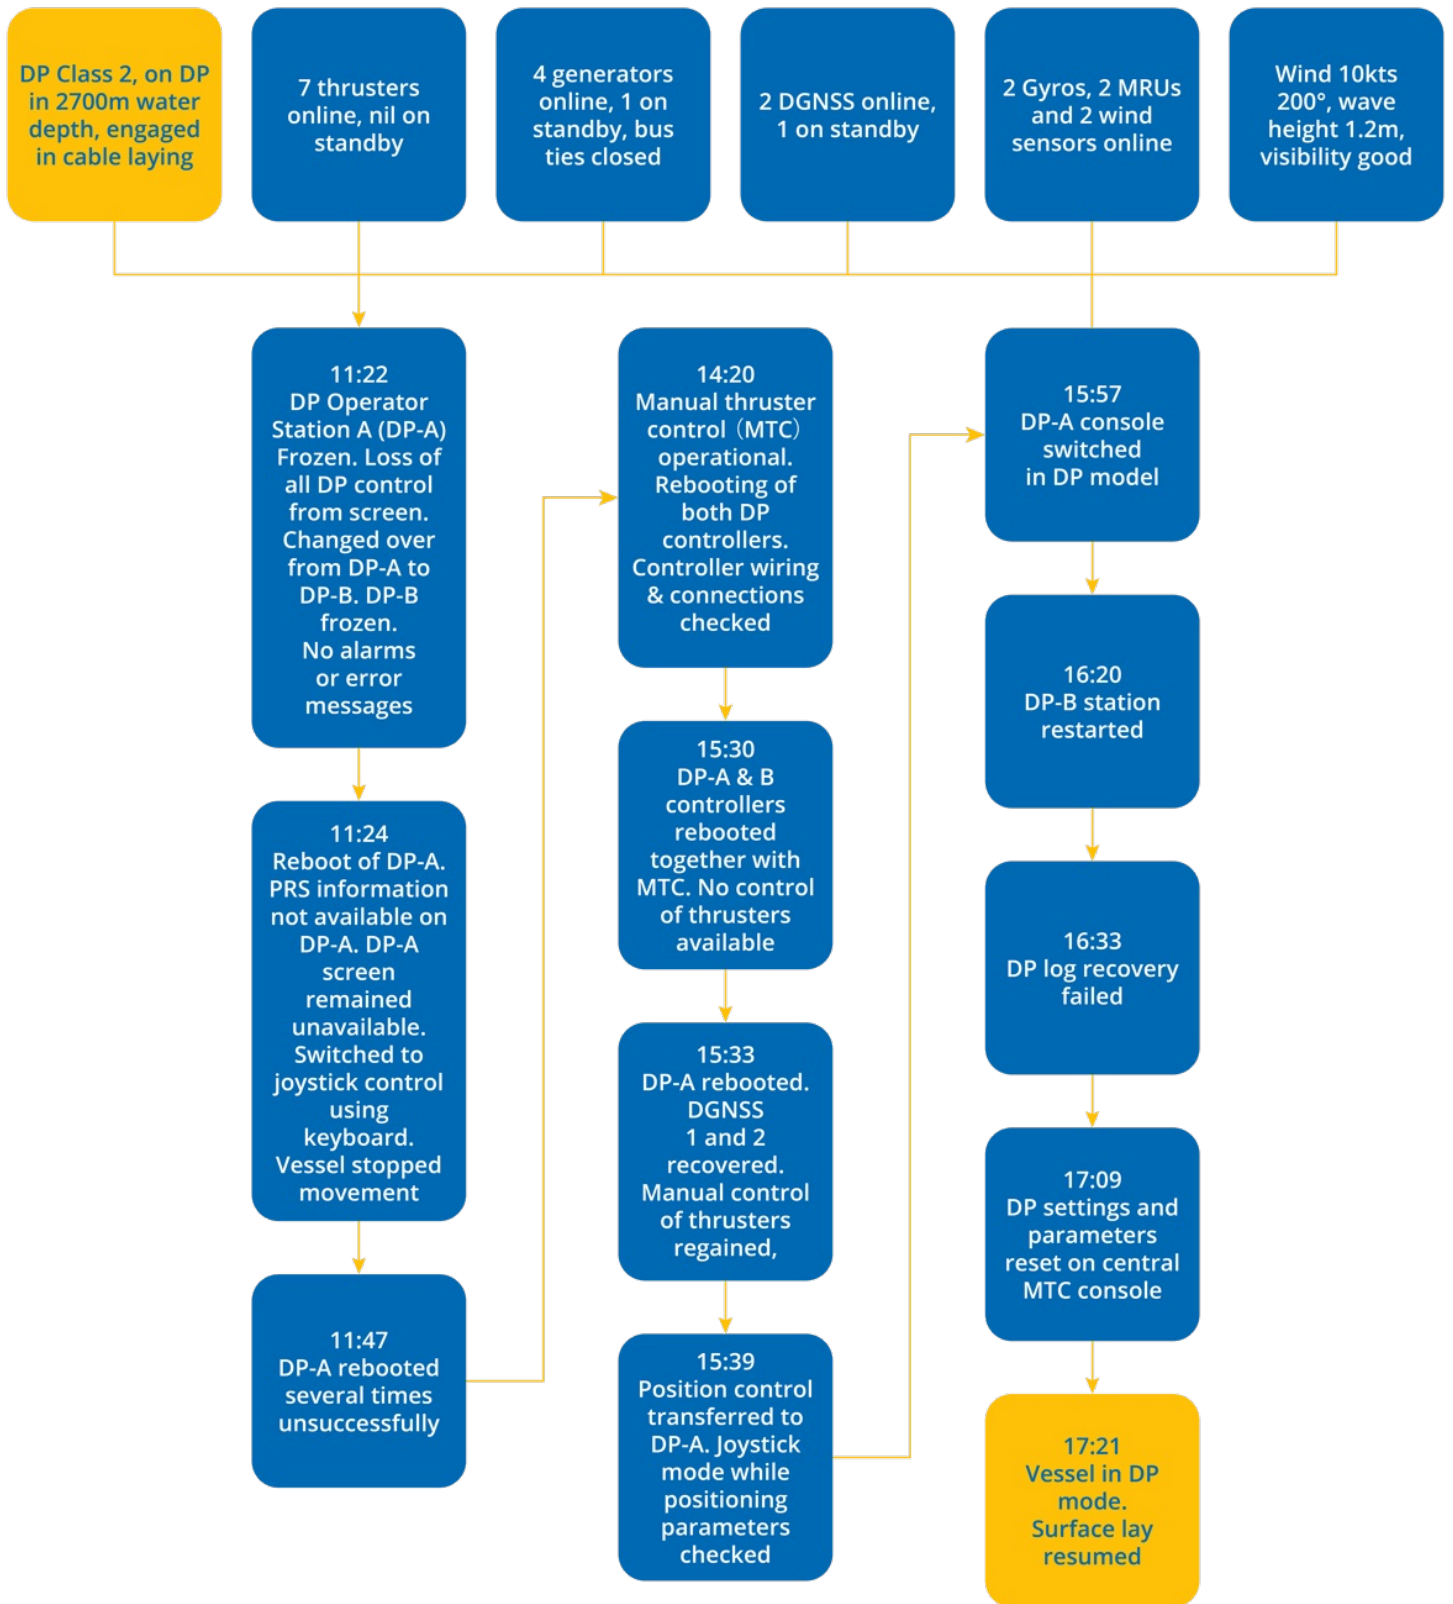
Checklists were completed but the minimum number of PRS for a DP class 2 operation were not used.

Human factors played a role here, checklists were completed but the minimum number of position reference systems (PRS) for a DP class 2 operation were not used. When both the DGNSSs failed due to high noise, other PRSs were not readily available for deployment.

- It is not clear from the events reported why the vessel made contact with the installation despite being in manual joystick mode for 11 minutes considering light weather conditions. In the absence of detail, it is assumed that those operating the vessel had inadequate manoeuvring competencies.

- Operational planning and the effective use of decision support tools should have ensured the correct deployment of position reference systems and identified the risk of DGNSS interference, prior to the operation.
