## Hybrid failure

DP Event • Published on 29 June 2023 • Generated on 16 January 2025 • DPE 02/23

A malfunction in the battery converter system caused circuit breakers to trip.

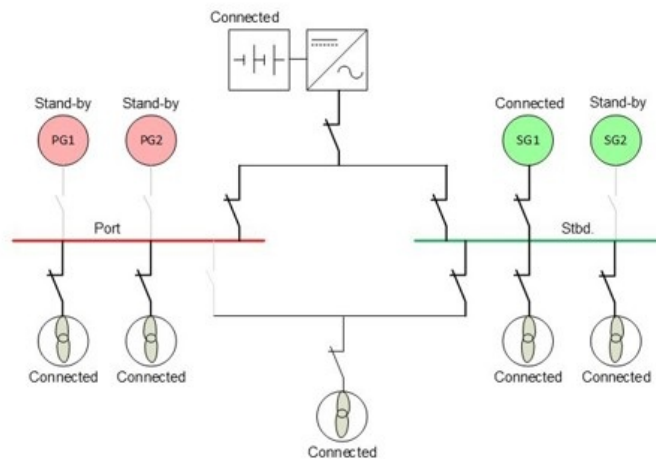
Figure: Initial setup

Three out of the five thrusters were powered from the starboard switchboard with a single generator connected. The port switchboard provided power to two of the five thrusters, with no generators connected. The two electrical systems were linked with the ESS connected to that link.

A malfunction in the battery converter system caused the battery incomer circuit breakers to trip, resulting in the separation of the switchboard, the loss of power to the port switchboard and the subsequent failure of two thrusters. The generators PG1, PG2 & SG2 automatically started and connected to restore power. There was no positional loss.
