Importance of units

DP Event • Published on 11 August 2022 • Generated on 23 January 2025 • DPE 02/22

A mix-up between feet and metres leads to DP systems becoming critically unstable.

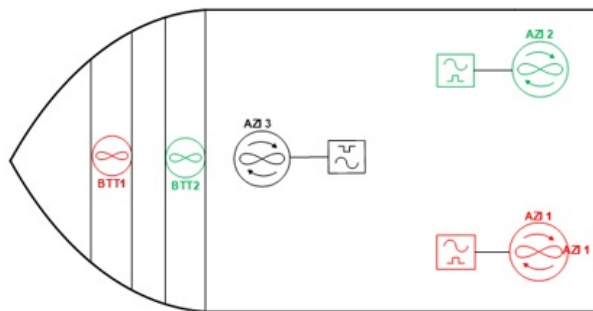
Upon completion of DP field arrival trials, the vessel began sub-sea operations. One ROV was deployed and the crane was in use subsea. The vessel set the two stern thrusters AZI1 and AZI2 to bias, in addition the bow drop-down thruster AZI3 was set to bias mode.

Biasing was set at 0.5t with a turn factor of 50%. The vessel lost position due to stern thrusters oscillating thrust against each other, ramping up to over the 50% turn factor causing them to kick into variable mode.

Figure: Thruster setup
