Inadequate communication and planning causes fouled thruster

DP Event • Published on 29 March 2017 • Generated on 21 January 2025 • DPE 01/17

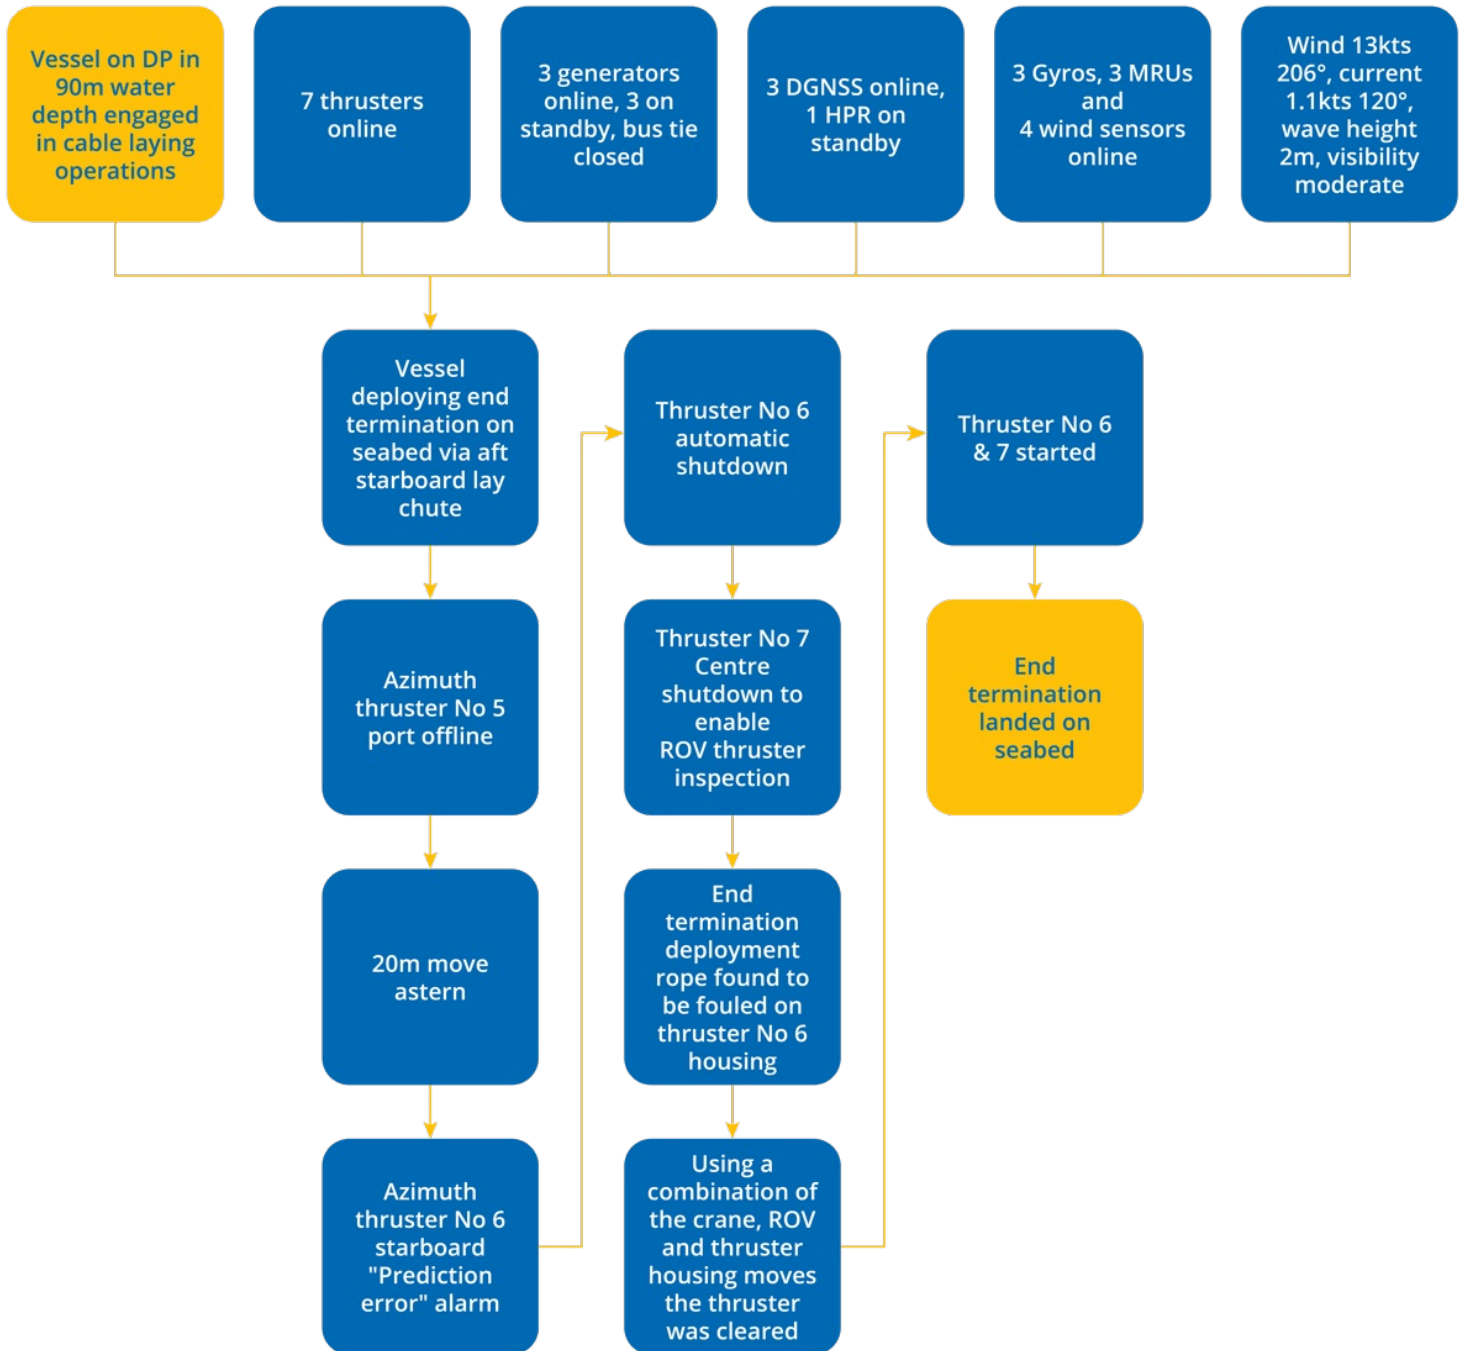
They did not realise they were isolating the opposite thruster and consequently the thruster closest to the lay chute was still running.

During the over boarding of the end termination through the starboard aft chute, the cable laying shift supervisor asked the bridge to isolate thruster No.5 (port quarter) instead of thruster No.6 (starboard quarter).

They did not realise they were isolating the opposite thruster and consequently the thruster closest to the lay chute was still running. Moreover, they asked the bridge to move backwards and in the same direction where the end termination was being laid down. This movement contributed to the end termination deployment rope fouling thruster No.6.

- There was either a lack of operational planning or it was inadequate.
- The event highlights the need for accurate and verified communication between key control centres.
- With three satellite derived position systems on line and the acoustic system on standby the vessel was not complying with the requirements of **IMO Circular 645**.
