## Incident with assisted mooring

DP Event • Published on 14 May 2020 • Generated on 28 January 2026 • DPE 02/20

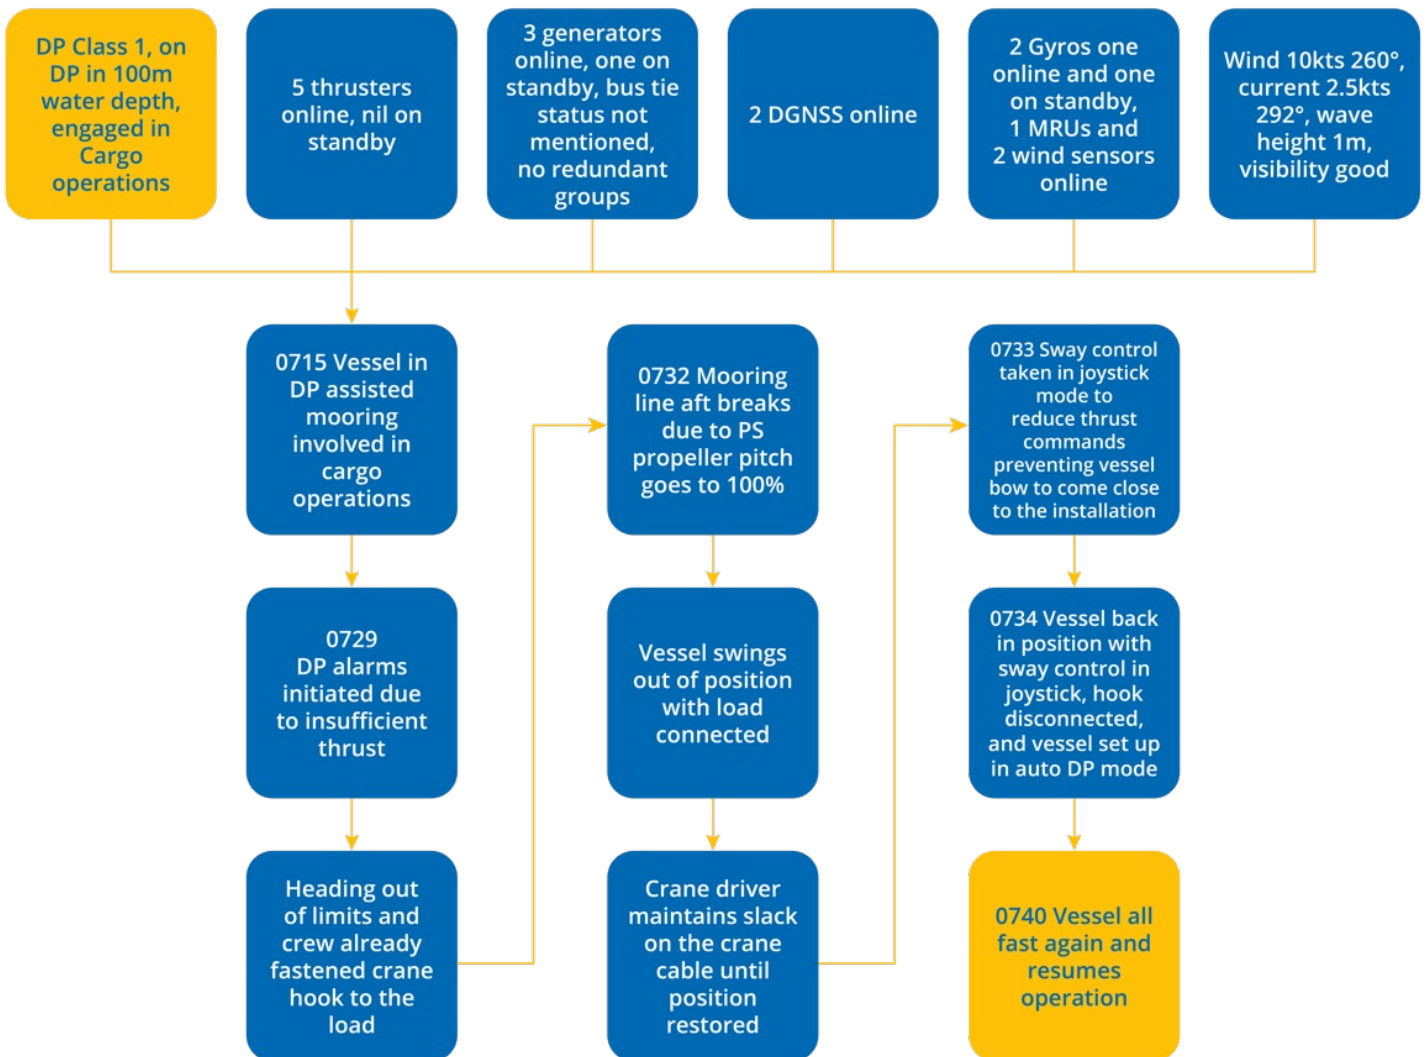
There appears to be no consideration to the external force being applied to the vessel due to the use of mooring lines when in DP.

During cargo operations in DP assisted mooring, due to undefined information being fed to the DP system, the pitch on the port propeller increased to maximum. The vessel started to drive off the installation with the crane connected to the load, dimensions 3.5\*10.5\*6.5 m weighing 11 M Tons. All deck crew were already in safety area behind crash bar ready with tug lines for the lift.

- There appears to be no consideration to the external force being applied to the vessel due to the use of mooring lines when in DP.
- If an external force is applied to a DP vessel without feedback and correct configuration within the DP system, it will have unintended consequences.
- It appears an appropriate Activity Specific Operating Guideline (ASOG) was not in use.
