## Incorrect wiring causes loss of all propulsion

DP Event • Published on 13 September 2016 • Generated on 21 January 2025 • DPE 03/16

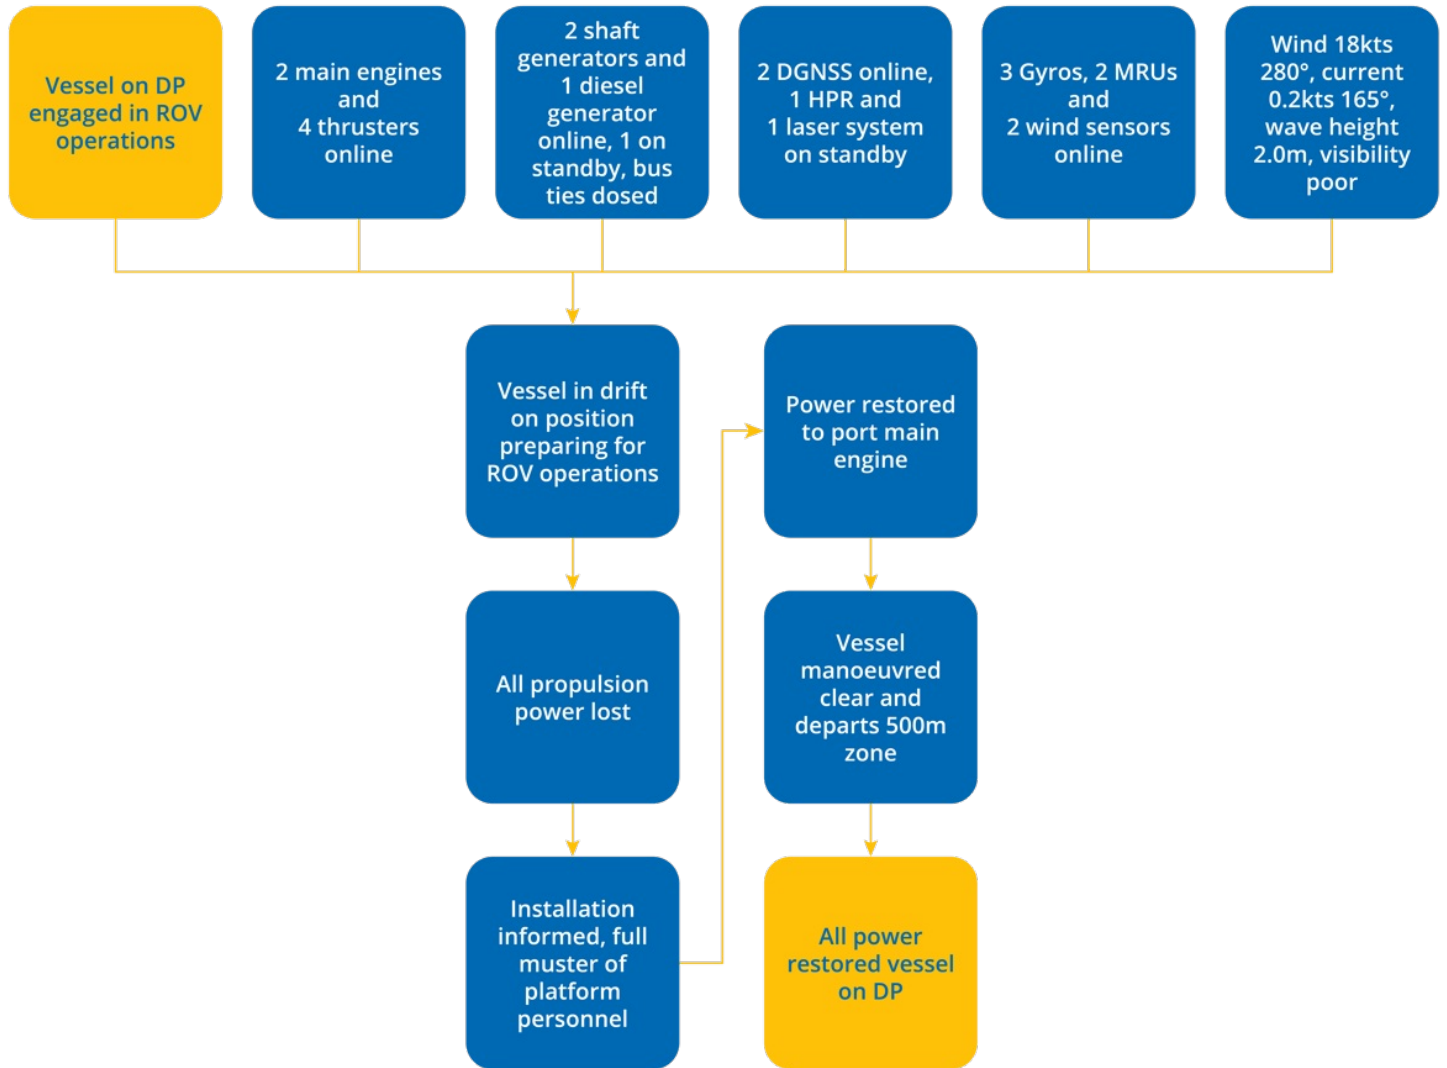
The main cause of the incident was found to be the improper wiring of the main and backup power supplies.

- Through extensive evaluation by numerous technicians, the main cause of the incident was found to be the improper wiring of the main and backup power supplies. Three engines were electrically connected through the DC40 main power supply. This enabled an erroneous shut down signal to be sent to three engines simultaneously.
- **What were the causes of the incident?** There was a fault in the wiring configuration of the vessel's main engine 24VDC supply. The wiring for the main power supply and the backup power supply was reversed which tied the two main engines to

the same main power supply, thereby reducing vessel redundancy. Furthermore, a ground fault was identified on the main 24V supply to the main engines. Subsequent testing revealed the diesel control units (DCU) responded differently when subjected to grounding tests; the port main engine would continue running while the starboard main engine would shut down.

Several changes were made to the vessel's systems such as the replacement of the governor, DC40 battery supply and the starboard DCU and all was tested to satisfaction. To ensure the matter has been completely rectified, the vessel was subjected to a full five-year FMEA.
