## Lack of maintenance caused a problem involving the bus tie breaker

DP Event • Published on 27 February 2018 • Generated on 28 January 2026 • DPE 01/18

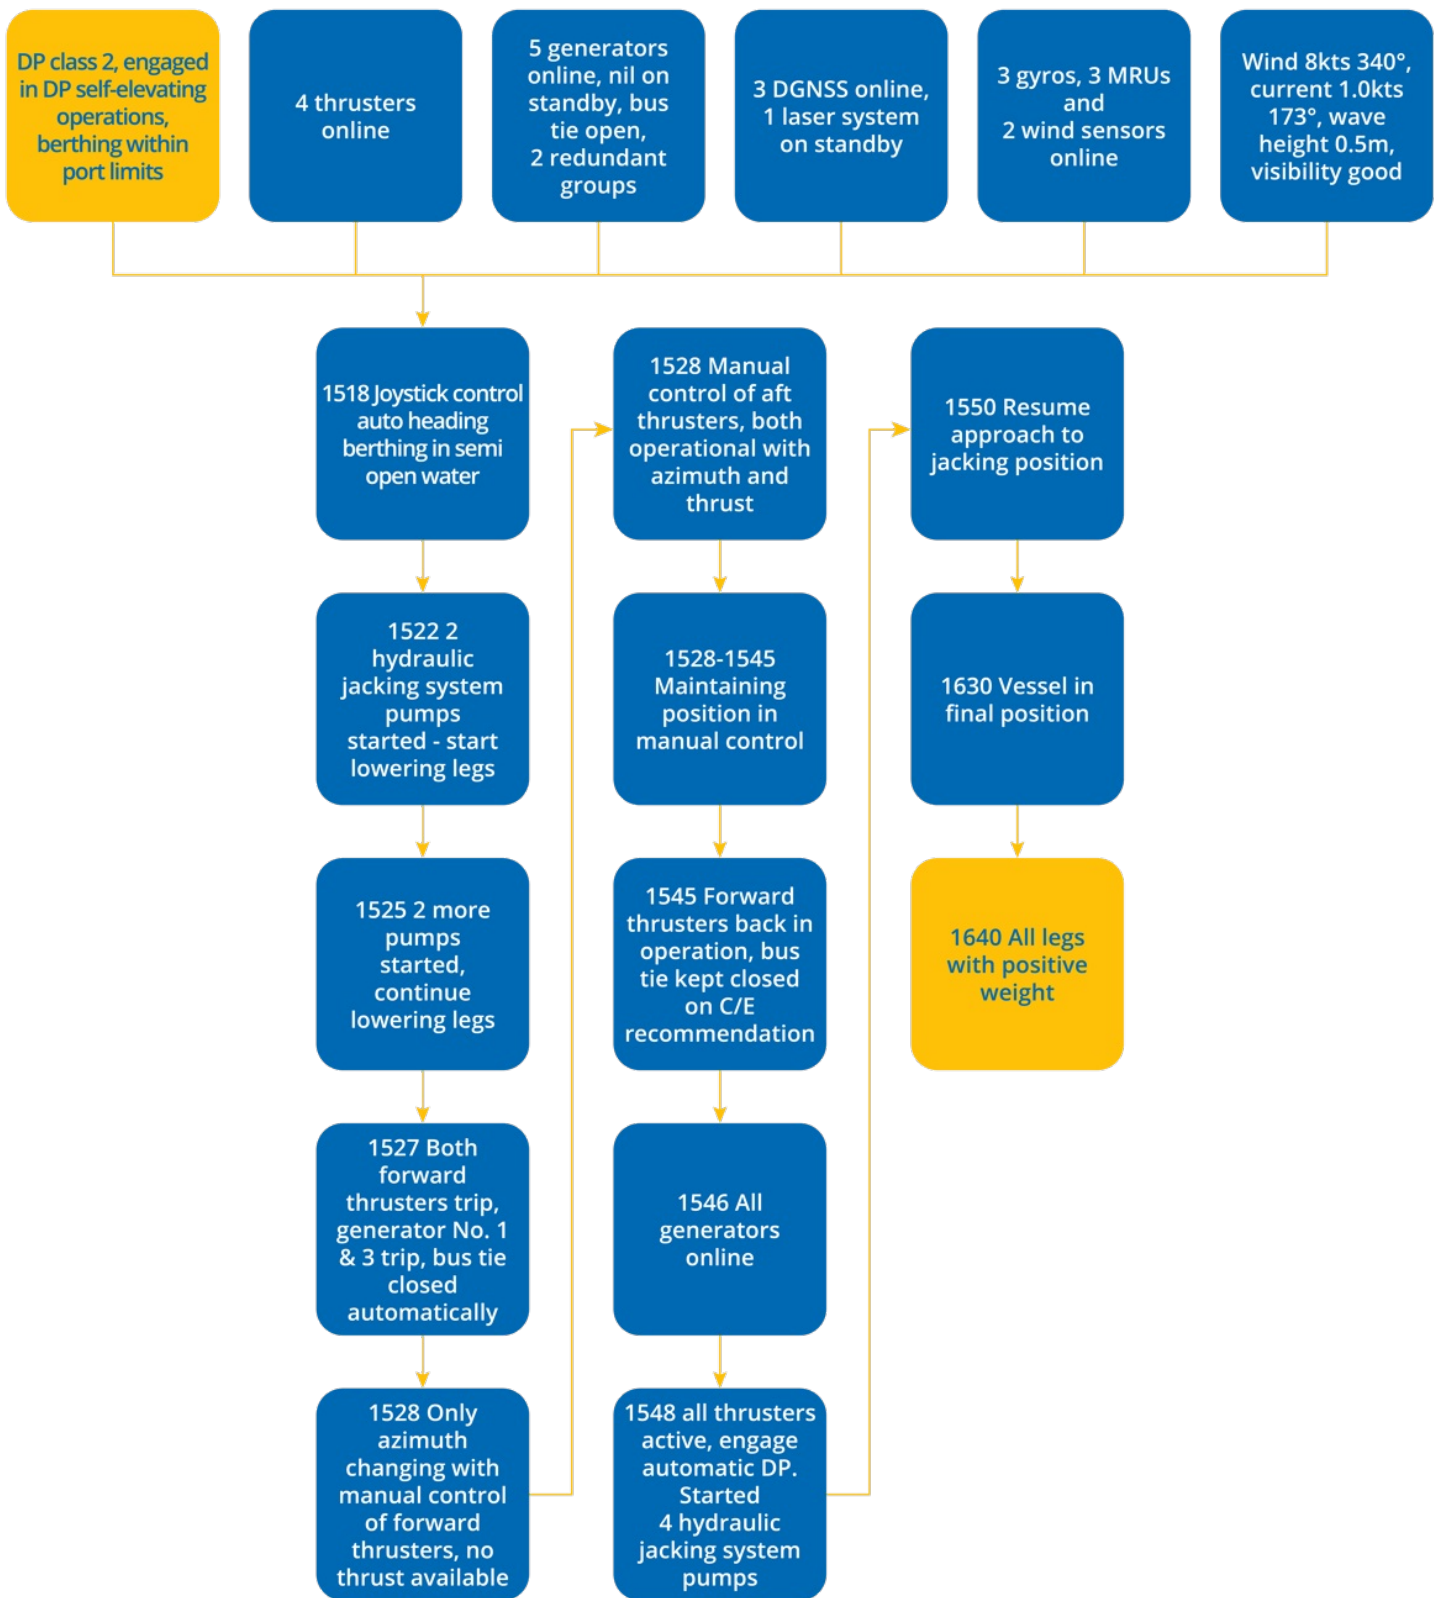
The maintenance requirements of some major DP components were not included in the vessel's computerised Planned Maintenance System.

Uncontrolled and unsynchronised closure of the bus tie breaker resulted in simultaneous trip of DG1 and DG3 with a consequence that the forward thrusters tripped.

Based on conclusions from the technical analysis, the primary reason (root cause) of the event had been identified as lack of maintenance of the DP critical system(s) more precisely the bus tie breaker.

The ship was provided with a computerised planned maintenance system (PMS) which should cover all maintenance activity on board. The maintenance requirements of some major DP components were not included in the PMS.
