# Loss of gyro input causes loss of position

DP Event • Published on 28 September 2020 • Generated on 23 January 2025 • DPE 03/20

A case study which highlights the importance of conducting daily compass checks and completion of all other operational checklists.

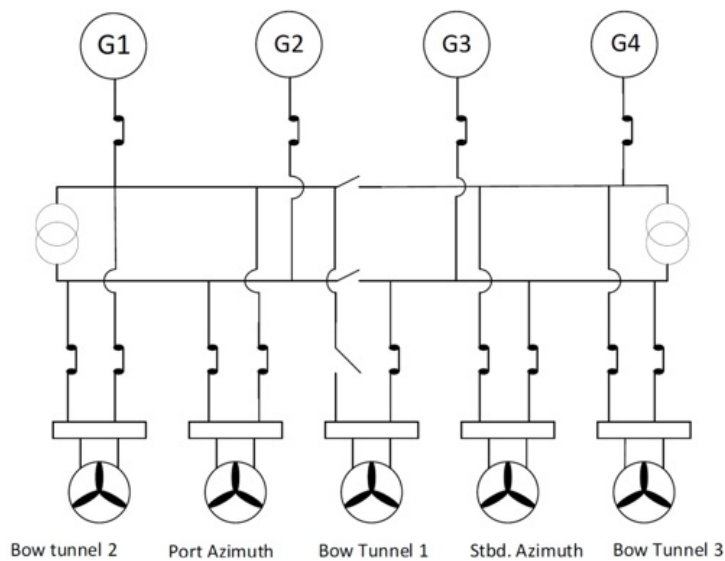
The following diagram depicts the system configuration prior to the event:

The investigation revealed that gyro 2 was lost due to the loss of its Interface and Power Supply Unit. After replacing this unit, a test was carried out to prove the independence of gyro 1 from gyro 2. On disconnecting the power supply to gyro 2, it was observed that gyro 1 was also lost. Further system analysis concluded that the gyro 1 ready signal was linked with that of gyro 2 in the DP controller cabinet. This cross-connection issue caused a detrimental effect on both gyros' performance. In addition, following a malfunction on any gyro, the No. 1 Control and Display Unit would force the gyro 1 ready signal to disappear at the DP operator station. These issues were corrected and tested to the satisfaction of all involved parties.

During the time of the incident gyro 3 sensor value was found to be approximately ten (10) degrees different from gyro 1 and gyro 2 headings. When both gyros 1 and 2 were deselected from DP, gyro 3 was selected to the DP system. However due to the large deviation in the heading value of gyro 3 compared with the estimated heading, which in this case should not have been more than two degrees, the DP controller rejected gyro 3.

- If a gyro has a static deviation from other gyros, this should have been identified, investigated, and rectified so that all gyros' measured headings are within the DP control system limits to avoid any such problems.

- The common mode failure related to the ready signal of gyros' 1 and 2, should have been identified during commissioning, FMEA proving trials and DP annual trials programme. IMCA documents M166, "Guidance on Failure Modes & Effects Analyses (FMEAs) and M190, "Guidance for Developing and Conducting DP Annual Trials Programmes", underline the importance of having robust FMEA and set of annual trials.
