Loss of tunnel thruster

DP Event • Published on 18 February 2019 • Generated on 28 January 2026 • DPE 01/19

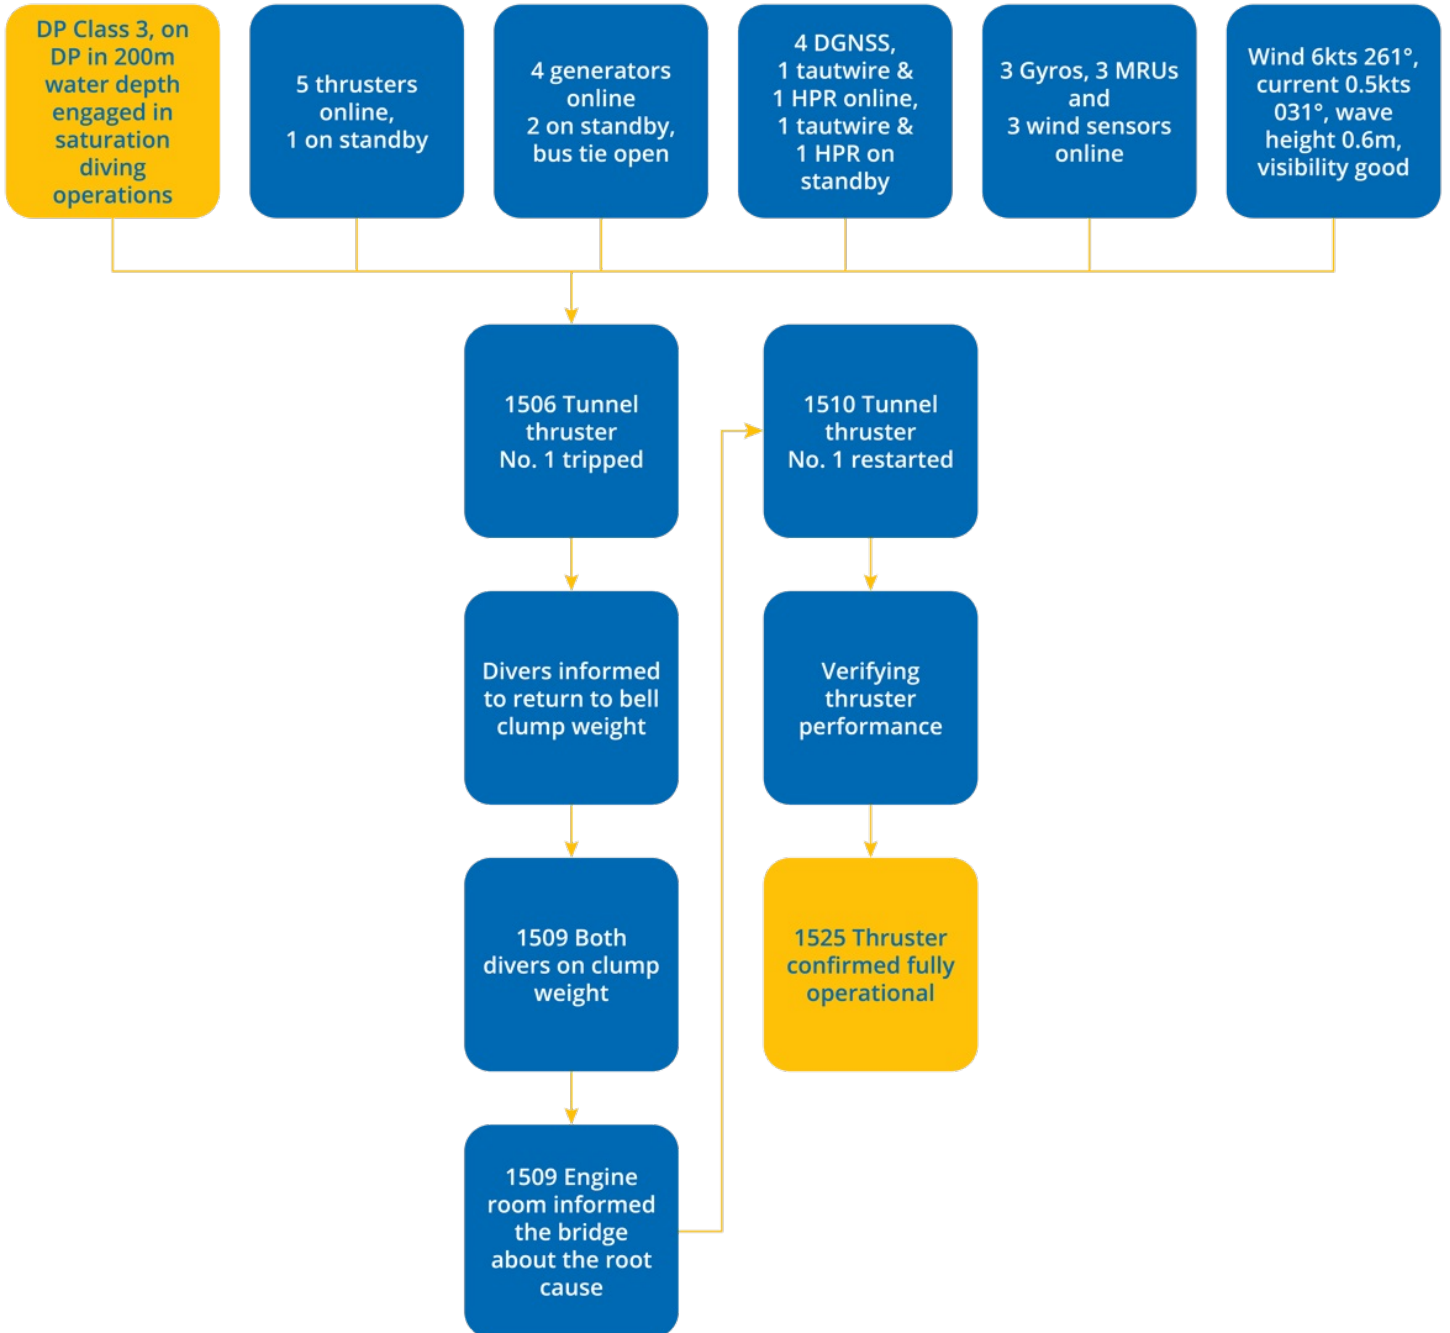
Voltage instability was caused by a spike load on an unrelated circuit breaker on the switchboard which tripped the thruster hydraulic pump.

During diving operations in open water, tunnel thruster No.1 tripped offline.

Investigation showed that the cause was due to tripping of the thruster hydraulic pump because of voltage instability. The voltage instability was caused by a spike load on an unrelated circuit breaker on the same switchboard which tripped. Because of the voltage drop on starboard 690V switchboard during the event some of the equipment breakers opened on under voltage:

- Tunnel Thruster No.1 due to power drop to hydraulic pump and signal command “External Shutdown” from controller to frequency converter drive.
- Starboard ER fans.

- This event highlights how unrelated equipment failure can have an effect on DP system equipment and therefore the vessels redundancy concept and needs to be considered during failure analysis.
- It is assumed that redundancy was not compromised by the tripping of the tunnel thruster and therefore it was not necessary to initiate a DP amber alert.
- It is not good practice to have four DGNSS selected to the DP controller, this could result in rejecting other selected systems if the DGNSS were to drift due to a common satellite problem.
- The root cause should have been identified and isolated from the 690v switchboard before the thruster was re-enabled.
