Operating outside DP equipment class 2 requirements

DP Event • Published on 3 September 2019 • Generated on 28 January 2026 • DPE 03/19

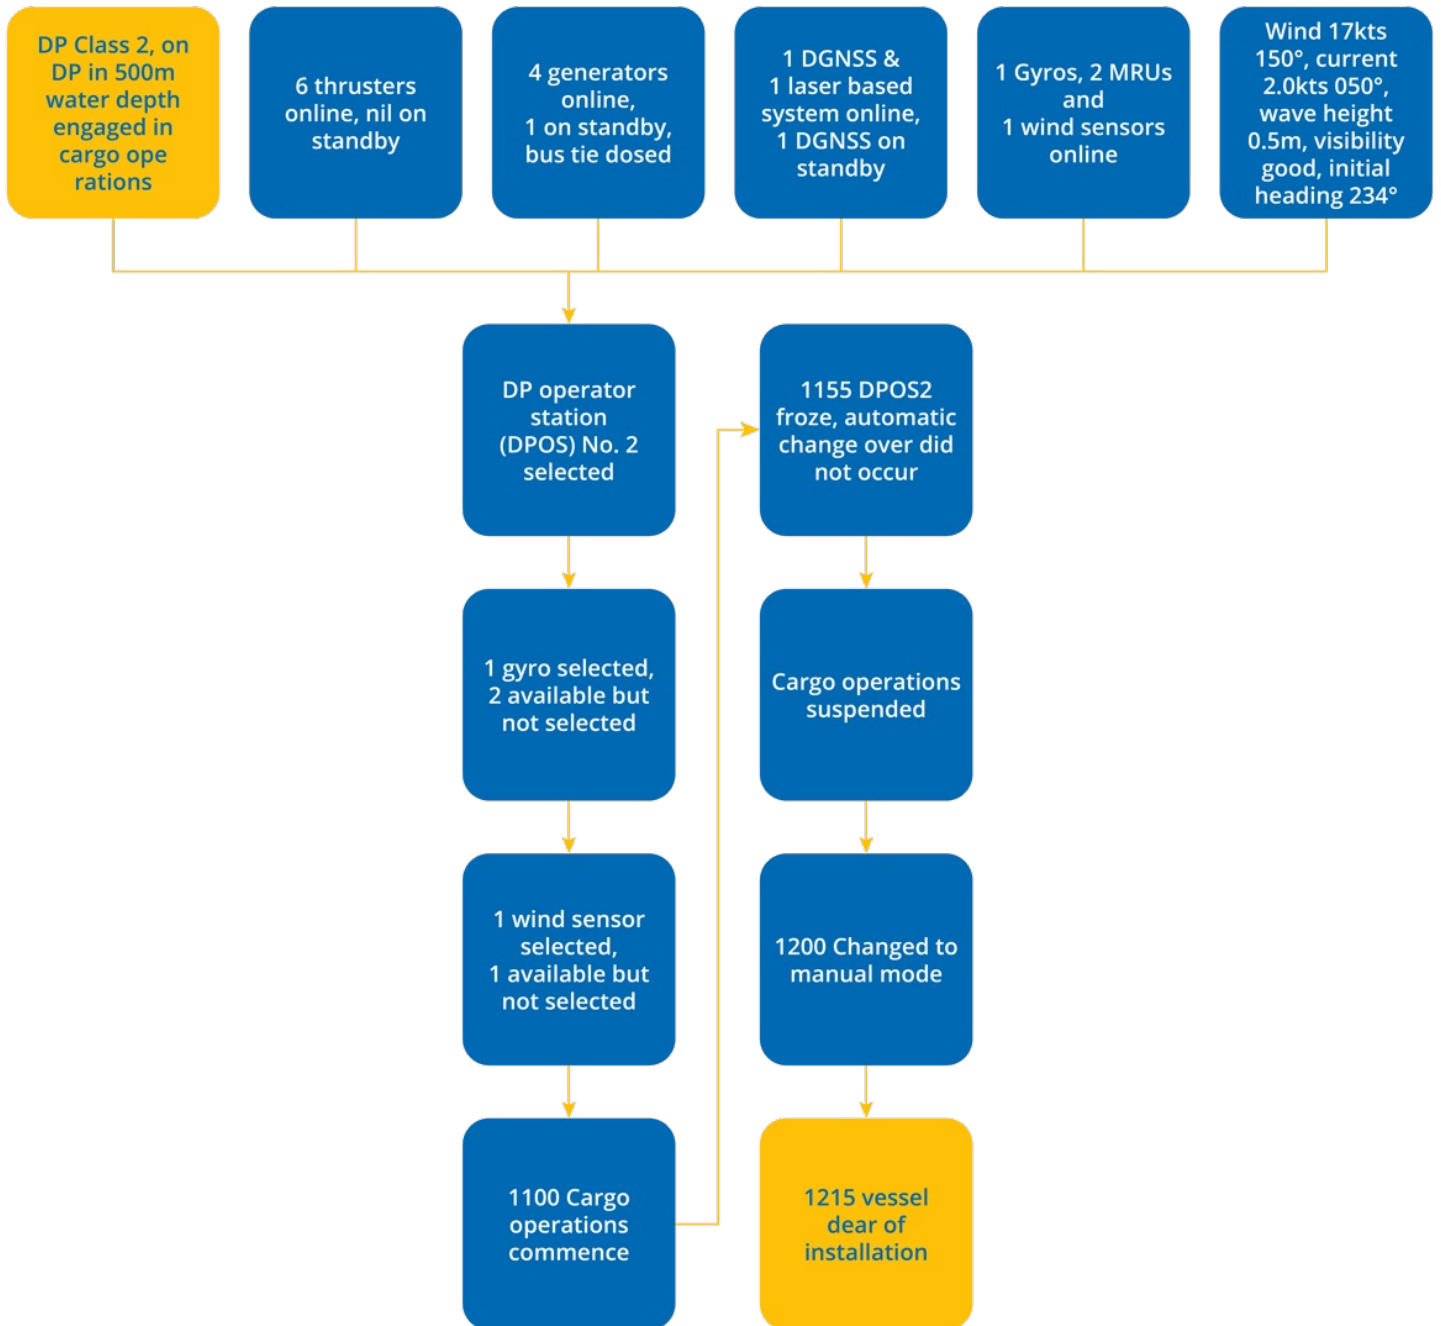
There were not enough PRSs or sensors online to meet requirements for equipment class 2 DP operations.

Although DP checklists were completed, the availability of the standby operator station was not confirmed. The most probable cause for DPOS2 to freeze and not auto changeover was traced to a faulty IO controller on DPOS2.

The vessel replaced the controller with a spare held on-board. At the time of the loss of DPOS2, Gyro feed was not available in any one of the controllers. Various position reference systems (PRS) and sensors were deselected and that caused the vessel to go in 'dead reckoning' when losing the IO controller on DPOS2.

- There were not enough PRSs or sensors online to meet requirements for equipment class 2 DP operations.
- The setup of the vessel and the content of the incident report suggests insufficient understanding and training for both the DP control system and the DP operation.

- There seems to be some confusion about 'operator station' and 'controller'.
- The report states that the possible reason that the DP operator stations did not automatically change-over was a faulty I/O controller. A faulty I/O controller should have activated an alarm.

- If the single gyro online was not available to the DP controllers, it is unlikely that the controller/operator station will change-over to a controller that also does not have an available gyro input. This depends on the system architecture and the DP control system FMEA should have been used as part of the investigation process.

Gyro 1 and 3 were both serviced at the next port call. Vessel simulated auto changeover of the DP Operating system and bump-less transfer was confirmed after maintenance.

- Test of the changeover function between DPOS consoles and DPC controllers should be part of the field arrival check list.
- The report is inconclusive and suggests that further investigation and testing is required.
