## Planned investigation resulted in DP incident

DP Event • Published on 18 February 2019 • Generated on 21 January 2025 • DPE 01/19

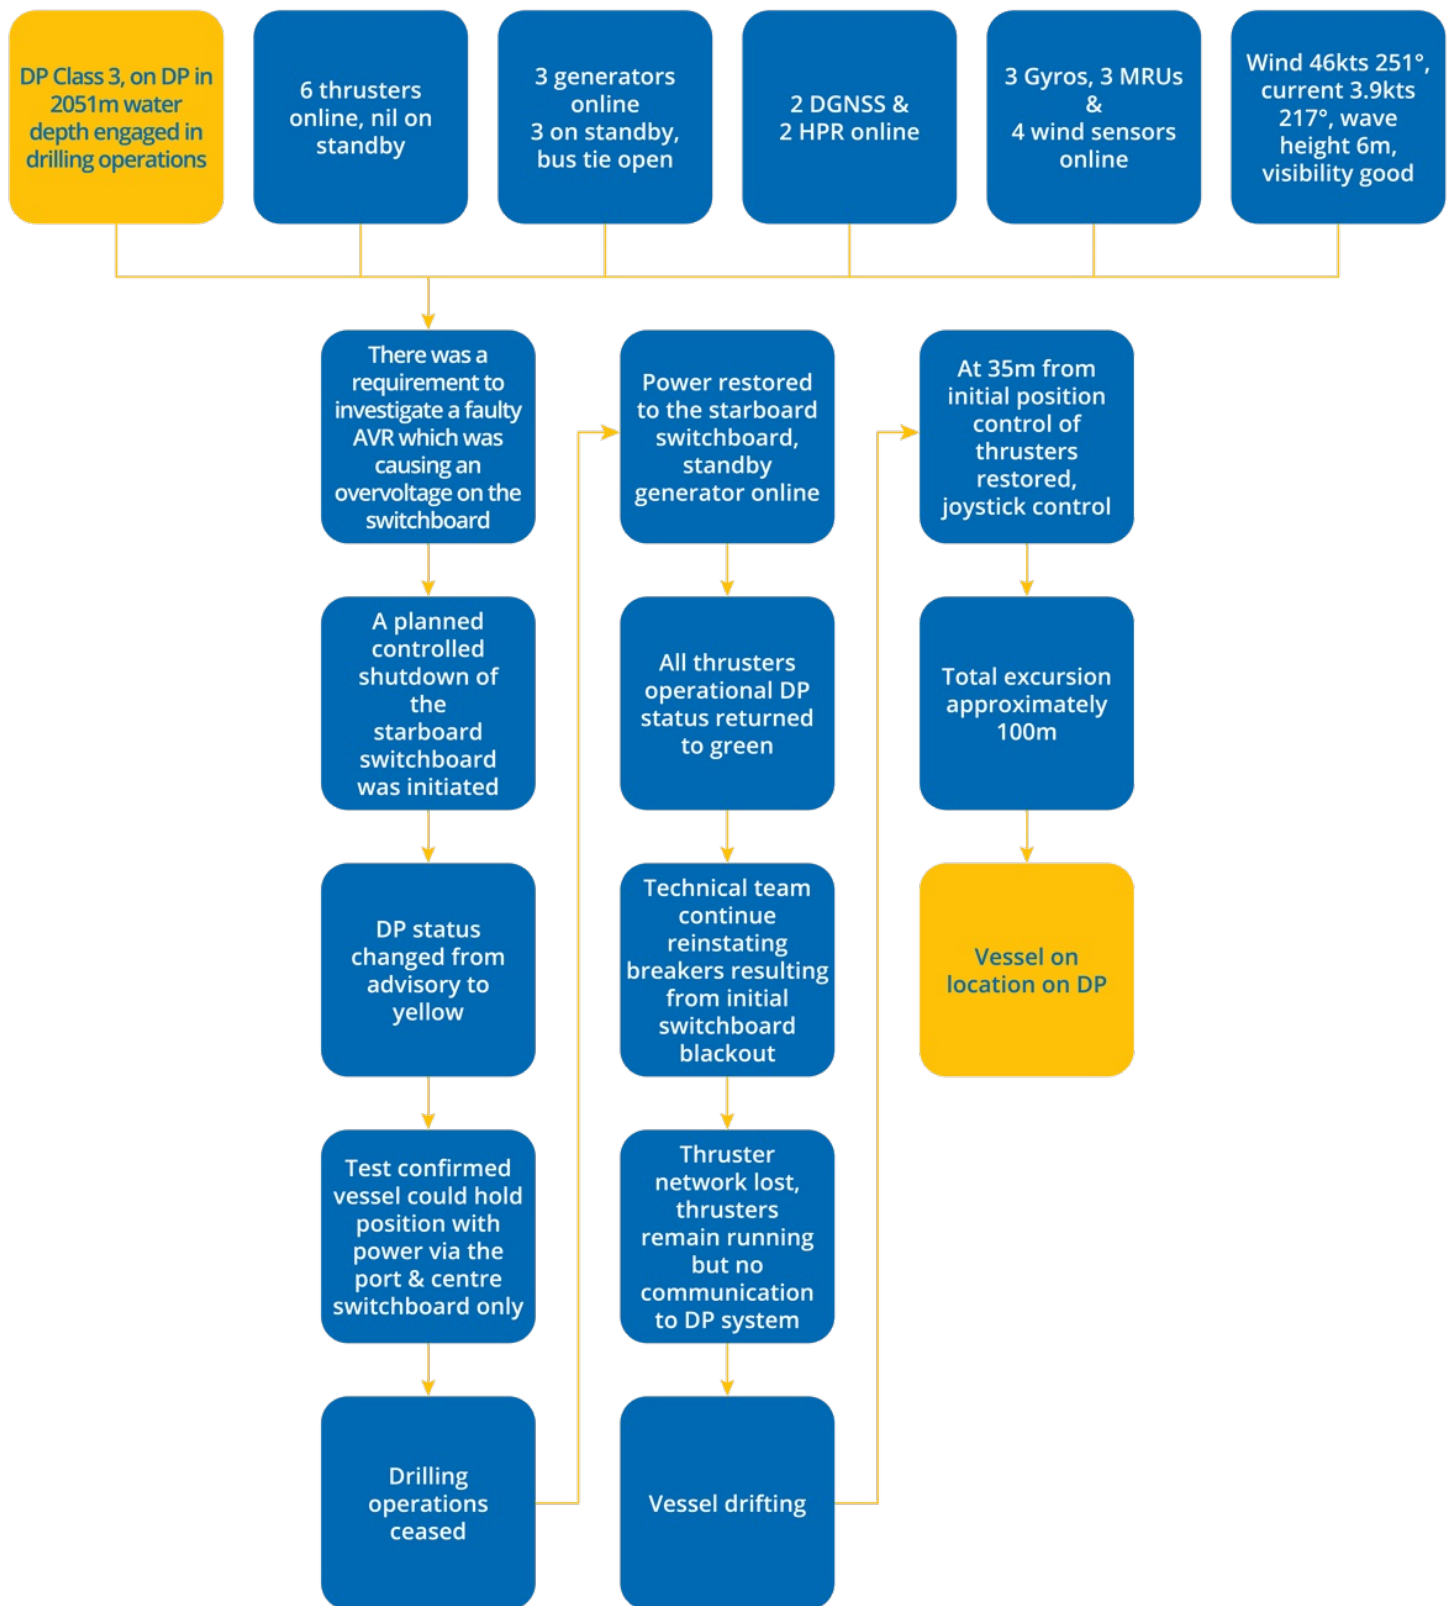
There was a total loss of network communication affecting many field stations together with loss of DP communication to all thrusters.

An AVR problem in diesel generator No.1 engine caused an over voltage in the system. Due to increased voltage, the standby machine could not be brought online, and the switchboard required a controlled blackout.

After this, many alarms from Network B were observed due to the supply being interrupted. An hour later, there was a total loss of network communication affecting many field stations together with loss of DP communication to all thrusters, which caused the vessel to drift off.

The probable cause was accidentally resetting network A, when trouble shooting of network B was taking place.

Further investigation of the overvoltage issue found a 3-phase breaker was faulty to engine No.1; the breaker was replaced by an onboard spare. The DP system manufacturer concluded that the vessel was operational as designed, indicating a possible human mistake by rebooting network A.
