## Rip tide presents problems

DP Event • Published on 2 June 2017 • Generated on 16 January 2025 • DPE 02/17

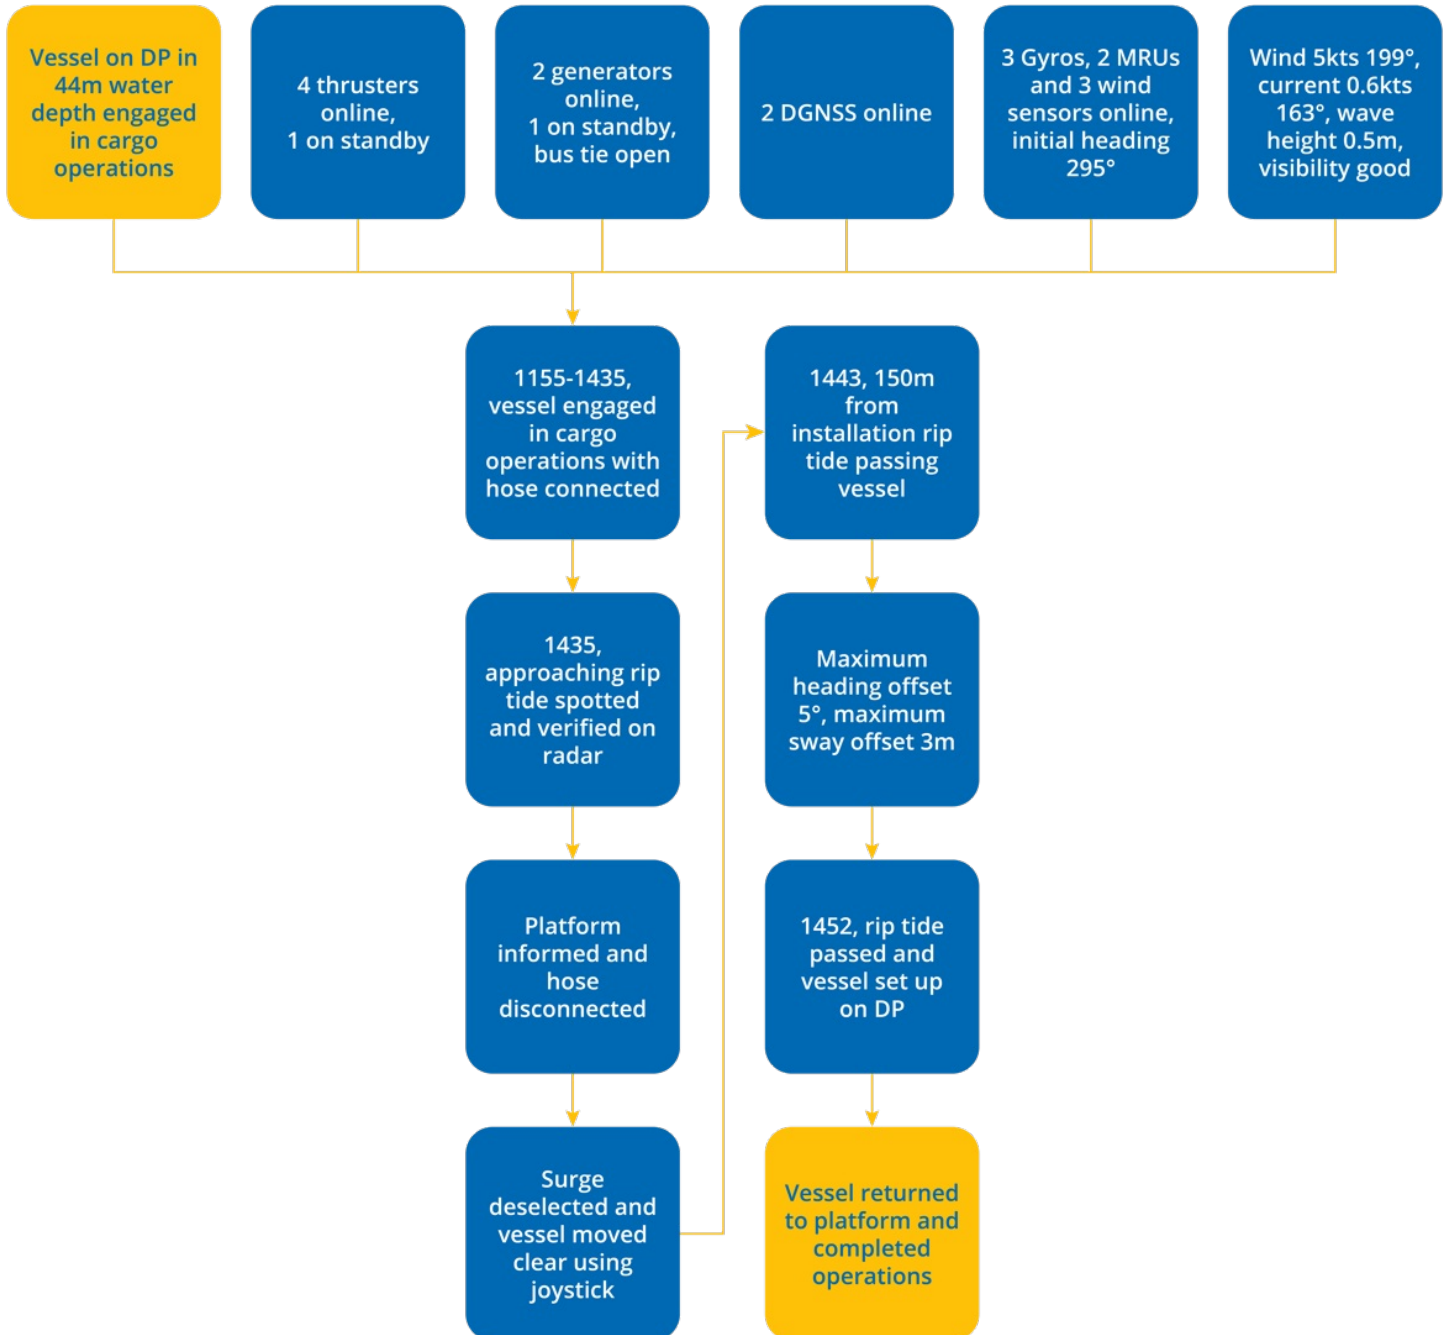
A degraded performance was caused by a rip tide. All DP checks were carried out, and the system's performance was monitored for 20 minutes.

It was a single rip tide and when it had passed the vessel was set up back in automatic position mode.

There was clear evidence that a degraded performance was caused by the rip tide. A risk assessment was made, all DP set-up checks were carried out and the DP system performance was monitored for 20 minutes.

Other rip tides were not observed and the vessel approached the installation to resume operations.
