## Simultaneous activities on the bridge caused a DP incident

DP Event • Published on 3 December 2020 • Generated on 24 January 2025 • DPE 04/20

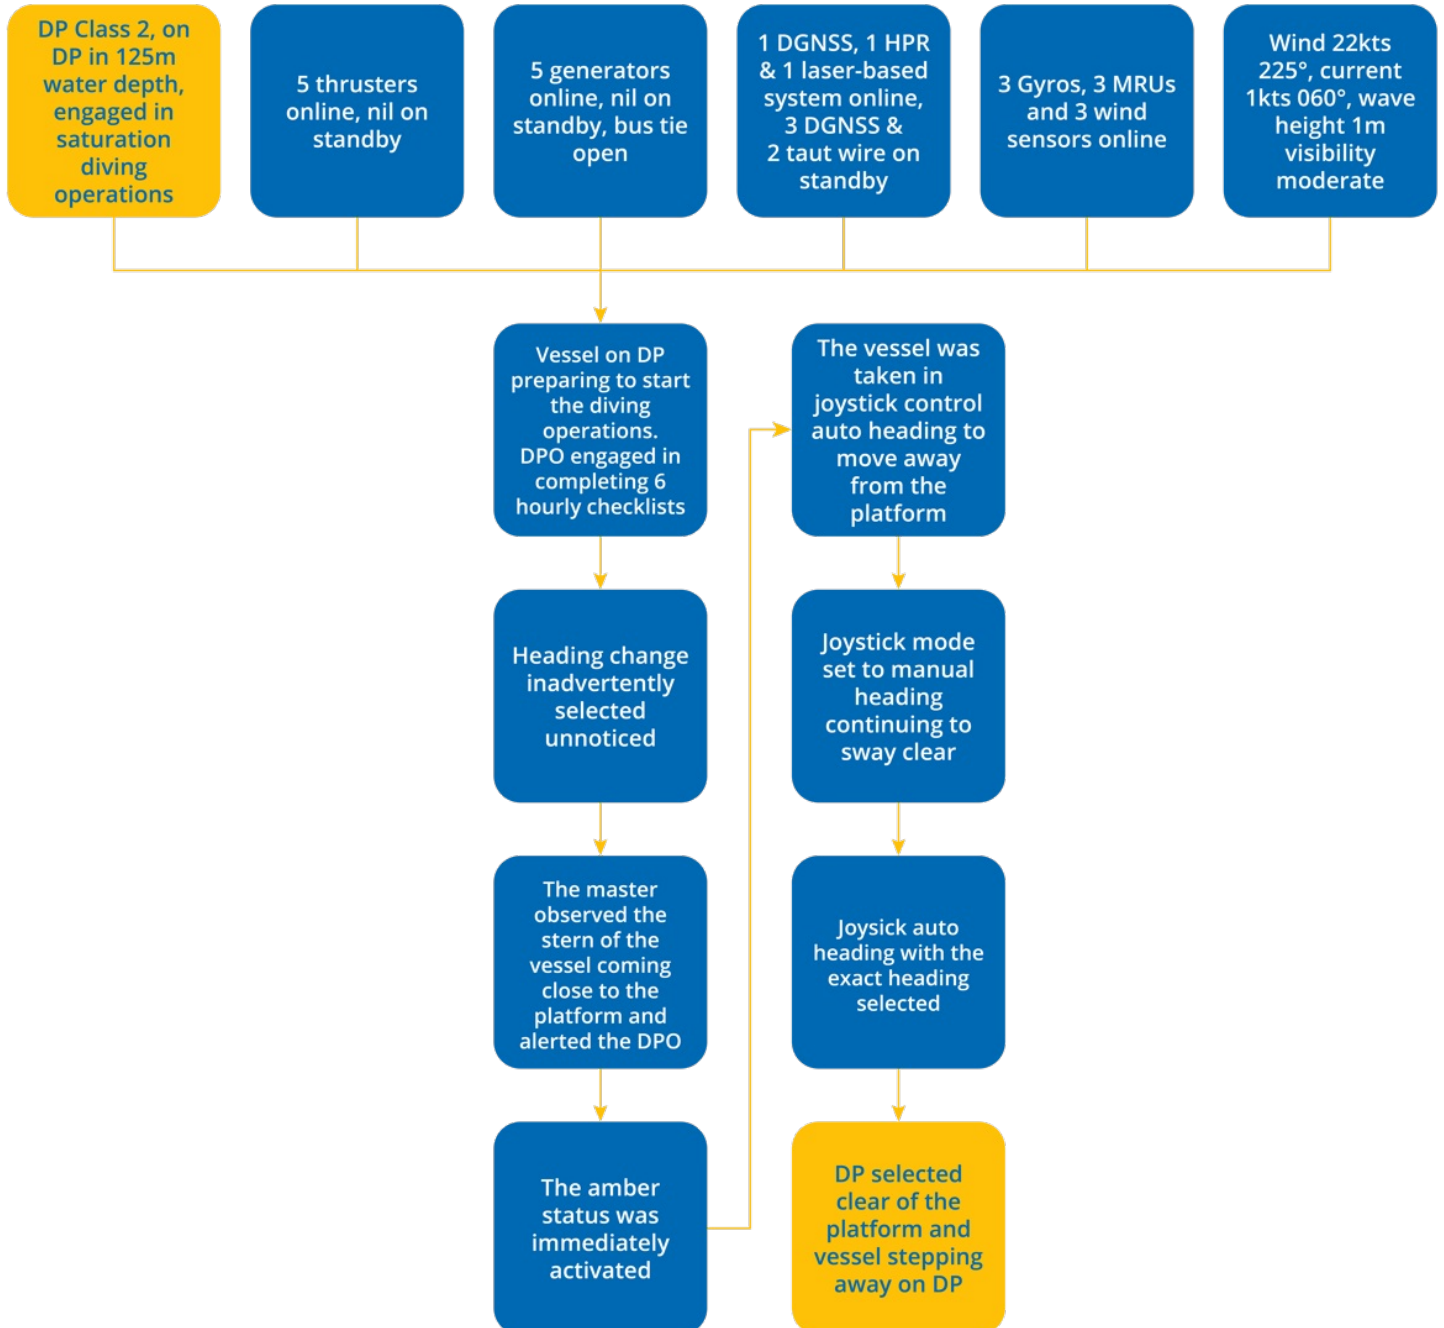
The experienced DPO was new to the vessel and misinterpreted a 30 degree heading increment as being a 30 degree/min rate of turn.

The DPO, though experienced, was new to the vessel and the DP system. He had undergone familiarisation of the system but misinterpreted 30° heading increment as being a 30°/ min rate of turn. As the 6-hourly checklists were being completed, the vessel was making moves and deploying references. Multiple operations were initiated just prior to watch handover which could have been delayed by a few more minutes.

- Bridge resource management was not properly exercised. In principle, the second DPO should fill out the checklists and the DPO at the desk should concentrate on vessel position keeping only.
- The familiarisation process should be reviewed to be more robust to ensure new DPOs are completely familiar with the desk and functions.
- Reference should be made to, The training and experience of key DP Personnel (IMCA M117).
- It should be noted that a 30° per minute rate of turn was considered to be far too high whilst engaged in diving operations.
