Steering motor failure leads to loss of both aft thrusters

DP Event • Published on 29 November 2019 • Generated on 22 January 2025 • DPE 04/19

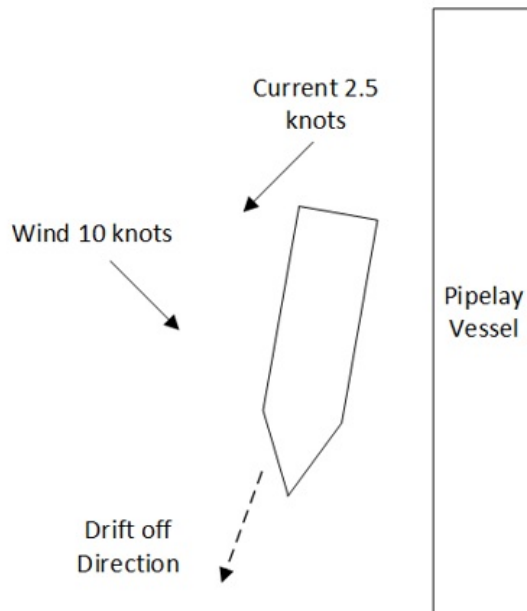
A DP2 cargo vessel was working close to a pipelaying vessel conducting cargo operations in a drift off position. The current at the time of the event was 2.5 knots which, in conjunction with 10 knots of wind, resulted in an external force of 30 tons acting on the port quarter.

The port azimuth thruster failed as a result of failure of both steering motors. One of the two starboard azimuth thruster steering motors also failed; however, the thruster remained available due to the remaining healthy steering motor. Cargo operations were immediately ceased, and attempts were made to restart the port thruster unsuccessfully. During these attempts, the starboard thruster tripped due to a 'low hydraulic pressure' alarm.

With no aft thrusters available, the vessel drifted for around 200m before power was regained to one of the starboard steering pumps allowing the thruster to restart. The vessel was subsequently manoeuvred outside the 500m zone for failure investigation.

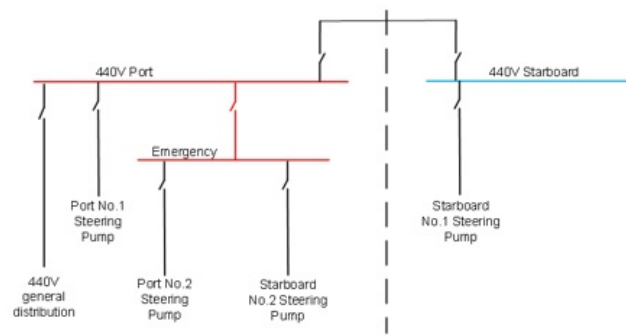
At the time of the event, the vessel was being operated on automatic DP2 mode, with four generators and four thrusters online. The main 690V, 440V and 220V switchboards were being operated with open bus tie; each side of the main switchboard powering one forward and one aft thruster as per the proven redundancy concept.

The supplies for port and starboard steering pumps were arranged in the same manner. Each pump was driven by electric motor controlled by variable speed drive (VSD). Steering pump no.1 for each thruster was supplied directly from the respective port or starboard main switchboard and steering pump no.2 for each thruster supplied from the emergency switchboard. The emergency switchboard was connected to the port main bus bar.

The investigation revealed a gradual but significant earth fault within a consumer supplied by the Port 440V general distribution panel. The Earth fault was caused by a trapped cable within a motor connection box. The cable had been trapped between the lid and body of the box during a recent maintenance inspection.

This earth fault had been detected by the sophisticated protection systems of the VSDs controlling the steering pumps on the port and emergency switchboards, but not the starboard switchboard as the bus tie was open. The VSDs tripped causing the three steering pumps to fail. Note that the VSDs are unable to differentiate whether an earth fault is upstream or downstream, therefore they will typically trip assuming that the earth fault relates to the equipment they control.
