Switching to manual mode caused loss of position

DP Event • Published on 31 August 2018 • Generated on 28 January 2026 • DPE 03/18

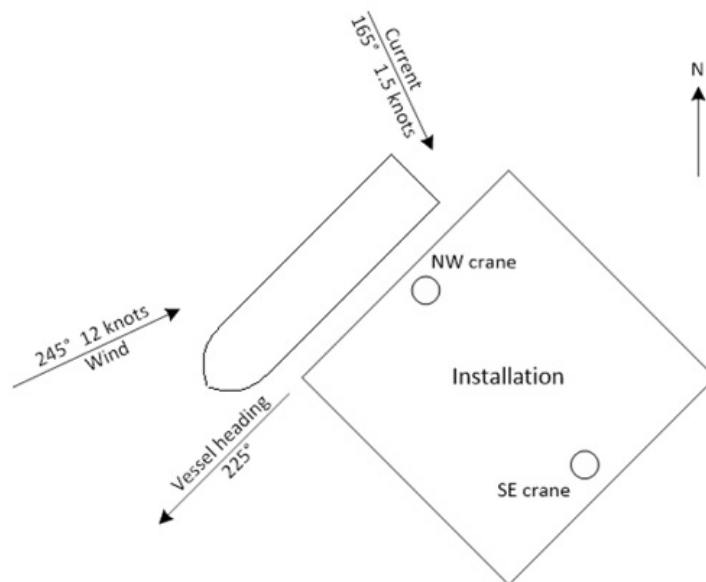
The port aft azimuth developed a failure that led to it tripping out of DP control and its main circuit breaker opened. As the vessel was being operated within its environmental envelope and the thruster failure did not exceed the designed worst case failure, the vessel maintained position.

However, as redundancy had been compromised cargo operations were immediately suspended and the instruction was given to leave the 500m zone for thruster investigation. The DPO, in consultation with the master, decided to deselect auto DP control mode and selected manual control mode, at which point the vessel became unable to maintain its position and light contact was made with the platform before vessel control was regained. The decision was made to return to port for investigation.

Investigation highlighted that when auto DP is deselected, all thruster setpoint references move to zero for the deselected surge, sway and/or yaw axis therefore when the DPO selected the vessel to manual control all thrusters effectively stopped producing force leading to the loss of position.

The decision to switch out of auto DP control in order to manoeuvre the vessel out of the 500m zone resulted in the vessel's position loss and contact with the platform. This decision was incorrect and the DPO had a lack of knowledge regarding how the system should perform. Had DP control been maintained, the vessel could have been manoeuvred away from the platform without harm.

The DP operations manual did not explicitly state what actions should be taken in the event of a major DP system component failure nor did it explain the consequences on station keeping during DP control mode changes.

The vessel in question was a platform supply vessel and by nature spends a much higher percentage of time in transit/port than in field in auto DP mode. In this type of scenario, it is vital that the DP crew are exposed to annual DP trials and regular DP exercises and drills so that experience and confidence in the system is gained during normal and failure condition.

Familiarisation and training of change of thruster control mode should be a regular part of on board training.
