# The cascade effect

DP Event • Published on 3 April 2024 • Generated on 24 January 2025 • DPE 01/24

A critical incident aboard a DP vessel, five years post-construction, which experienced a significant power management failure.

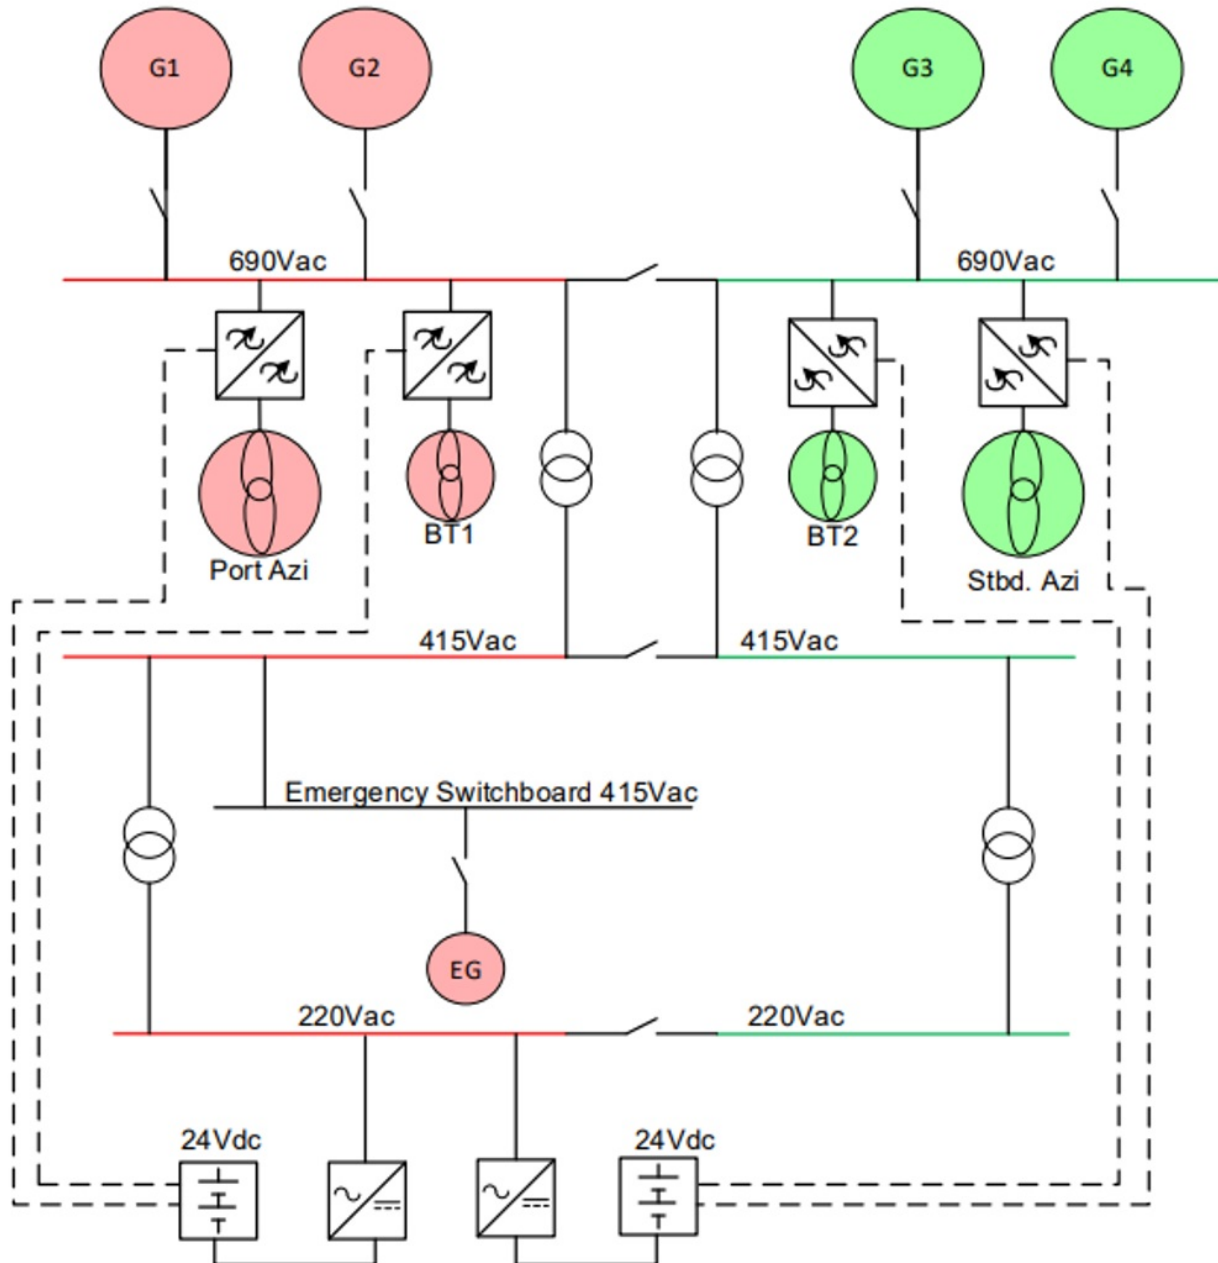
Figure – Overview of power system:

**1) Failure of DG No.1:** Following the filter change, DG No. 1 experienced a blackout due to fuel oil starvation, attributable to incorrect operation of the duplex fuel filter.

**2) Inadequate Power Supply from DG No.2:** DG No.2, also part of the port redundant group, was initiated but failed to supply power to the bus.

**3) Emergency Generator Disconnection:** The emergency generator did not engage with the emergency switchboard as the breaker was inadvertently left in manual mode, resulting in a loss of power to the emergency bus bar.

**4) Battery Failure:** Control power for DP essential equipment, typically supported by batteries during such failures, was compromised as the batteries were drained.

**5) Design Flaw in Power Distribution:** Despite no failure in the starboard redundant group, the loss of all propulsion control power occurred due to a design fault. The 220v AC and 24v DC systems, providing control power for all propulsion, were sourced solely from the port redundant group.

This design flaw was not identified in the Failure Modes and Effects Analysis (FMEA) or during the annual DP trials, the most recent of which was conducted less than three weeks prior to the incident.

- Prohibition of maintenance on active or passive DP components within 500 metres of an installation to be indicated in the Engine Room DP checklist and handover checklist.
- Permanent modification of the switchboard setup to ensure propulsion control power is supplied from different redundant groups.
- Verification of switchboard setup by two separate watchkeepers.
- Regular DP blackout drills.
- Regular training on switchboard setup.
- Enhanced battery checks and testing routines.
- Review and update of the company's test and trials programmes.
