Vessel degraded capability

DP Event • Published on 27 January 2023 • Generated on 28 January 2026 • DPE 01/23

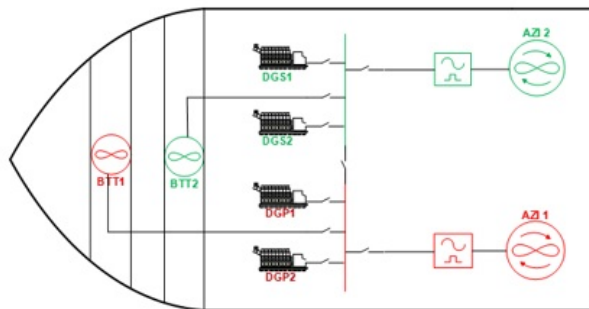
Figure 2-1 Thruster Setup

The Worst Case Failure (WCF) identified from analysis of the DP system on the vessel is loss of the port engine room due to an auxiliary failure, this would cause the loss of the two generating engines, Switchboard, Azi 2 & BTT1, with BTT1 being the most forward thruster.
