Diver falls into bell maintenance pit

Safety Flash Published on 9 February 2010 Generated on 25 April 2025 IMCA SF 01/10

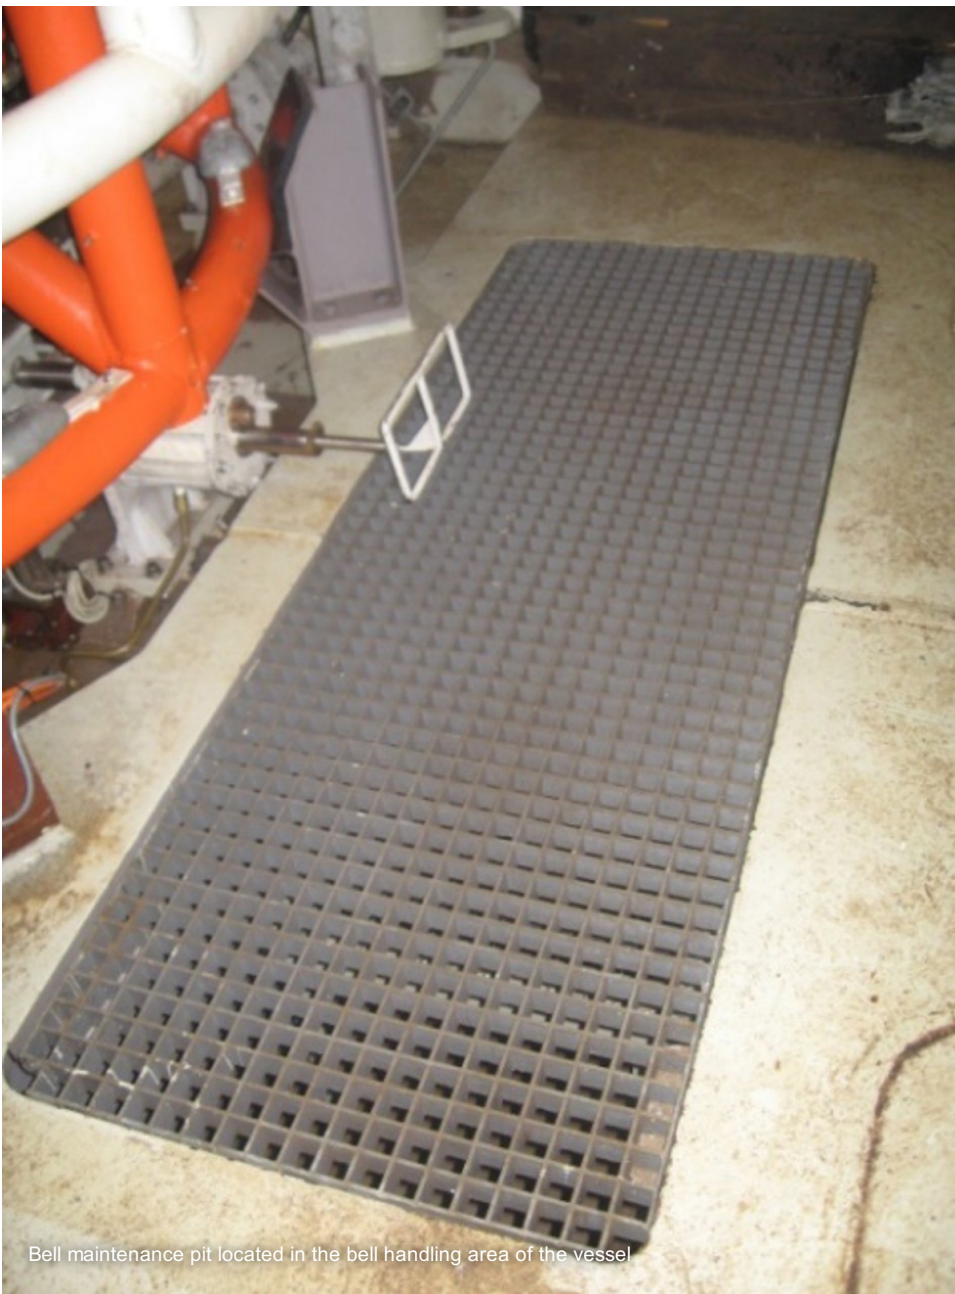
After the grating was removed the dive supervisor proceeded into dive control, at which point the diver moved the grating further and overstepped backward into the pit, falling 1m.

- The direct cause of the injuries was the 1m fall into the maintenance pit.
- The root causes included:
 - inadequate design/engineering of the bell maintenance pit, including depth of the pit itself.
 - risk assessment tools used did not include key hazards associated with the steps being undertaken as part of the overall maintenance work on the bell, including safe access into/out of and around the maintenance pit.
 - Basic safety training modules (specifically risk assessment and manual handling) had not been completed within the first week onboard (as per procedure) and could have acted as a refresher for any training previously done on this, before being involved in risk assessing manual handling activities onboard.

- The bell maintenance pit did not have to be 1m deep in order to be fit for the purpose for carrying out bell maintenance activities.
- Manual handling and falls into the open pit, were not included in the risk assessment tools used, so may not have been recognised and discussed at the time.

Bell maintenance pit located in the bell handling area of the vessel

- Review of the existing task based risk assessment (TBRA) and creation of a TBRA specific to bell maintenance, including working in and around the bell maintenance access pit.
- False floor installed into maintenance pit to reduce the depth as required.
- Audit and review of employees onboard to ensure minimum safety training modules and requirements have been completed as per procedure.
