Luff ram clevis failures

Safety Flash Published on 18 January 2013 Generated on 17 January 2025 IMCA SF 01/13

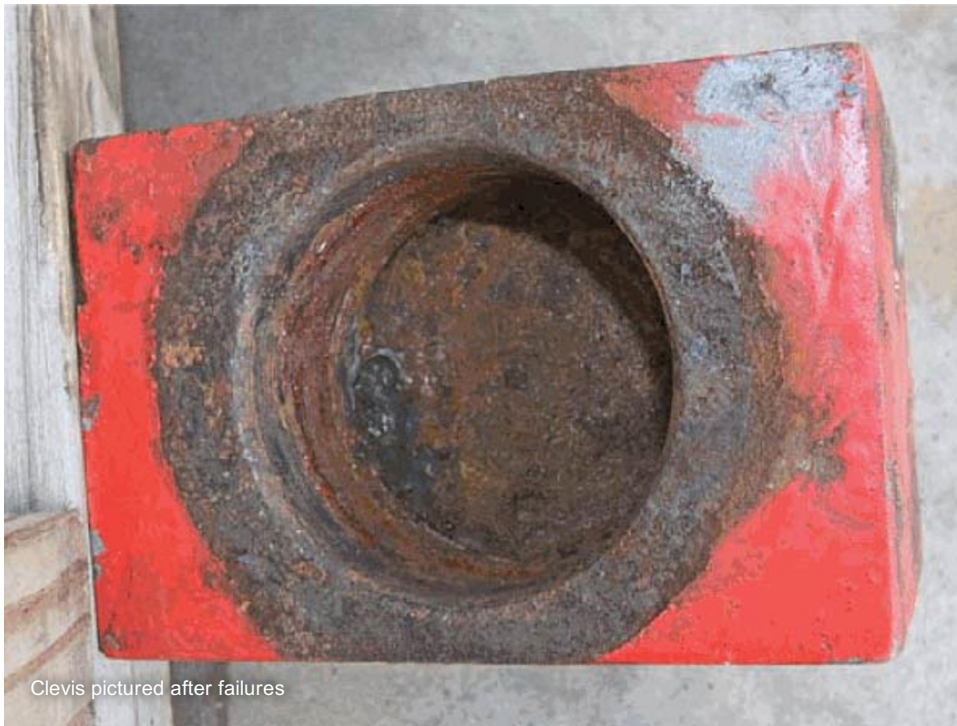
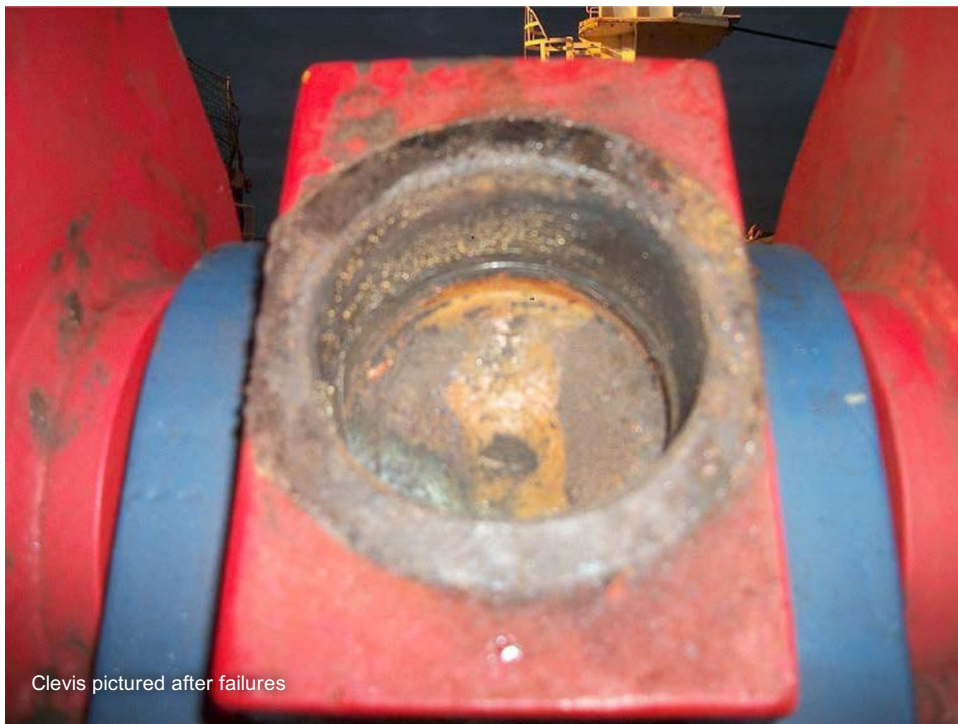
Clevis pictured after failures

- No evidence of anti-seize compound or other corrosion inhibitor in the rod end threads or on the rod threads.
- Dead space between rod eye and cylinder rod allows generation and collection of moisture/condensation.

- Excessive corrosion of each clevis (rod eye).
- Dimensional check shows clevis to be deformed.

The company notes that root cause analysis for multiple failures is on-going; however, the causes of the corrosion are in part attributable to a missed step during service and maintenance of the cylinders.

- the planned maintenance system was updated with the manufacturer's recommendations for inspection of cylinder rod eyes:
 - while A-frame foot is approximately 1" from the hard stop so the luff cylinders are in tension, use a feeler gauge to determine if there is any gap between the faces of the rod eye and rod (there should be zero gap). If there is a gap, the cylinder should be removed, rod eye

removed and inspected

- verify that counterbalance valves are adjusted properly
- perform a visual inspection of the A-frame operation to focus on cylinder timing or excessive lateral movement
- perform a visual inspection of the rod eye surface for excessive signs of corrosion at point of rod entry.
