## High potential dropped object

Safety Flash Published on 16 January 2015 Generated on 21 January 2025 IMCA SF 01/15

**A member has reported an incident in which an object fell 10 m onto the main deck of a vessel.**

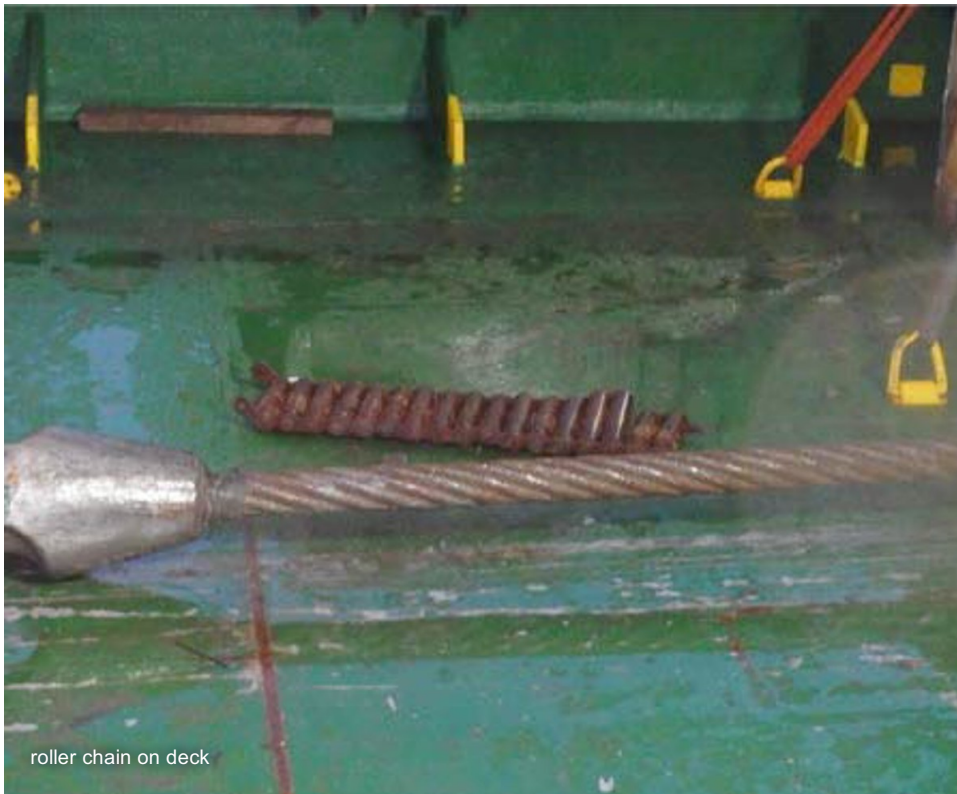
The incident occurred during pipe spooling operations on a vessel. Deck crew observed the object fall 10 metres from the ramp structure into the barriered area of the main deck. An 'all stop' was called and the object was found to be a 'Hilman Roller Chain' which weighed 60 kg. This incident has been classified as having high potential and was reportable under local regulatory requirements.

roller chain on deck

- Area was made safe and a DROPS sweep conducted for further potential dropped objects, in immediate area and vessel-wide.
- Rope Access Team deployed to check integrity and function checking of all Hilman Rollers.
- Review of maintenance and other procedures and working practices to be reviewed and updated as necessary.
- All personnel reminded that not only can anyone call an ALL STOP, but they are obliged to call an all stop if they see any act or condition they

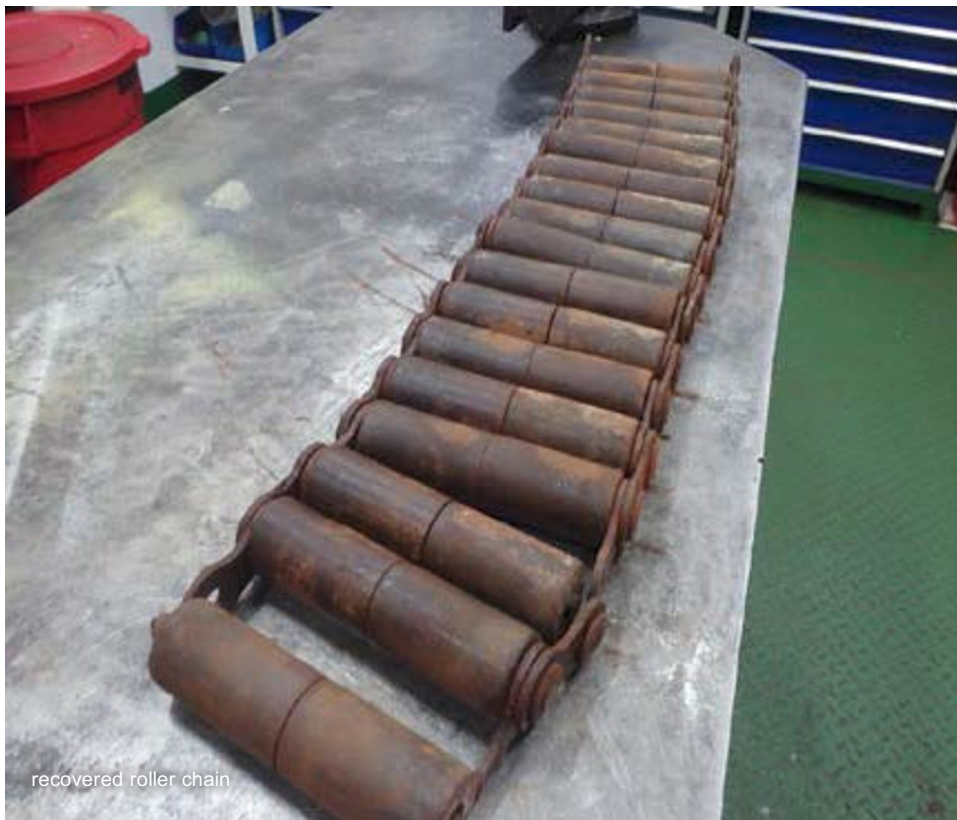
Thorough risk assessment, in addition to the fact that crew followed the correct control measures, meant this particular incident was injury free. However, one roller, weighing 2 kg, was found outside the barriered area and this alone, hitting someone from a 10m height, could easily have resulted in a fatality.

recovered roller chain

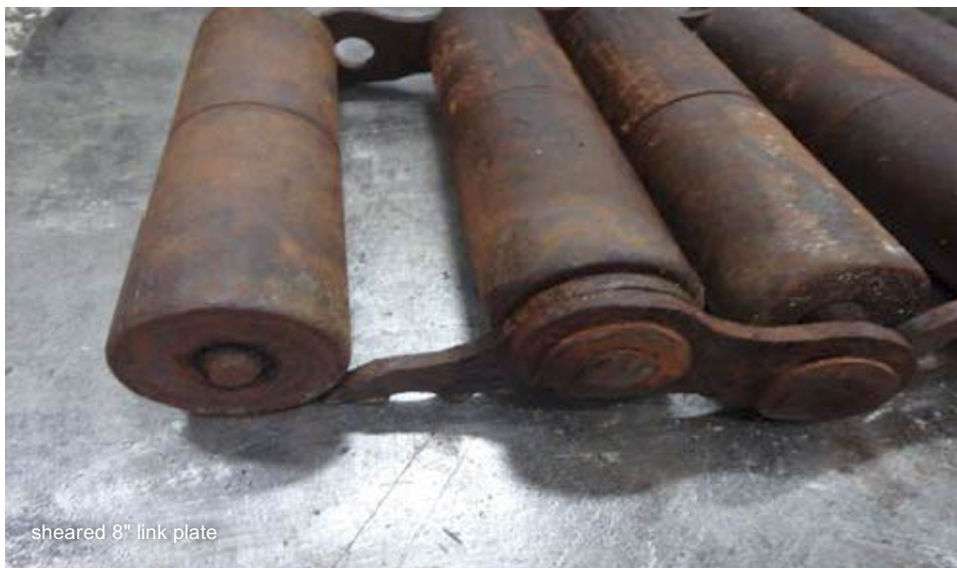
sheared 8" link plate

- The Hilman Roller Chain parted and dropped as a result of an '8' link plate failing and allowing the chain sections to part.
- A single roller weighing 2 kg, dislodged from the chain assembly and was found to have landed outside the barriered area.
- The cause of the failure was not identified; however, several factors including maintenance procedures, accessibility and seizure by corrosion may have been contributory factors.
