LTI – back injury

Safety Flash Published on 12 January 2026 Generated on 28 January 2026 IMCA SF 01/26

A member of the crew of a crew transfer vessel (CTV) badly pulled their back whilst helping with mooring operations.

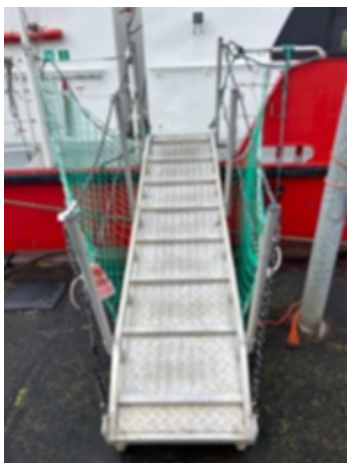
During normal operations, the gangway is stored on the quay while the vessel is operating in the field. After removing the lashings and securing ropes, the Able Seaman used a line to lower the raised end of the gangway down onto the quay. While doing this, the AB experienced a sudden and severe pain in the lower back, and cried out in pain. The job was stopped and the AB was assisted to a chair for assessment and rest.

- The task of removing or stowing the gangway prior to sailing was not specifically addressed within the risk assessment.
- The risk associated with manual handling during gangway operations was underestimated or insufficiently controlled.
- The absence of mechanical lifting aids, combined with single-person execution resulted in conditions which led to an injury.
- Statement provided by the Master indicated that the IP has said the injury was caused due to an awkward movement made while attempting to lower the gangway to the quay.

Due to the vessel's crane configuration, the final positioning, securing, and rigging of the gangway must be completed through manual handling rather than by crane.

The injury occurred due to insufficient procedural controls and risk assessment for gangway handling, combined with unclear gangway weight information and single-person execution, which exposed personnel to a risk of injury.

- Ideally have two person handling for all gangway operations when mechanical aids cannot be used.
- Review and update all relevant risk assessments to explicitly include gangway handling, specifying safe handling limits and required personnel.
- Record and verify the exact weight of all gangways across the fleet.
- Can the task be done in a better, smarter way – e.g. can the gangway access

can be moved to the bow?
