## LTI: Step into open deck hatch causes fall

Safety Flash Published on 10 January 2020 Generated on 12 January 2025 IMCA SF 02/20

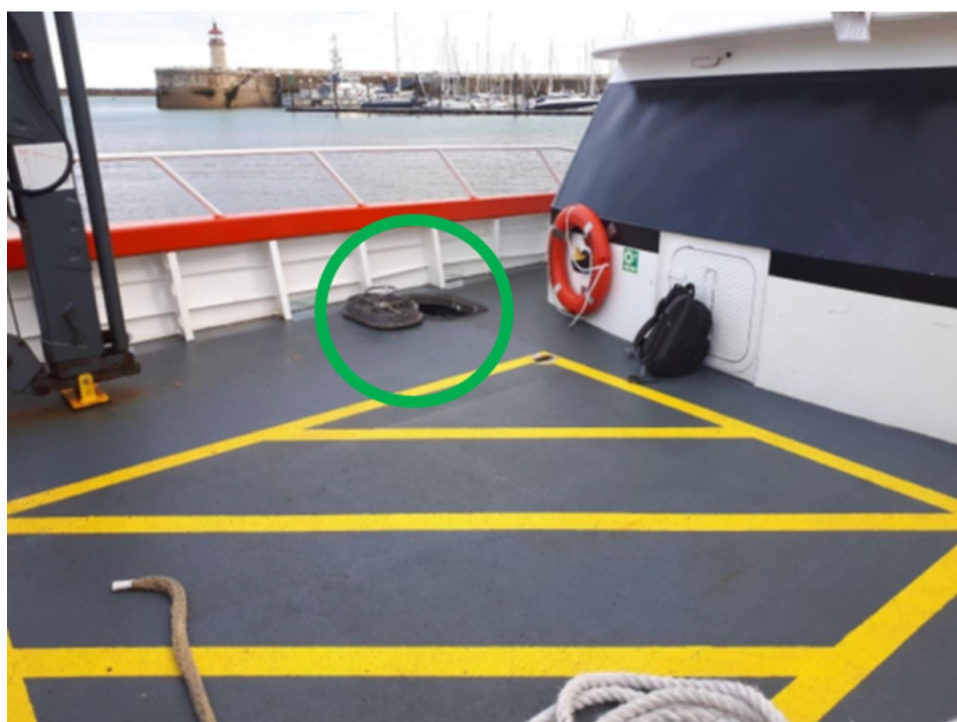
During personnel transfer operations on an offshore renewables crew transfer vessel (CTV), a deckhand stepped backwards into an open hatch and fell, resulting in an injury.

The direct cause – what went wrong – was that the deckhand stepped backwards and did not see, and thus fell into the open hatch.

- Because of miscommunication between the two crew members, only the aft hatch was closed.
- The forward hatch was left open when the lifting operations started. There were no barriers around the hatch. The outside of the hatch was marked yellow and was clearly distinguishable from the deck when closed. However, there are no proper markings or distinct colour on the inside of the hatch and as a result the hatch is less clearly distinguished when opened.

- Amend risk assessments to include all relevant preventive measures (including responsibilities for lifting, and deck checks prior to lifting operations and clear means of communication).
- Provide distinct (colour) marking on the inside of the hatches to make them easily distinguishable when open.
- During 24hr operations, time for maintenance should be scheduled in;
- Investigate improvement measures for radio communications when working in the engine room.
- Reiterate lesson '*time pressure should be prevented and in case it does occur unexpectedly; this should not lead to rushing or taking short cuts*'.
- Reiterate 'stop work authority'.
