MSF: Cargo Snagging

Safety Flash Published on 4 January 2021 Generated on 28 January 2026 IMCA SF 02/21

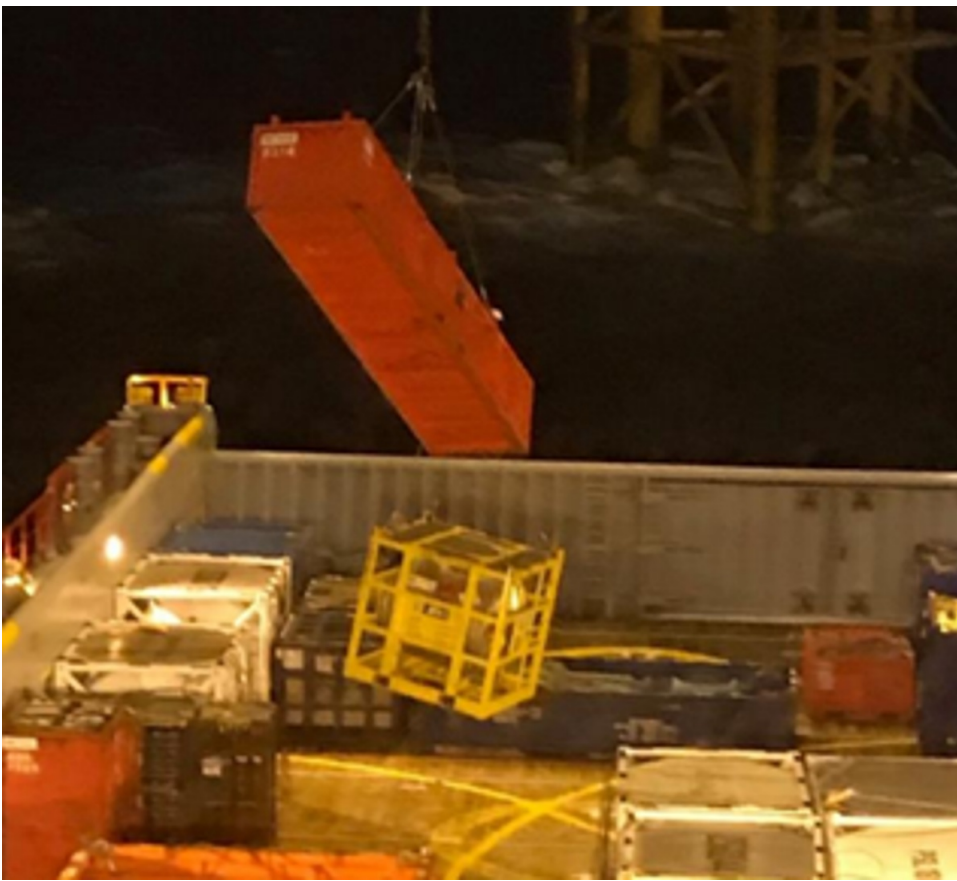
A vessel was engaged in deck cargo operations at an offshore location. A number of lifts had been successfully discharged and backloaded which led to limited space on deck. The crane operator advised the next lift would be the 25ft basket on the starboard side which was duly connected to the crane hook. The vessel deck crew moved to a safe place and confirmed to the crane operator that he was clear to hoist. As the crane operator began to lift the basket off the deck, the vessel bridge team noticed a corner of the basket had become snagged on a heli-tank and called an ALL STOP.

The call was not acknowledged, and the crane operator continued to hoist. As the 25ft basket was raised approximately 3m above the deck, the snagged lift was suspended approximately 0.5m and the 'Stop' call was given again by the bridge team. The crane operator continued to hoist causing the basket to rotate over the adjacent cargo and a third 'Stop' call was issued by the bridge team. The crane operator acknowledged the third stop call and began to take avoiding action. The crane operator was able to successfully land the snagged helitank in a clear area of the deck. The snagged lift was naturally freed, the vessel deck crew remained in a safe location and the basket successfully offloaded without further incident.

- The vessel deck crew did not 'tuck in' the heli-tank bridle on completion of backload.
- The crane operator missed two opportunities to stop the job when the call was given.

- Reinforce the need for good communication between vessel and platform crew during lifting operations, particularly in relation to 'stop the job'.
- Improve deck space management and planning. Vessel crew are encouraged to pro-actively give feedback in this area where possible.
- All crew are reminded to always be aware of potential snagging hazards and proactively take avoiding action where possible.
- Where possible, containerised cargo bridles should be stowed or tucked into the framework or basket to prevent snagging.
