MAIB: Parted mooring rope leads to fatality

Safety Flash Published on 6 February 2025 Generated on 28 January 2026 IMCA SF 02/25

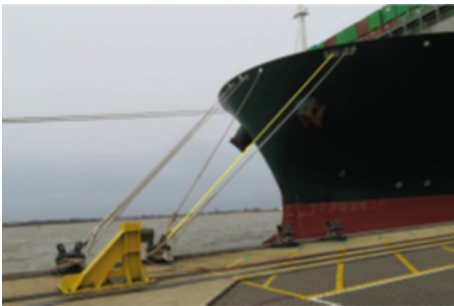
Moored vessel

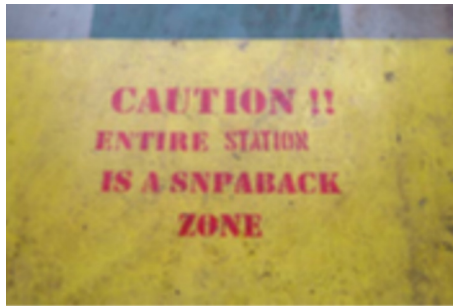
Warning sign

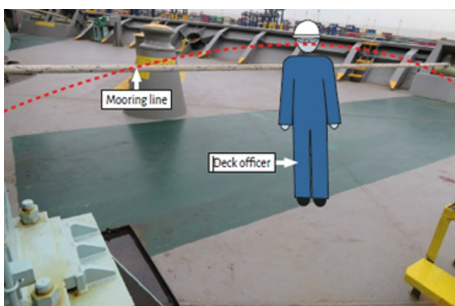
Incident location

- On this occasion the line parted just behind the mooring eye close to the jetty. Although the end of the rope did not snap back onto the forecastle, the sudden release in the line's tension caused a bight of the rope on board to fly up and strike the deck officer.
- It is possible that the deck officer did not realise the risk involved of being stood in that place. The vessel's mooring lines were almost new, still in good condition and no audible creaking or groaning was present to indicate imminent failure.

- The entire forecastle mooring station had been identified as a snap-back zone;
- Additional measures to reduce risk could include fitting snap-back arrestors to mooring lines. These arrestors absorb the force within a parted line;
- STOP THE JOB!! The vessel operator in this case also introduced a campaign to encourage crew members to challenge colleagues who they observed as about to put themselves at risk.

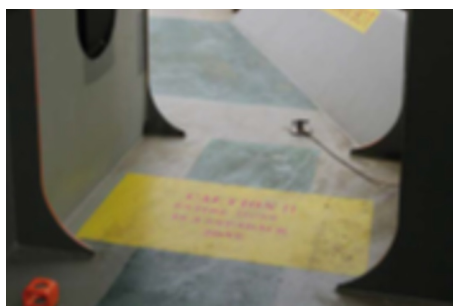
Where the warning sign appears on the floor
