Fatality and serious injuries during heavy lift operation

Safety Flash Published on 1 April 2003 Generated on 22 January 2025 IMCA SF 03/03

One man was killed and nine others were injured at a construction site during the lift of a 300 tonne alternator.

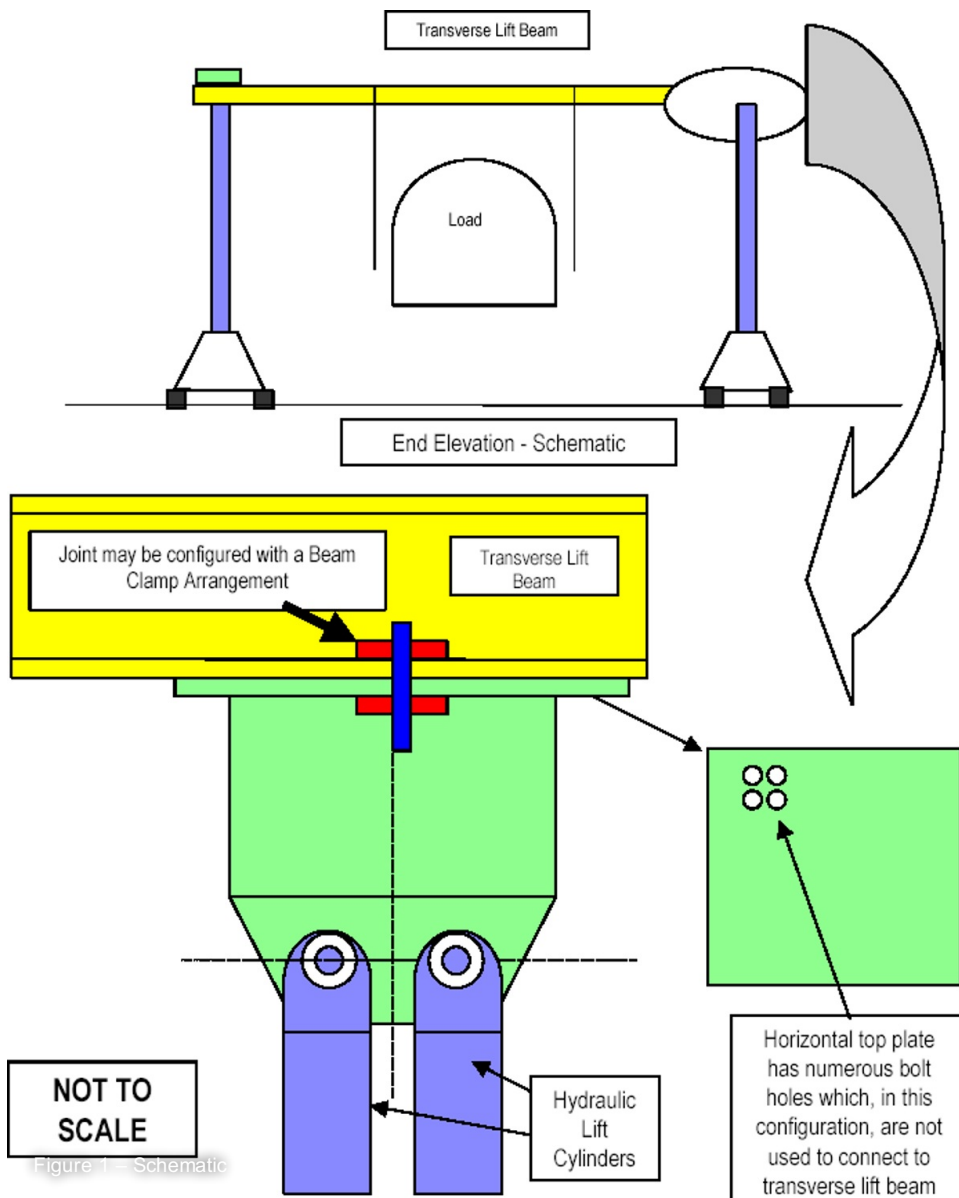
Figure 1 - Schematic

The system may be assembled as shown schematically above in figure 1. In this configuration, the horizontal top plate, which forms part of the connection to the vertical lift cylinders, is connected to the flange on the underside of the transverse lift beam via a 'beam clamp' arrangement.

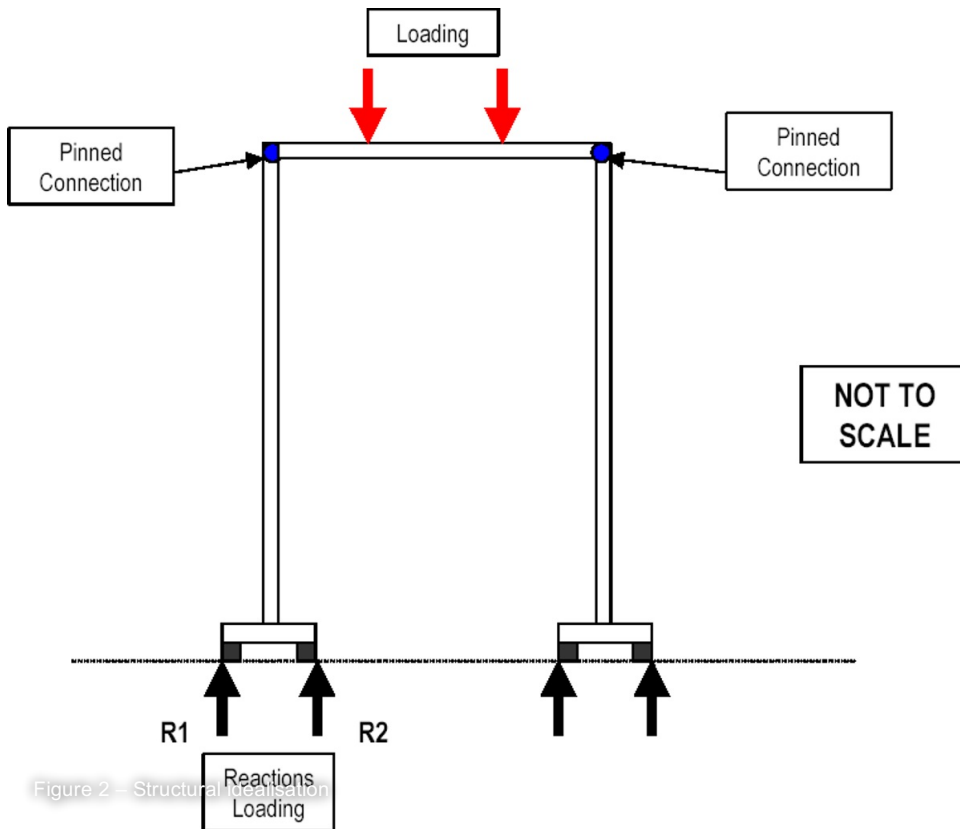
If it is configured in this way, the lifting arrangements may be represented by the structural idealisation shown in figure 2. In this case, the transverse stability of the system is derived from the moment generated by the difference in vertical reactions (at points R1 and R2) between the inner and outer guide rails. However, this may be limited as the supports may have no capacity to resist an uplift or tensile load.

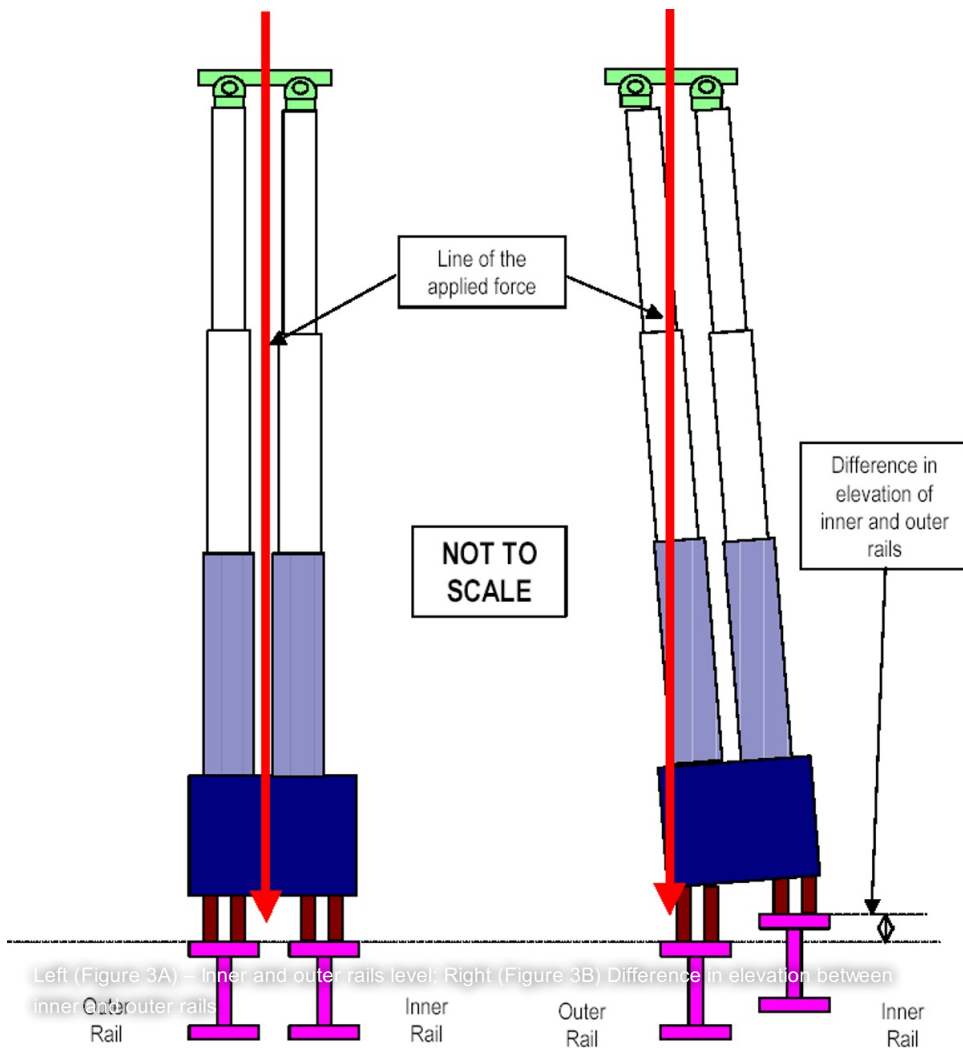
When the inner and outer guide rails are level, the line of action of the force is between the guide rails, as shown in figure 3A. If there are differential levels between the inner and outer guide rails, this may result in the line of action of the force moving outside the base, which in turn may impact the stability of the entire system, as shown in figure 3B.

1. A suitably qualified and competent person should check the stability of any lifting arrangements which incorporates similar vertical lift systems. This review should address the following issues:

- All possible conditions which may result in a differential deflection between the inner and outer guide rails at the base should be considered and their impact on the overall stability of the system fully evaluated.

- The permissible out-of-level tolerance between the inner and outer guide rails and the permissible tolerance for the vertical alignment of the lift units should be derived by calculation for all stages of the operation.

- All permissible tolerances should be included in the method statement and clearly communicated to all those involved in the operation.
2. A system which is capable of monitoring the vertical alignment (in two orthogonal planes) of the hydraulic lift cylinders should be devised and used during the operation.
