## Fatality during diving operation

Safety Flash Published on 1 April 2003 Generated on 28 January 2026 IMCA SF 03/03

**A Member has provided a report of a diving fatality that occurred during the installation of a 20" flexible hose (40m long) between a pipeline end manifold (PLEM) and a new buoy in a water depth of 35 metres.**

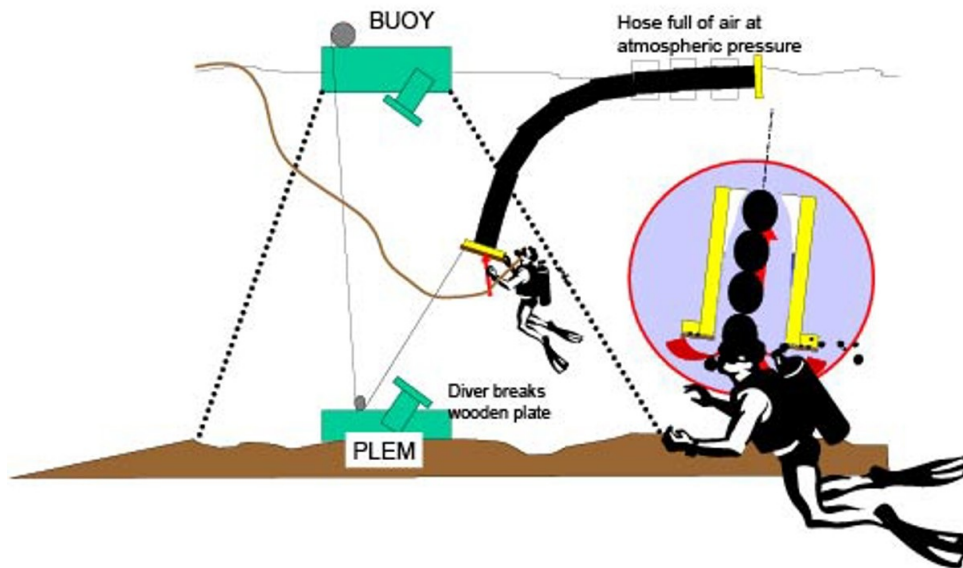
Meanwhile the diver took his broken knife blade and with his hammer he punched the plate. At this stage there was a loss of communication with the diver and there was a fast payout of his umbilical. See sketch.

The umbilical was recovered to the surface along with the diver's Kirby Morgan 18 bandmask. The bandmask was damaged but intact except for the video camera which had been smashed off. Also hooked to this equipment was the ring shaped remnant of the wooden plate. Diver rescue procedures were then launched. After a little time searching the diver was found. He had massive head injuries. Death was evident.

Management and SHE-Q representatives from the client group and the contractor immediately launched a detailed investigation into the accident, and produced a joint report. The immediate cause of the accident was the loss of integrity of the wooden plate which then allowed a sudden flooding of the flexible hose. The diver was sucked into the pipe end by the rapid inflow of water.

- Deviations from the operational procedures (no flange with valve for flooding)
- Human error, such as the misperception of risk and the eagerness to correct an error, that caused a delay.

- ensure that company and IMCA guidance are implemented as a basis of any local procedures and contractual arrangements.
- review current or recent diving practice against company procedures and the IMCA International Code of Practice for Offshore Diving. Modify current practices and procedures accordingly to be in line with these two standards.
- perform job safety analysis before all diving operations.

- ensure that the modifications or changes to working procedures are covered by defined rules and steps.
- ensure that the level of supervision is adequate and well defined.
- that a culture of get-the-job-done on time and on budget does not exist to the detriment of safety.
