Near miss: Unidentified differential pressure led to diver's umbilical getting trapped

Safety Flash Published on 13 February 2017 Generated on 28 January 2026 IMCA SF 03/17

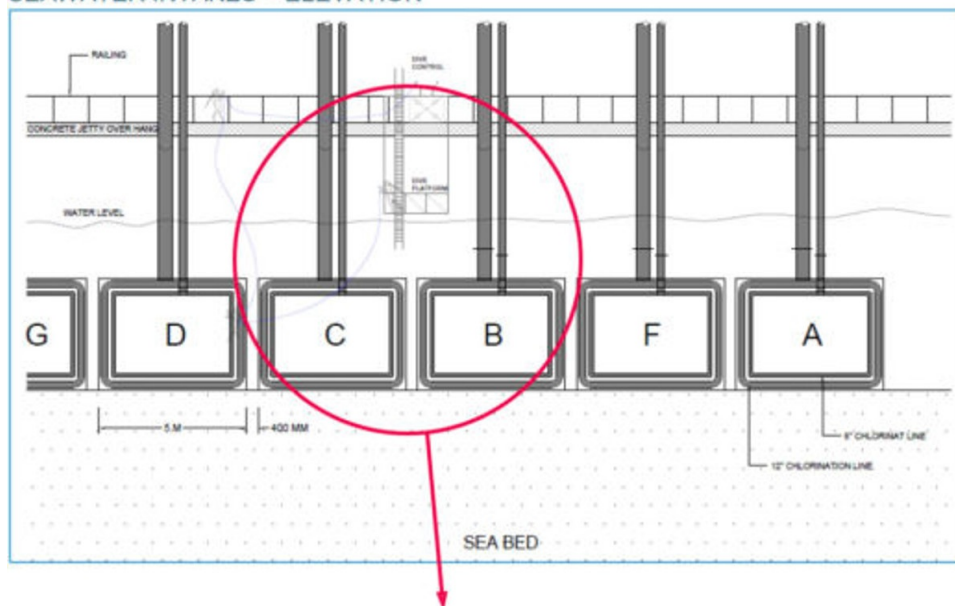
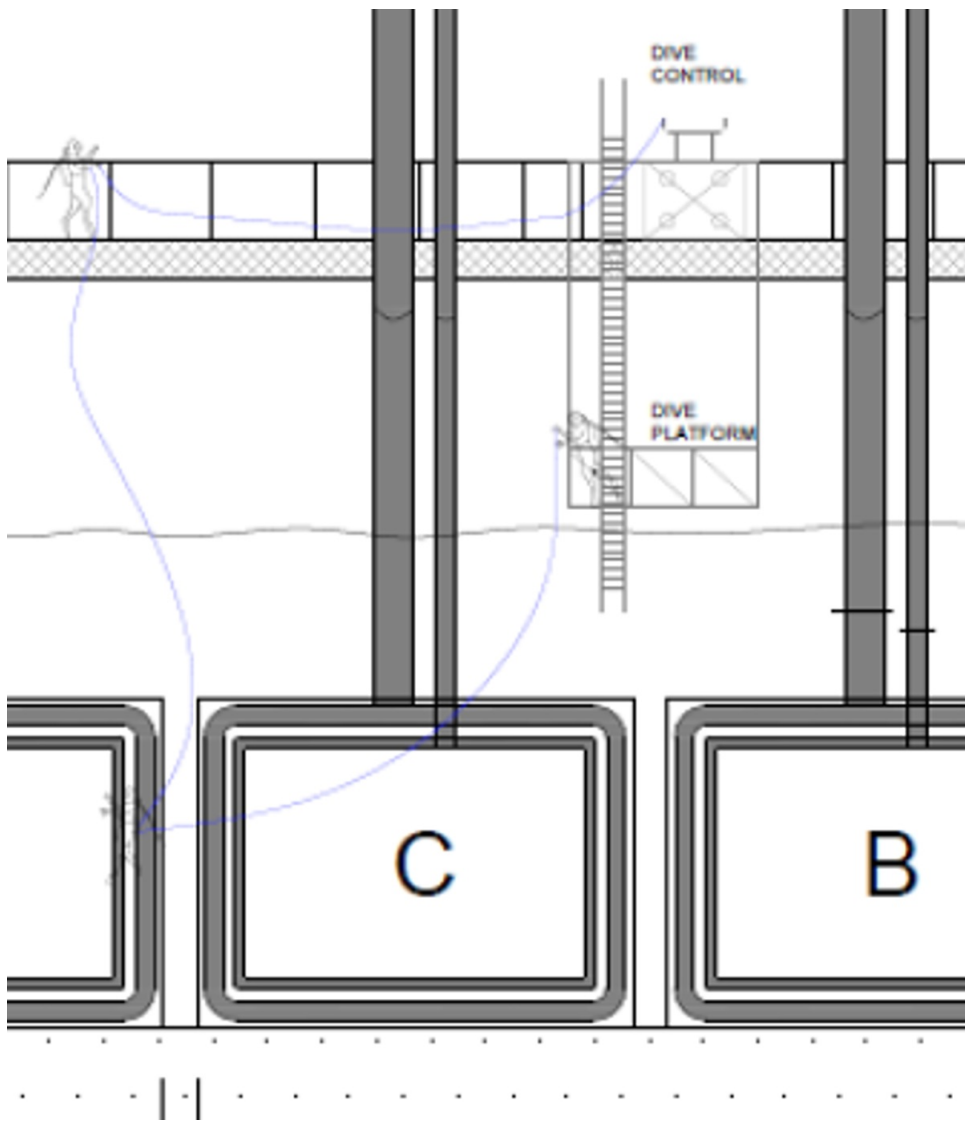
SEAWATER INTAKES – ELEVATION

Each of a number of culverts at the location contained a seawater intake fitted with an automated grating and trash cleaning system recessed 5m from the main opening. The diving operation necessitated moving repeatedly back and forth across the 5m wide intake opening between the clamps. This allowed some slack to be unintentionally introduced into the divers deployed umbilical.

After an extended period of incident free operations, one of the divers' umbilicals became entrapped with the automated trash cleaning system, resulting in the diver being pulled towards the intake. The 2nd diver cut the umbilical to facilitate escape and both divers ascended to the surface in a controlled manner without injury.
