Explosion and fire on-board the chemical tanker *Stolt Groenland*

Safety Flash Published on 30 January 2020 Generated on 22 January 2025 IMCA SF 03/20

The UK Marine Accident Investigation Branch (MAIB) has published its interim report into a serious explosion and fire on-board the chemical tanker *Stolt Groenland* on 28 September 2019 at Ulsan in South Korea.

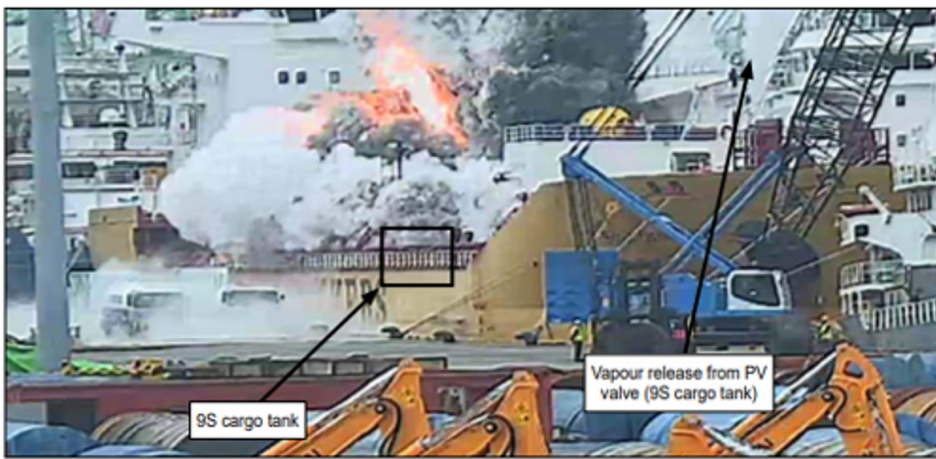
Figure 1: Tank rupture and ignition of released vapour

The MAIB's initial findings were that the explosions were probably caused by the rupture of the deck above the cargo tank, followed immediately by the ignition of the styrene monomer vapour that was then released.

The rupture was due to over-pressurisation and the likely sources of the ignition were static electricity, sparks or elevated steel deck plate temperatures resulting from the tank rupture.

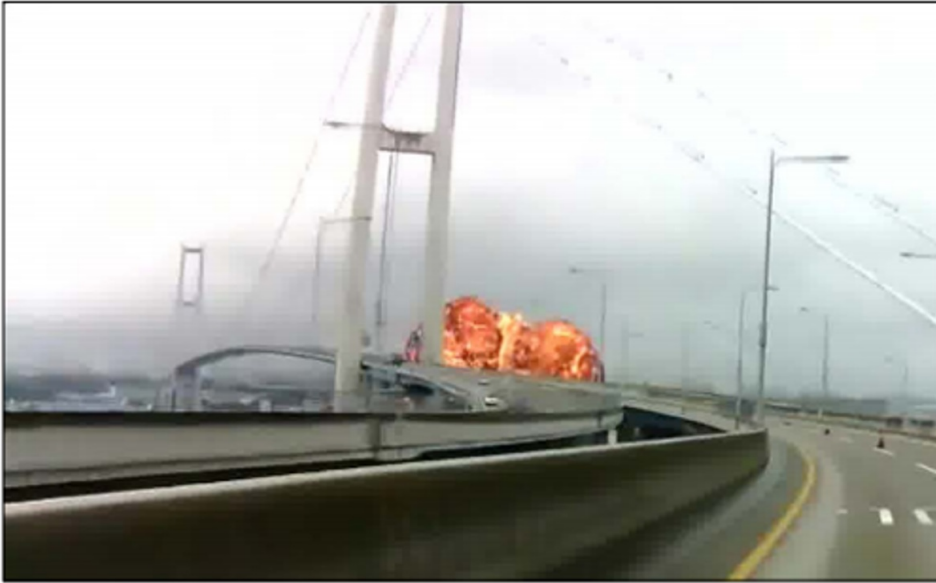
At 1050, two explosions were seen and heard in rapid succession in way of the tanker's cargo manifold. The resulting fireball passed very close to a road bridge above the quay.

Figure 2: Fireball viewed from the Ulsan bridge
