Dutch Safety Board: Fatality when mooring line snapped

Safety Flash Published on 19 January 2021 Generated on 23 January 2025 IMCA SF 03/21

The Dutch Safety Board has issued the following report on a mooring line fatality onboard chemical tanker *RN Privodino* on 28 June 2018, while entering the Noordersluis lock at IJmuiden, en route to Amsterdam.

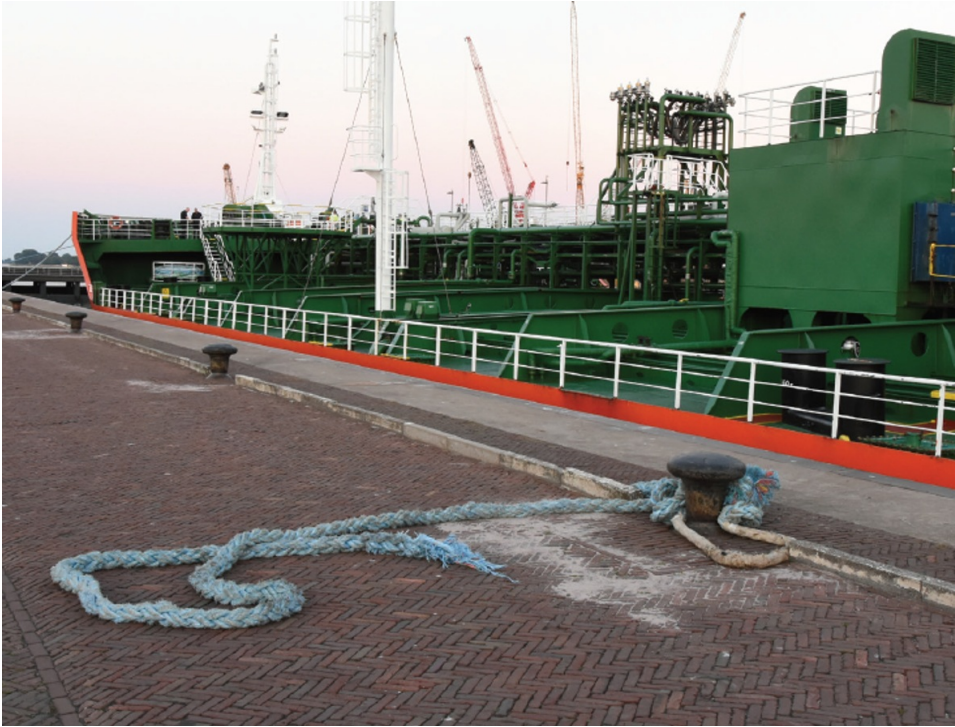
As part of the analysis of the accident, the Dutch Safety Board identified four missing or failing barriers:

1. Slowing down the vessel on time.

2. Only place the spring under tension when the vessel reaches its final position in the lock.
3. Intervention by mooring team leader (supervision).
4. Working outside the Snap-back zones.
