Near miss: narrowly avoided fall from height due to missing deck gratings

Safety Flash Published on 20 February 2025 Generated on 28 January 2026 IMCA SF 03/25

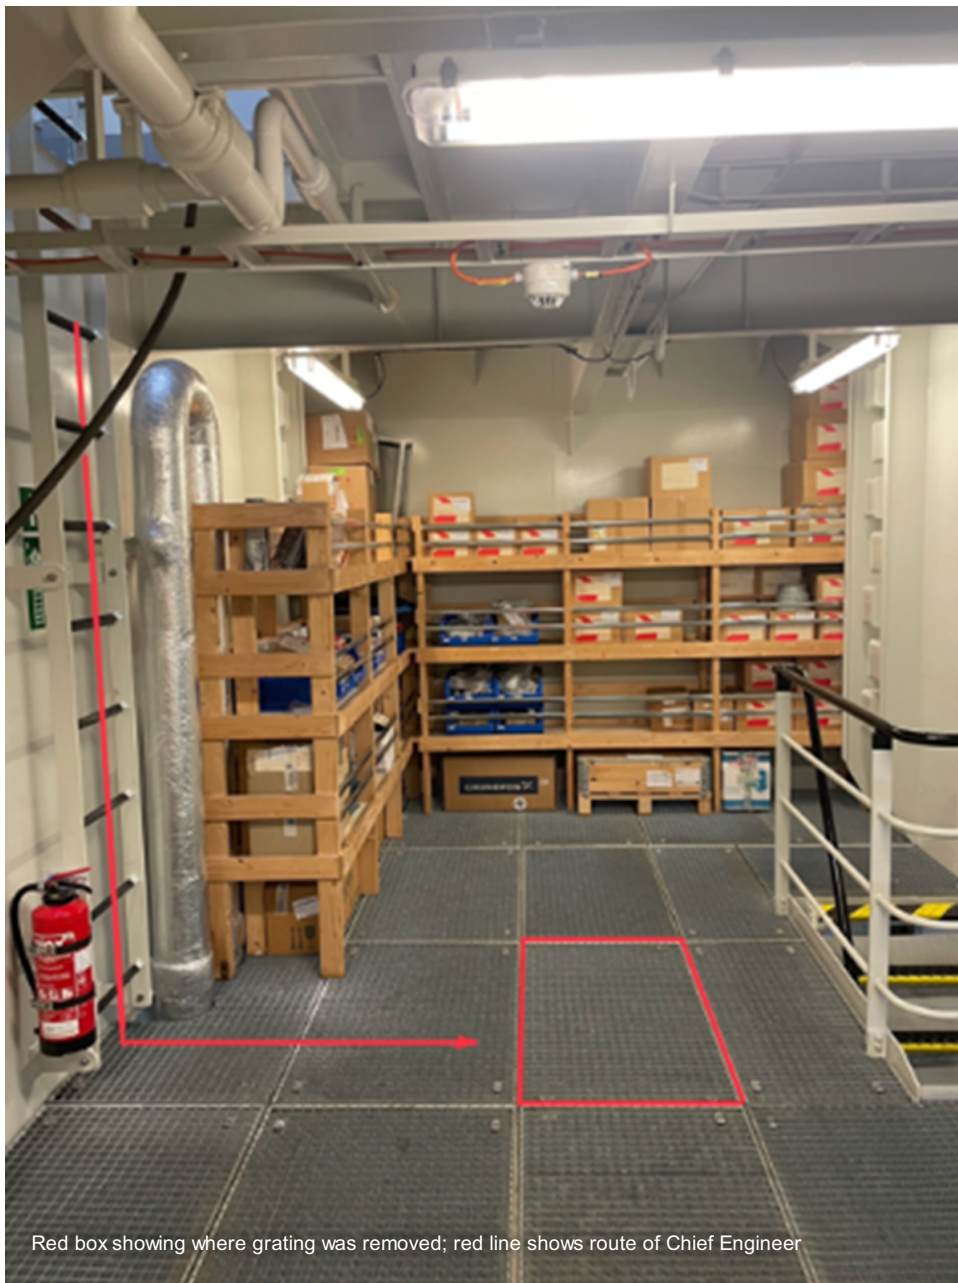
Subsequently, the Chief Engineer, on the way to inspect the work, entered the mezzanine level using a vertical access ladder directly from the forecastle, which had not been signed/barriered. At the bottom of the ladder he turned, took one step, and his next step was into the hole. He only managed to prevent a fall of 4-5m by instinctively reaching out to break his fall, ending up supported by his forearms and one leg, with the other hanging through the hole.

Red box showing where grating was removed; red line shows route of Chief Engineer

- The possibility that workers would use the vertical ladder had not been considered.
- It is unclear why, after removing the lifting gear and worksite barriers, the grating had not simply been replaced immediately, there being no further work planned.

- Lack of hazard awareness in missing the possibility that a 'secondary' access route could be used.
- The hierarchy of risk controls was not applied – replacing the grating straight

away would have eliminated the hazard, as well as the need for any signs and barriers at all.

The incident was investigated by the yard, and the need for vigilance in planning tasks was stressed at inter-departmental work planning meetings. No similar events were observed during the remainder of the stay in dock.

Preventing the use of the vertical ladder (which formed part of an emergency escape route) for general access was considered, but this was deemed to be a practicable, safe means of access, with no more risk attached than several other vertical ladders around the ship.
