Near miss: potential dropped object left on top of cargo

Safety Flash Published on 20 February 2018 Generated on 21 January 2025 IMCA SF 04/18

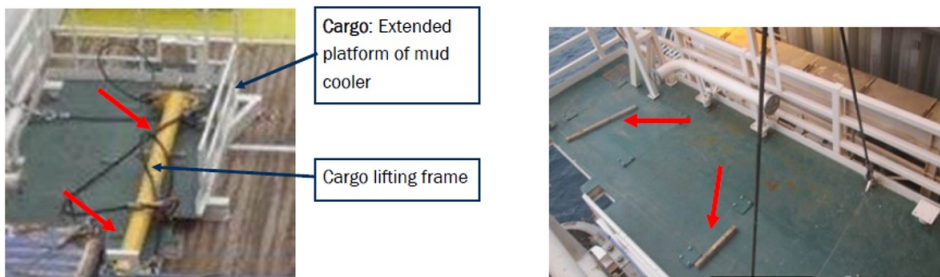
During deck cargo loading operations from a vessel to an offshore platform, two pieces of unsecured timber were inadvertently lifted from the vessel onto the platform, on top of the lifted cargo – a mud cooler module.

This was discovered and reported by the deck foreman on the platform, who immediately informed all involved parties. There were no injuries or equipment damage.

Investigation revealed that the two timbers were initially placed as dunnage under the lifting frame (“spreader bar”) after loading onto the vessel at the quayside. Third party shore-side stevedores originally placed them to prevent damage to the lifting frame and its slings being caused by movement during the voyage.

When the platform hooked the frame, it was anticipated (by the third-party workers) that the crew would go under the suspended load to remove the dunnage. However, the vessel crew correctly declined to do so and left the timbers in situ. However, the vessel crew did not identify the further hazard left by leaving the timbers on the roof of the mud cooler module.

In this specific case, a possible solution could have been a pre-lift for repositioning the spreader bar, allowing removal of the timbers by using a hands-off approach, using push/pull poles.

- Task risk assessments for lifting operations were reviewed to include risk and controls related to potential dropped objects while handling bulky/heavy loads where cargo lifting frames are used;
- Permit to work checklist was reviewed to include a specific requirement to check for potential dropped object (PDO) associated risks;

The incident, investigation and outcome to be shared with the quayside lifting authority, such that future lifting plans take into account the offshore environment.
