LTI: Stored energy – rigger injured leg working on quayside

Safety Flash Published on 2 February 2021 Generated on 23 January 2025 IMCA SF 04/21

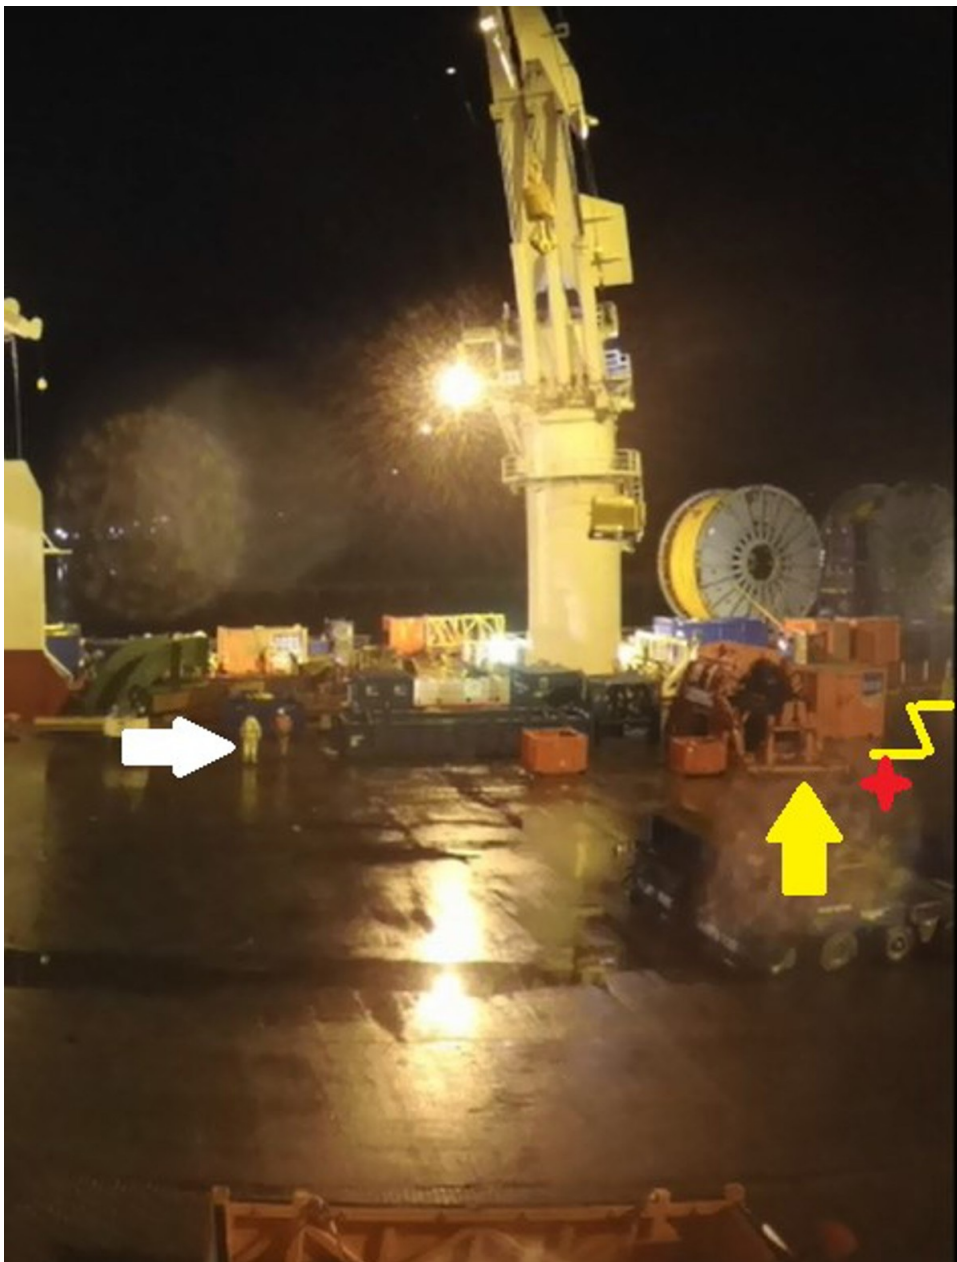
The following image shows the quayside prior to the incident.

The white arrow shows the rigger in full hi-viz clothing.

The yellow line shows the route taken by him from aft of the vessel, with the red star indicating the location of the incident.

The yellow arrow denotes the location where he awaited medical attention.

- A known risky technique (this method for moving slings with a forklift) had been accepted as the norm.
- There was no port induction for vessels coming into port, explaining quayside safety requirements including hi-viz and safe walkways.
- Containers removed from the vessel blocked the safe walkway.
- The forklift driver had to take a route which gave restricted visibility of personnel.
- The rigger had removed his hi-viz jacket further reducing his visibility.
- There was reduced lighting on the quayside.
- There were simultaneous activities occurring in the area which were not properly controlled.

Remain aware of what is going on around you and don't be afraid to **stop the job** when required.
