NTSB: Failure to disconnect and secure vehicle batteries led to fire

Safety Flash Published on 10 February 2022 Generated on 22 January 2025 IMCA SF 04/22

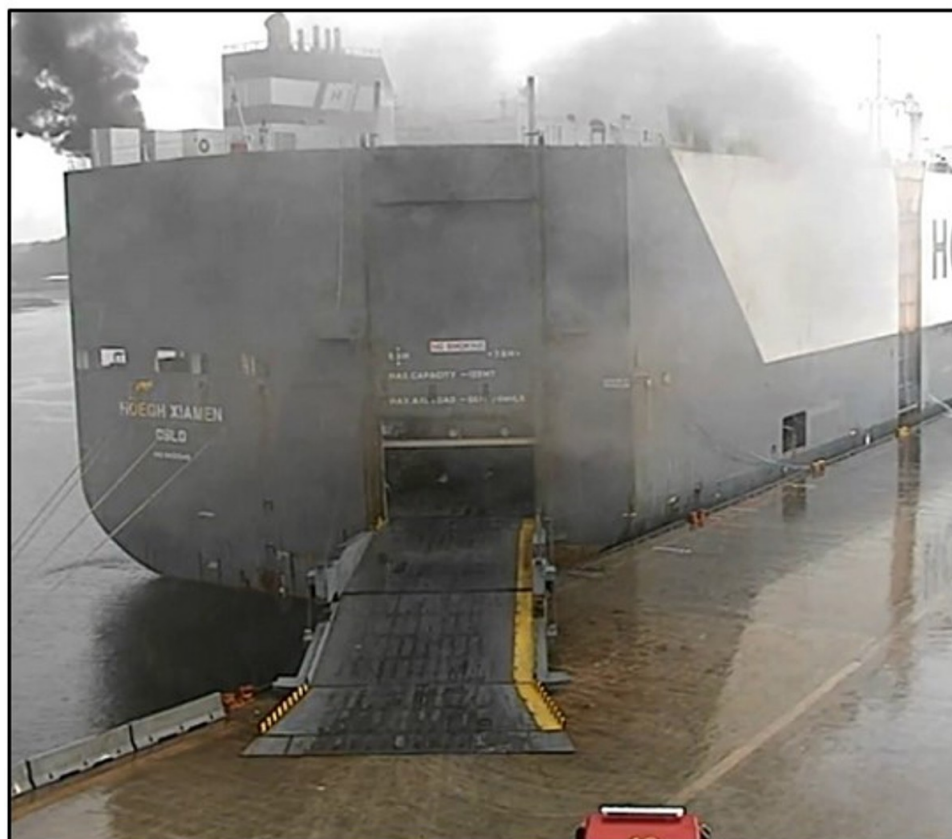
An electrical fault from an improperly disconnected battery in a used vehicle led to a fire aboard the vehicle carrier *Höegh Xiamen* at Jacksonville, FL, in June 2020. Nine firefighters were injured tackling the blaze, which took over a week to put out. The vessel and its entire cargo (over two thousand used cars) were effectively destroyed.

- Many of the vehicles loaded had batteries that were not disconnected and secured in accordance with procedures, which increased the risk of electrical arcing and component faults. During loading operations, both the loading

personnel and crew missed opportunities to address these hazards.

The NTSB determined the probable cause of the fire was ineffective oversight of the loading crew, which did not identify that the charterer's vehicle battery securement procedures were not being followed. This resulted in an electrical fault from an improperly disconnected battery in a used vehicle;

- Improved oversight and training of personnel involved in loading and in dealing with batteries and potentially hazardous cargo.
- Revision of procedures for the reactivation of fire detection systems after loading.
- Ensuring emergency contact information is immediately available for bridge teams.
