Dropped objects in dry dock

Safety Flash Published on 9 February 2023 Generated on 22 January 2025 IMCA SF 04/23

A member reports two dropped object incidents during a vessel dry-dock, both with serious injury potential

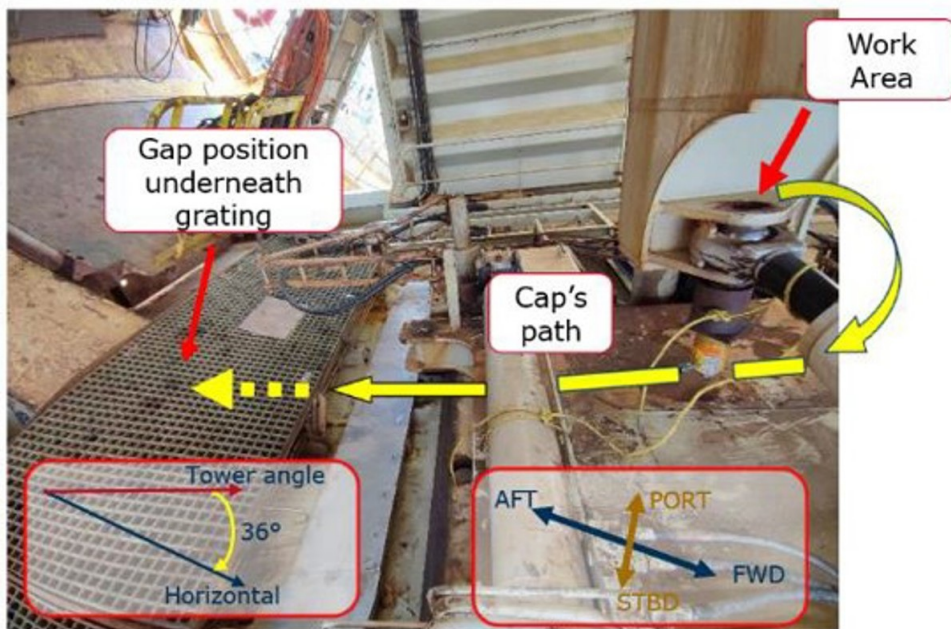
A hydraulic cylinder clevis pin “cap” slid from the tower during workstation maintenance and fell 14 metres into the dry dock.

To remove the cap, seized to the cylinder pin by rust, one of them used a hammer; the cap bounced outwards and fell 40 cm onto a platform below.

Due to the tower angle of 36° the cap then slid towards an uncovered gap and fell to the dock bottom.

A third-party work team were in the dock bottom near to where the dropped cap landed.

Path of 1.1 kg cylinder pin cap

- Ensure appropriately controlled safety barriers are maintained to provide adequate protection and prevent an incident.
