High-potential near miss: Uncontrollable movement of auxiliary whip line

Safety Flash Published on 9 February 2023 Generated on 3 July 2025 IMCA SF 04/23

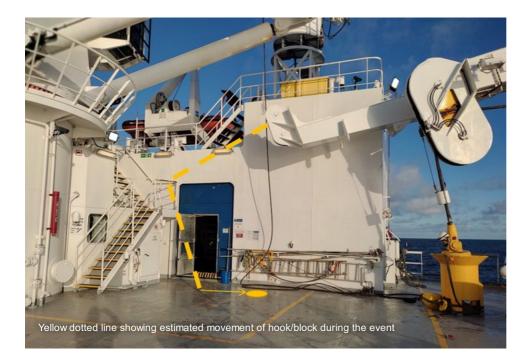
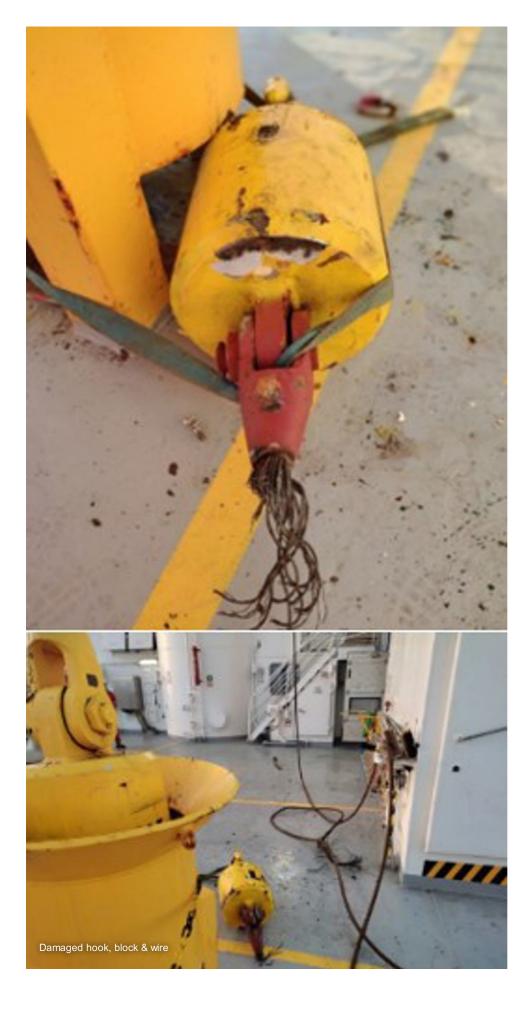
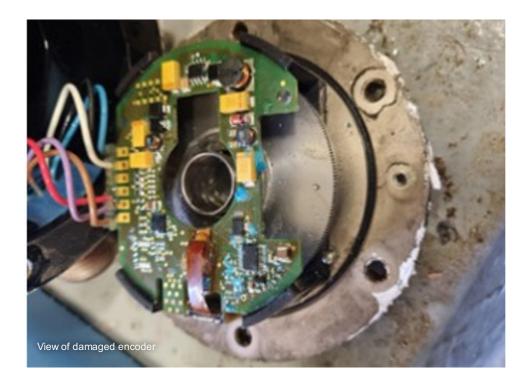
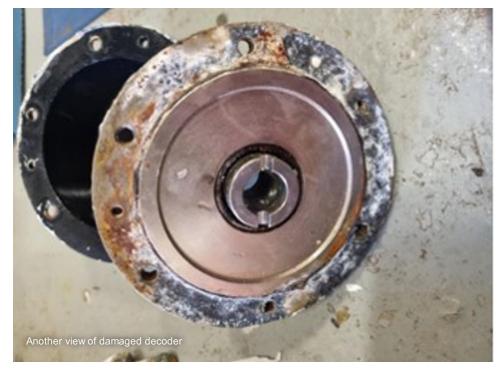
The block and hook were hoisted up to the sheave, when the auxiliary wire parted due to the forces applied. The block and hook were ejected forward until they hit a stair railing, approx. 4 m forward of the sheave. Then the block and hook fell approx. 3 m to the deck, and bounced before coming to rest.

The main crane auxiliary line encoder unit was damaged due to water ingress, and gave the wrong input to the crane, causing uncontrolled movements of the auxiliary wire as the crane was started up.

- The door to the deck workshop was open with no barrier in place to the main deck, leaving three personnel in the workshop exposed to the risk of walking into a hazardous/line of fire area.
- There was also additional risk for personnel not part of the operation to be accidentally hit, as there were no barriers in place at the stair from the mezzanine deck to the main deck.

- The faulty encoder was replaced with a new encoder with drain plug.
- The crane was repaired and inspected by the crane manufacturer. It was also inspected by a competent and independent third-party expert.
- A safety bucket was installed on deck for the auxiliary crane hook. This will prevent use of anchor point which will then prevent need for personnel to unhook at crane start up.

• The risk assessments and procedures for crane operations (including barriers) were reviewed and updated.
