## Divers helmet struck and damaged subsea by crane hook

Safety Flash Published on 6 March 2025 Generated on 16 March 2025 IMCA SF 04/25

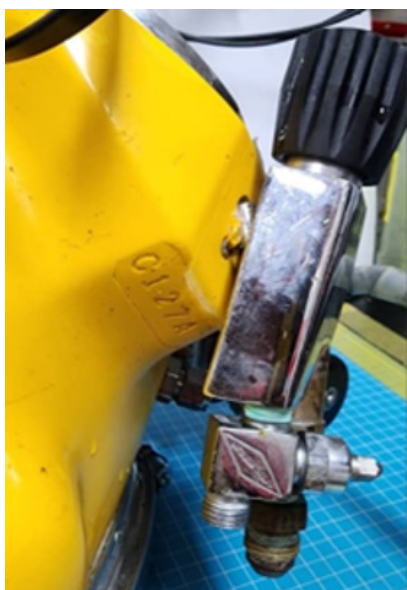
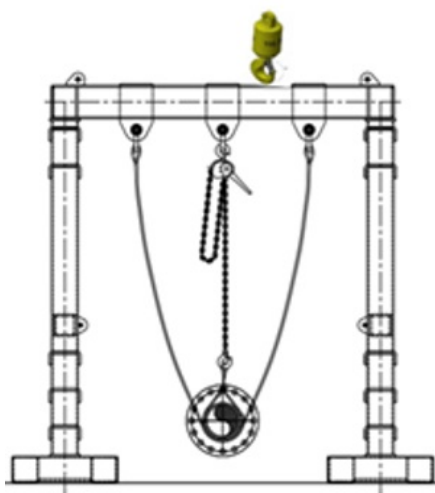
Whilst the diver was positioned beneath the PHF and moving up to disconnect the rigging, the crane hook unexpectedly struck the diver's helmet. The diver reported that they were unharmed and well, and returned immediately to the dive bell. The dive was aborted. Upon inspection, the diver's reclaim helmet was found to be damaged beyond repair, including the side block. Despite the impact, the integrity of the helmet was maintained throughout, demonstrating the high quality and durability of the diving helmets. The diver was unharmed.

When the crane hook was lowered for PHF rigging disconnection, it came to rest on the top beam of the PHF. This resulted in a 'no weight' reading, leading the crane operator to assume the hook had reached the seabed. As the diver approached the disconnection point, the hook slipped off the beam and struck the side of the diver's helmet.

- Inadequate length of crane pennant / stinger, which did not provide sufficient distance between the divers and the crane hook.
- Poor visibility, which hindered the ability to accurately observe the position of the crane hook.

- Ensure adequate distance between divers and crane hook:
  - The length of the crane pennant/stinger should be sufficient to maintain a safe distance between the divers and the crane hook during subsea operations. This will reduce the risk of accidental contact with the hook, particularly in limited visibility conditions.

- Enhanced visibility aids and monitoring:
  - In environments with poor visibility, alternative methods such as additional locating beacons, underwater cameras, or sonar should be considered to better track the position of critical equipment like the crane hook. Improved monitoring can help prevent misjudgements about the location of the crane hook.

- Reinforce communications, challenge assumptions!
  - Assumptions regarding equipment position should be minimised.
  - Clear communication and confirmation procedures between the dive supervisor, crane operator, and divers should be reinforced to ensure all parties are fully aware of the equipment's location at all times.

- Updated project procedures to specify minimum pennant lengths for different operations;
- Conducted pre-operation inspections of all rigging and lifting equipment, including crane hooks and pennants, to ensure they meet safety

- Updated the Job Hazard Analysis (JHA) to incorporate lessons learned from this incident, particularly regarding safe distances, visibility, and communication requirements for subsea lifting operations.
