MAIB: Very serious leg injury during crane operations

Safety Flash Published on 6 March 2025 Generated on 16 March 2025 IMCA SF 04/25

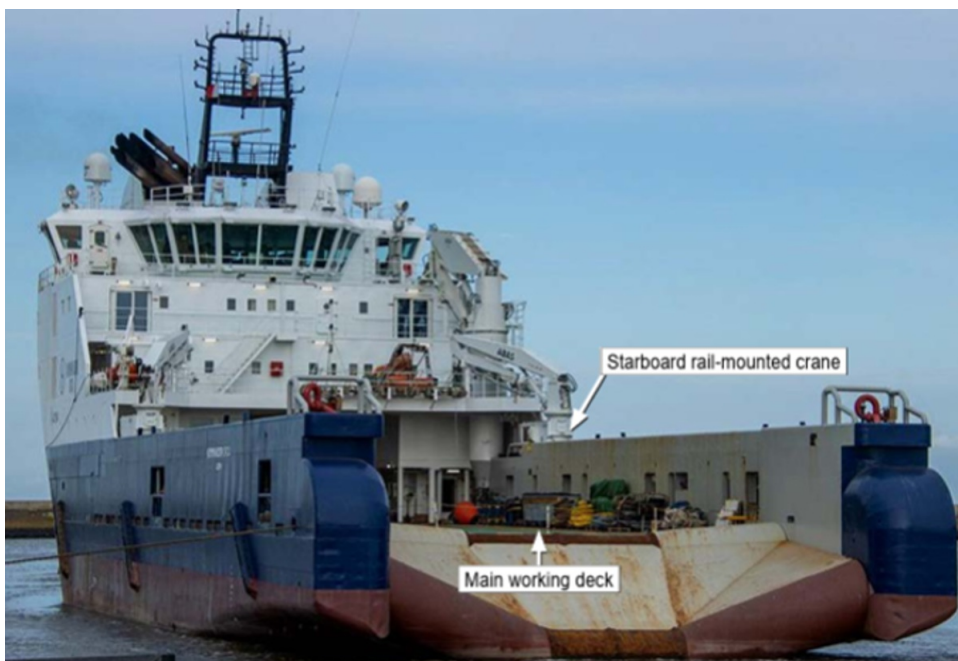
While operating the crane, the second officer stood with his left foot on the inboard bulwark and his right foot on the crane drive motor casing; this enabled him to see both the fitter and the load positioned 4m below on the main deck. Operating the crane from the local controls in the pedestal was unsafe. The 2/O's lower left leg became caught in the crane's rack and pinion traversing mechanism when he moved the crane aft for a lifting operation, and was crushed. A helicopter transferred the second officer to hospital, where his leg required amputation below the knee.
