Explosion causing fatal injury during maintenance of Metocean buoy

Safety Flash Published on 4 April 2013 Generated on 28 January 2026 IMCA SF 05/13

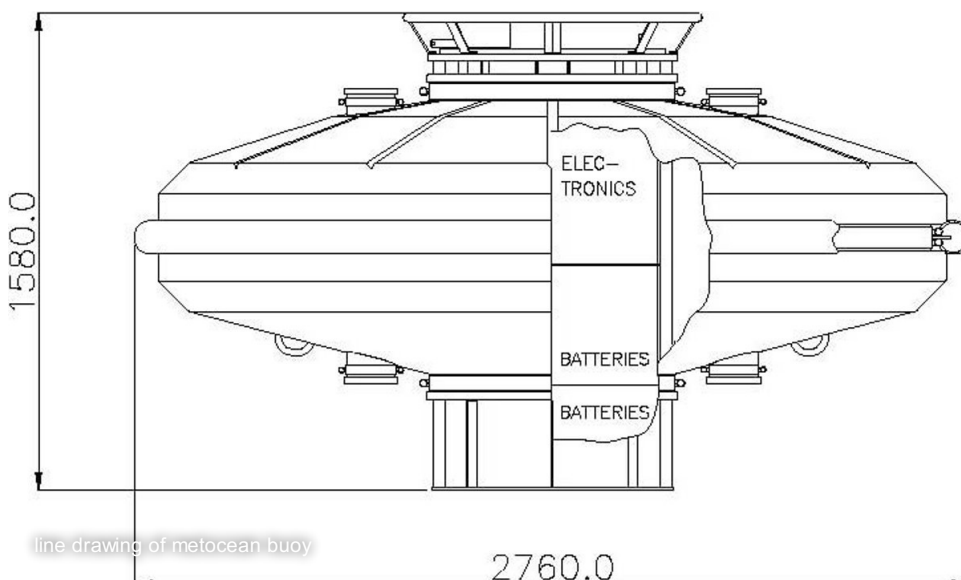
The buoy had a discus shaped hull that could be split in two to ease transportation. A keel with counterweight was mounted under the hull to stabilise the buoy. A cylinder in the middle of the hull contains all electronic modules, the power package and the wave sensor. The different electronic modules were mounted into special splash proof compartment boxes to secure safe handling of the sensitive electronics. The buoy was equipped with a mast to support the meteorological sensors and the communication antennae. The dimensions in the diagram below are in millimetres.

The **immediate cause** of the explosion was found, on investigation, to be sparks from the grinder igniting an explosive mixture of hydrogen and oxygen which had built up inside the compartment. The hydrogen build-up was assumed to stem from the lead-acid batteries.

The **root cause** of the incident was determined to be to a combination of lack of maintenance and a failure to follow existing procedures. The investigation concluded that the following chain of events led to the hydrogen build-up, and eventually the accident.

1. Corrosion around lid sealing due to bird droppings and rain or sea spray caused the sealing to fail.
2. Water, sea salt and bird dropping (guano) ingress into the instrument compartment past the leaking lid sealing.
3. Corrosion and subsequent volume increase on details of battery rack due to ingress.
4. Increased pressure on batteries from rack, resulting in cracked battery cases.
5. Hydrogen build up due to one or more of these effects.
6. Corrosion of aluminium, accelerated by guano and sea salts dissolved in water.
7. Corrosion due to spilled battery acid from cracked batteries.
8. Gas leakage from cracked battery cases.
9. Hydrogen escapes due to leaking lid sealing and increasing temperature.
10. Grinder ignites hydrogen.

- Improvements to warning signs and clearer instructions were developed, and also improved designs for the instrument compartment and battery rack.
- Development of clearer instructions, which emphasise that at all times the buoys should be treated with the assumption that they could contain an explosive gas mixture.

- Exercise particular care with buoys that have not operated normally in the period prior to retrieval.
- Equalise the pressure inside the buoy to the ambient air pressure by opening the gas filling valves.
- Purge the interior of the buoy with air or nitrogen in order to remove any possibility of hydrogen gas, using the procedure described in the user manual.
- Do not allow any ignition source -including power tools -near the buoy until it is fully opened.
- Maintain a safe distance. Only the minimum required number of persons should be in the vicinity of the buoy until it is fully opened. Never stand in direct line of the instrument compartment lid.
- When flushing has been completed, proceed immediately with the opening of the lid.
- Leave the lid fully open for a further 10 minutes.
